EMERGENCY TRANSPORTATION INFRASTRUCTURE RECOVERY
WATER BASIN ASSESSMENT
AND FLOOD HAZARD MITIGATION ALTERNATIVES

FULMER CREEK
HERKIMER COUNTY, NEW YORK

April 2014

MMI #5231-01

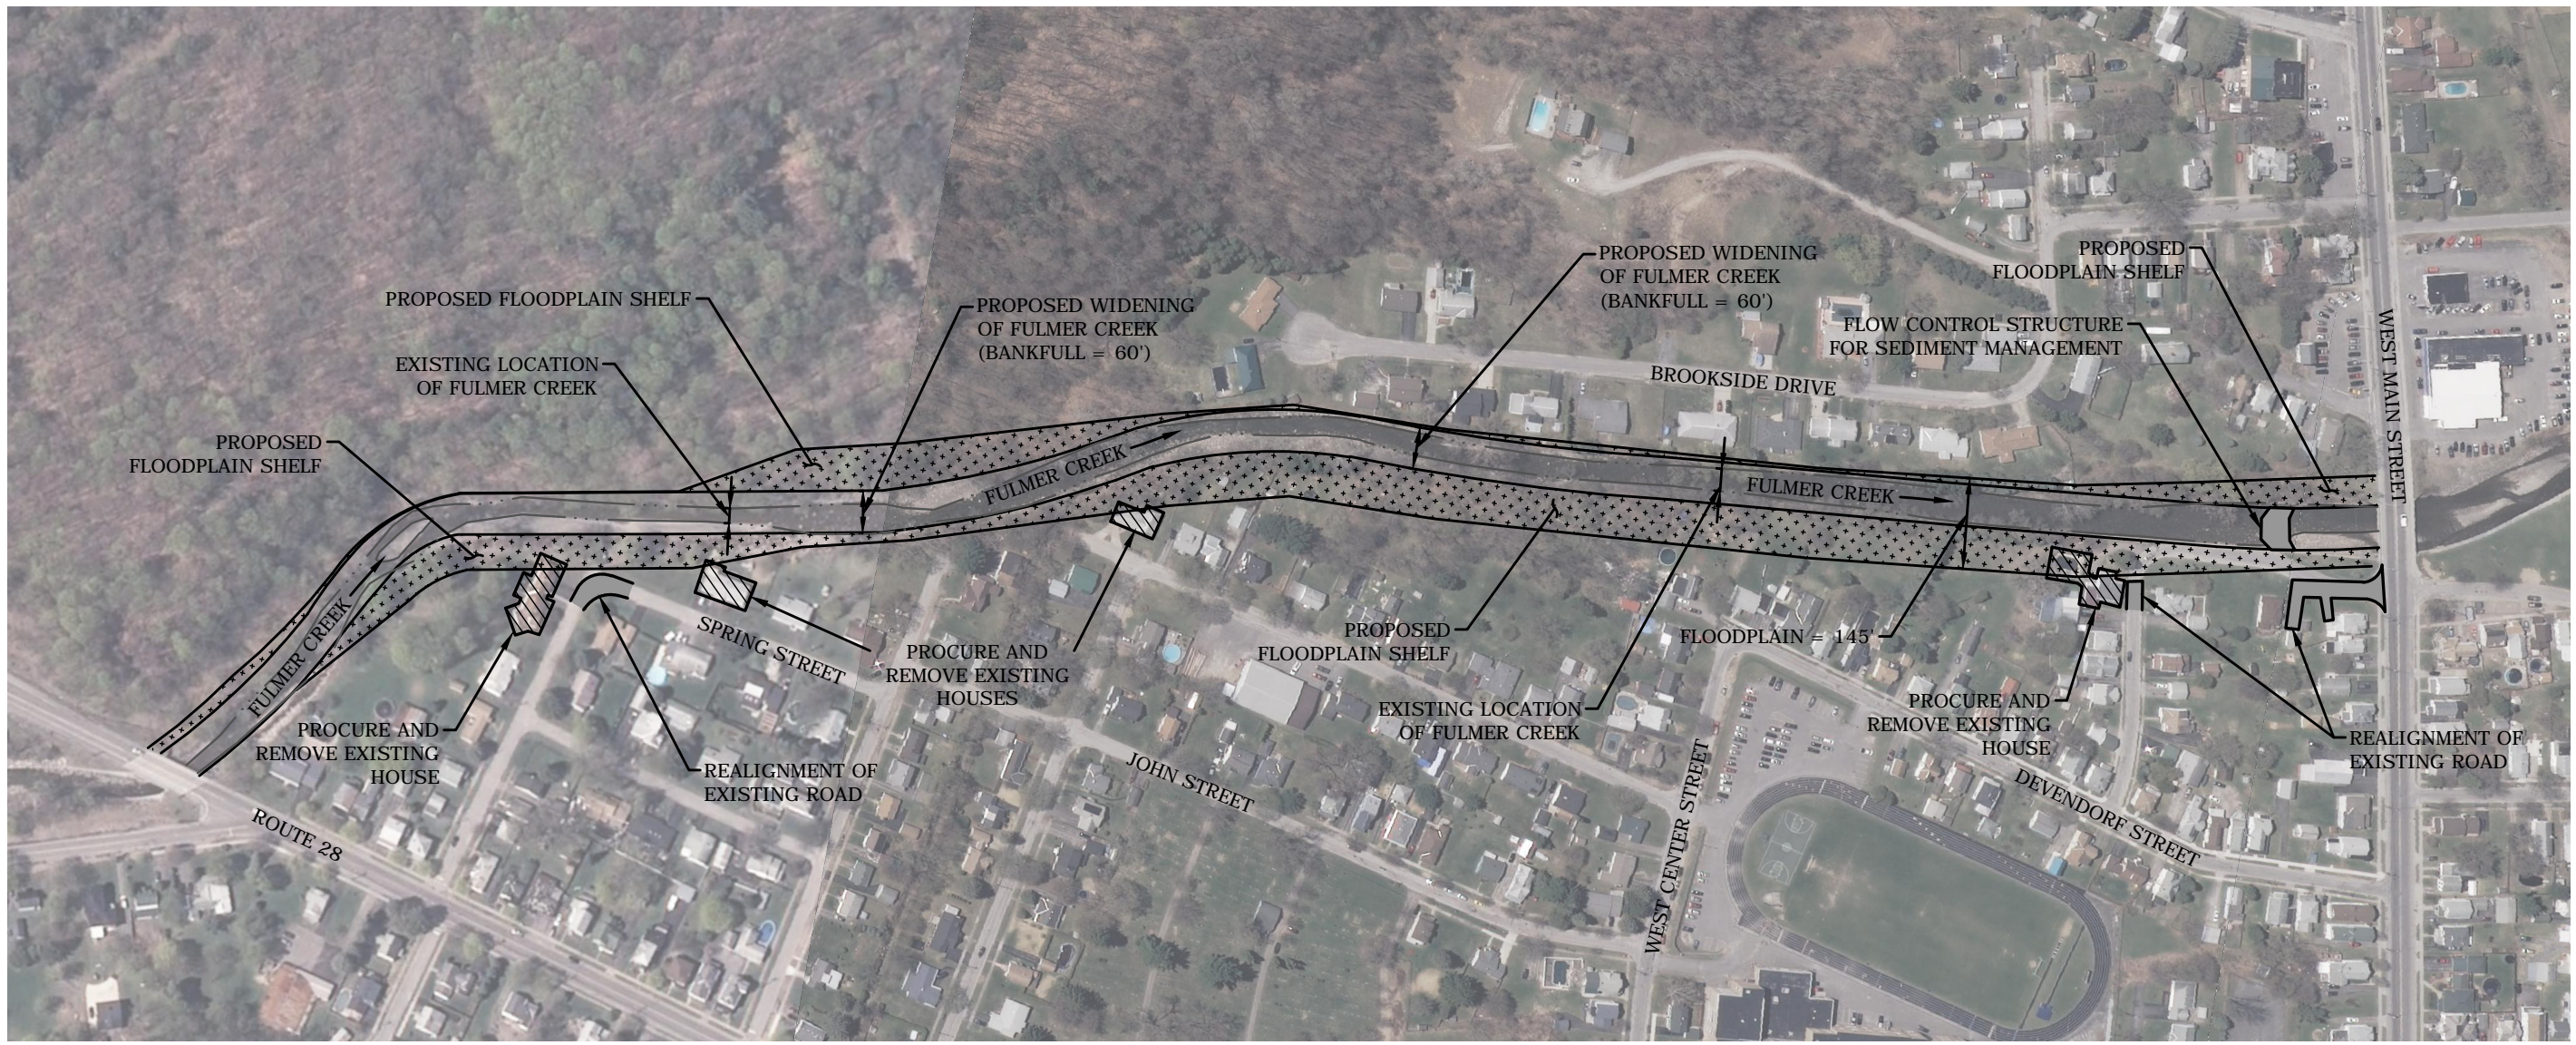
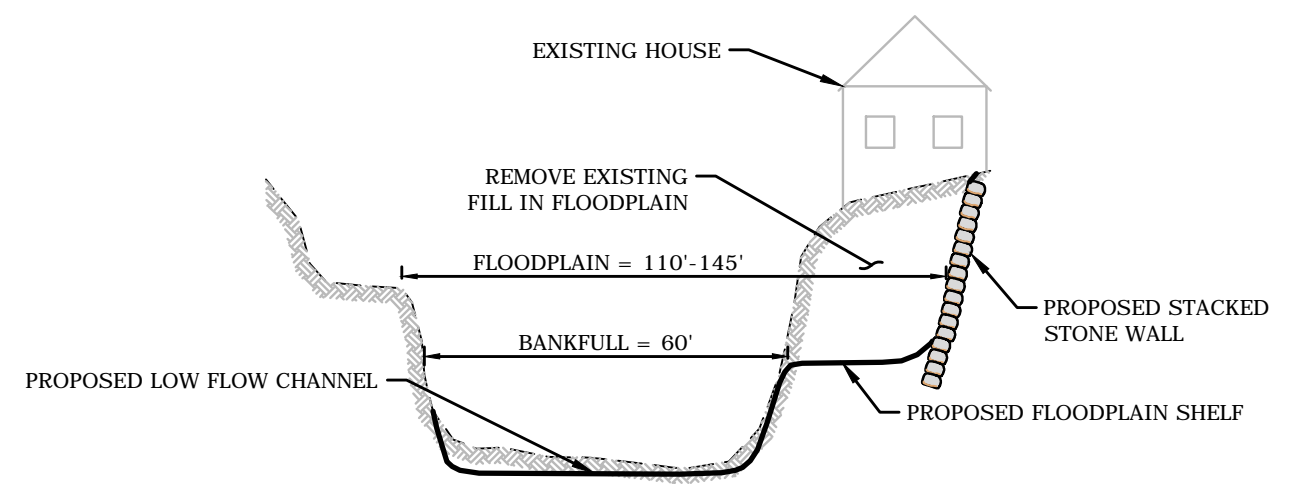
FULMER CREEK HIGH RISK AREA #3 ALTERNATIVE 3-1
WATER BASIN ASSESSMENT AND FLOOD HAZARD MITIGATION ALTERNATIVES
 FULMER CREEK
 MOHAWK, NEW YORK

Figure 10 is a location plan of High Risk Area #3. This area includes Devendorf Street at STA 52+00 to downstream of West Main Street at STA 22+00. Extensive sediment accumulation within the channel was observed in this area, especially where the channel widens between STA 28+00 and STA 22+00. Sediments are reportedly removed annually from this area and taken off-site. Houses have been flooded along Firman Street and Mohawk Central Valley School has received extensive flood damage. Ice accumulations also contribute to flooding in this area, including ice that jams at the Main Street bridge and downstream.

This alternative involves widening the Fulmer Creek channel to better accommodate bankfull flows, and removing fill from the floodplain to create a floodplain bench. This alternative is presented in Figure 11, and involves the following actions:

- a) Acquiring and removing four houses constructed on the banks of the creek.

- b) Restoration of 3,300 linear feet of the creek channel (from Route 28 to West Main Street) to create a floodplain bench and create a more natural channel configuration. The estimated bankfull dimensions would be 60 feet wide by three feet deep; a floodplain bench would range in width between 110 feet and 145 feet wide. Figure 12 is a cross section of a typical compound channel.

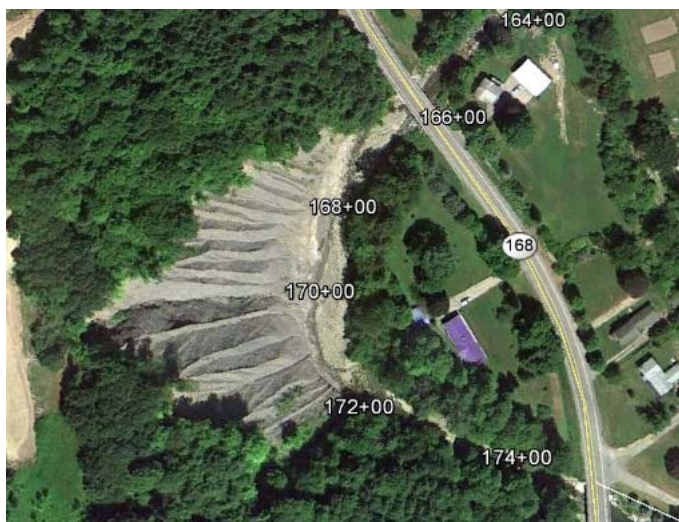
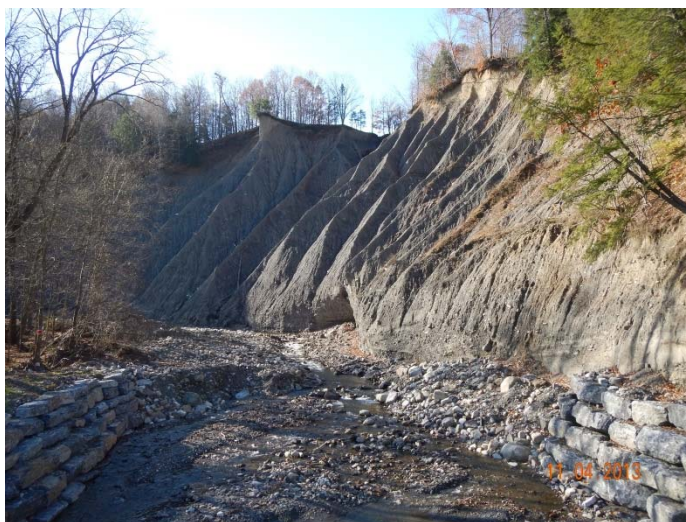
High-Risk Area #1 - Route 168 Double Bridge Site (STA 171+00 to 167+00)

Site Description: The site consists of a high bank failure that is contributing sediments to the creek and threatening a home and property located at the top. The bank failure is 400 feet long and 200 feet high at its highest point, has a slope in the range of 75% to 85%, and is composed of clay intermixed with cobble.

- Acquiring and removing the existing house at the base of the bank failure;
- Moving the creek channel eastward, away from the bank failure;
- Constructing a revetment wall 600 feet in length along the channel at the outside of the bend along the toe of the slope;
- Diverting runoff at the top of the slope to prevent further erosion of the slope;
- Creating a floodplain bench on the inside of the bend; and
- Seeding the slope to promote the growth of vegetation to further stabilize the slope.

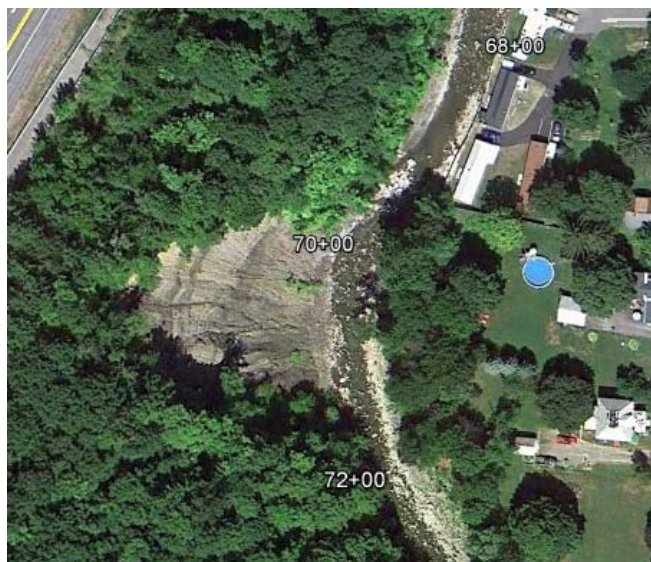
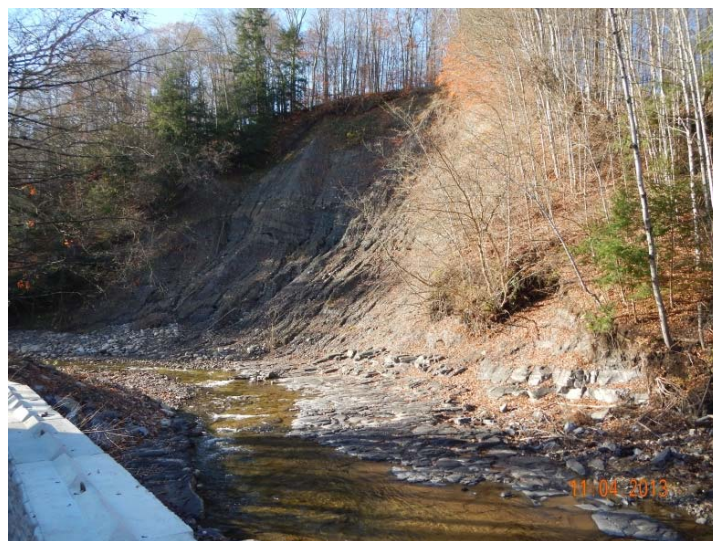
High-Risk Area #2 - High Bank Failure at STA 70+00

Site Description: The site consists of a high bank failure that is actively contributing sediments to the creek. If this bank failure continues to erode, it will threaten a run-away truck ramp located along Route 28, and eventually Route 28 itself. The bank failure is approximately 160 feet long and 90 feet high.

- Acquire properties and remove structures across from bank failure, as necessary for stream alignment;
- Move the creek laterally away from the bank failure;
- Construct 400 ft long revetment wall along toe of slope on left bank, from STA 72+00 to STA 68+00;
- Create floodplain along right bank;
- Once stabilized at its base, seed slope to promote the growth of vegetation.

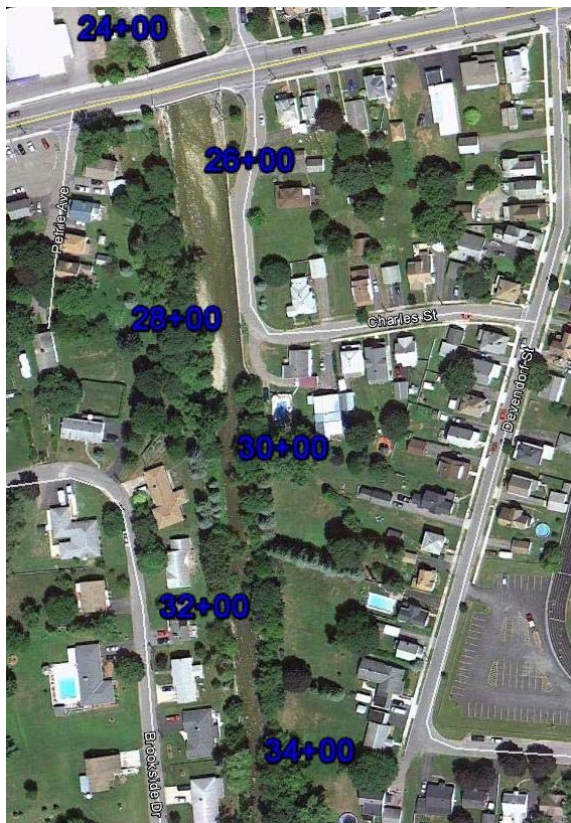
High-Risk Area #3 – Devendorf Street to W. Main Street

Site Description: Severe flooding has occurred in the vicinity of Devendorf Street downstream to the West Main Street Bridge, between STA 52+00 down to STA 25+00.

Restoration of this reach of Fulmer Creek to its pre-development dimensions is recommended for the purpose of increasing flood flow conveyance and reducing bank overtopping.

- acquiring and removing four houses constructed on the banks of the creek;
- restoration of 3,300 linear feet of the creek channel (from Route 28 to West Main Street);
- construction of a floodplain bench;
- construction of flow control structures upstream of the West Main Street Bridge to promote sediment mobility through flatter reach of channel;
- development of parameters for maintenance dredging of accumulated sediment.

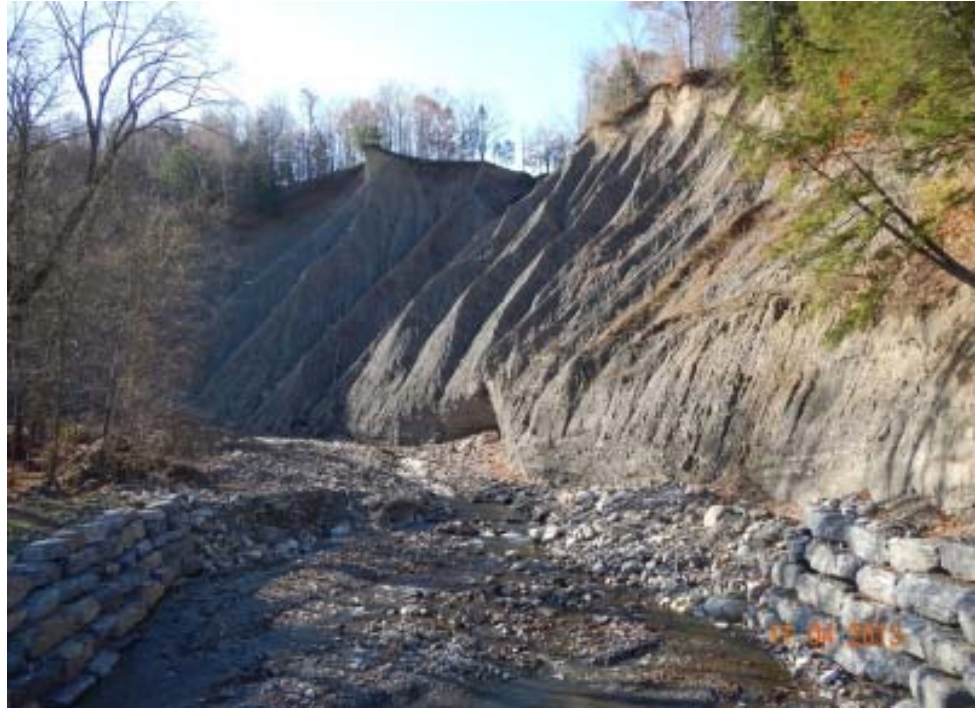
The high bank failure is nearly 500 feet long at its base, and is approximately 220 feet high at its highest point. The failing hillside has a slope in the range of 75% to 85%. The failing material is composed of glacial till that is silty clay intermixed with coarser, cobble-sized rock. The failure of the hillslope is being triggered by lateral erosive action at the toe of the slope, which is occurring along the outside of the bend on Fulmer Creek, combined with local surface runoff that creates gullies.

This is the high bank failure known as the Route 168 Double Bridge Site, viewed looking upstream from the bridge on Route 168 (at STA 166+00).

Alternative 1-1 is recommended as a comprehensive, long-term solution to reduce a major source of sediment in this reach and reduce the erosive water forces on the high bank failure.

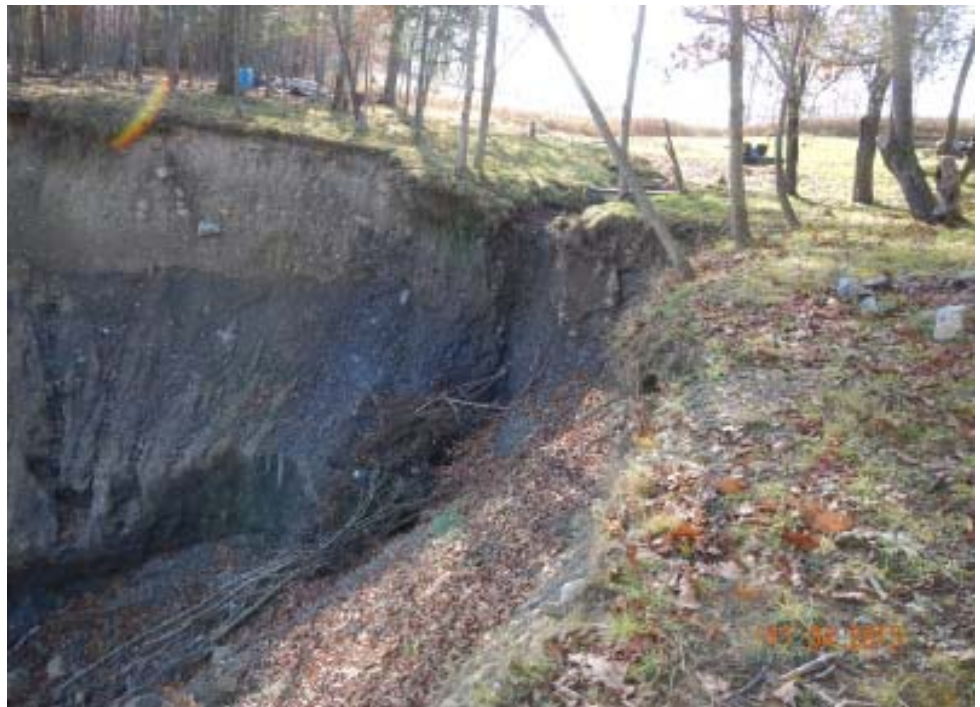
PHOTO NO.:

A private property at the top of the Route 168 Double Bridge Site bank failure.

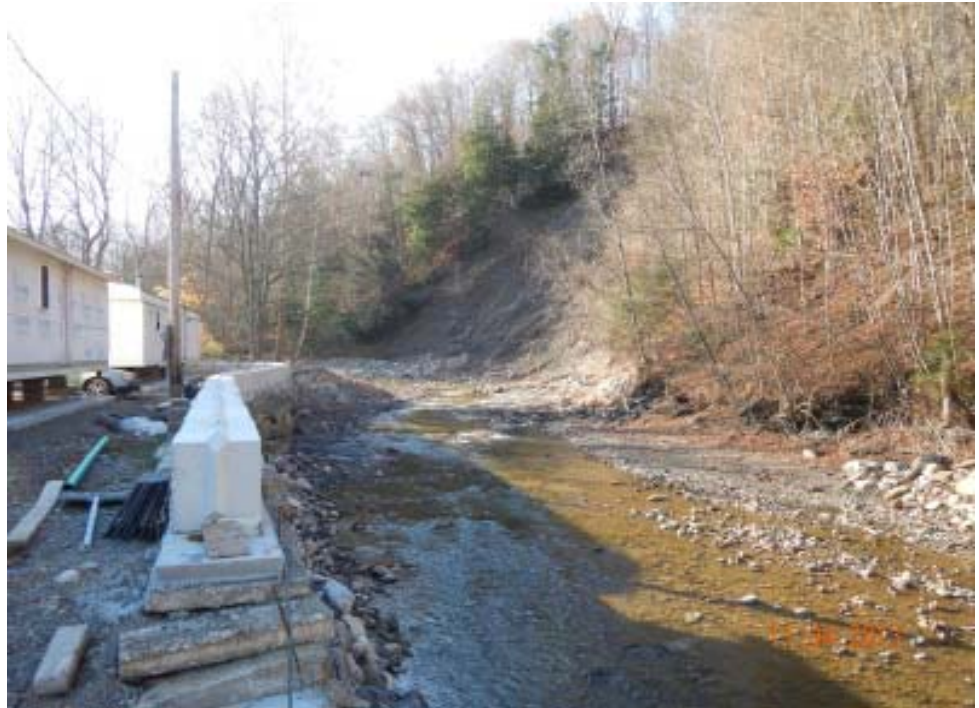
PHOTO NO.:

A high bank failure (STA 70+00) is eroding the left bank, which contributes sediment to Fulmer Creek. This bank failure is approximately 140 feet high, and extends 300 feet long. It is similar in character to the bank failure at High Risk Area #1, but less severe. If this failure continues to erode, it will threaten the run-away truck ramp located along Route 28 and eventually Route 28 itself. Stabilization of this area would eliminate a substantial sediment source in Fulmer Creek, much of which appears to deposit in High Risk Area #3 just upstream of West Main Street.

Bank failure located behind Fulmer Lane Drive (STA 71+00) acting as a sediment source during high flows, and the trailer park to the left that became flooded out during the June 2013 flood event.

The favored approach to stabilizing this bank failure would be to design a bank treatment similar to that proposed in Alternative 1-1. Relocating the channel to lessen the severity of the meander bend and stabilizing the toe of the bank failure will arrest the active erosion, and allow the bank to begin vegetating and self-healing.

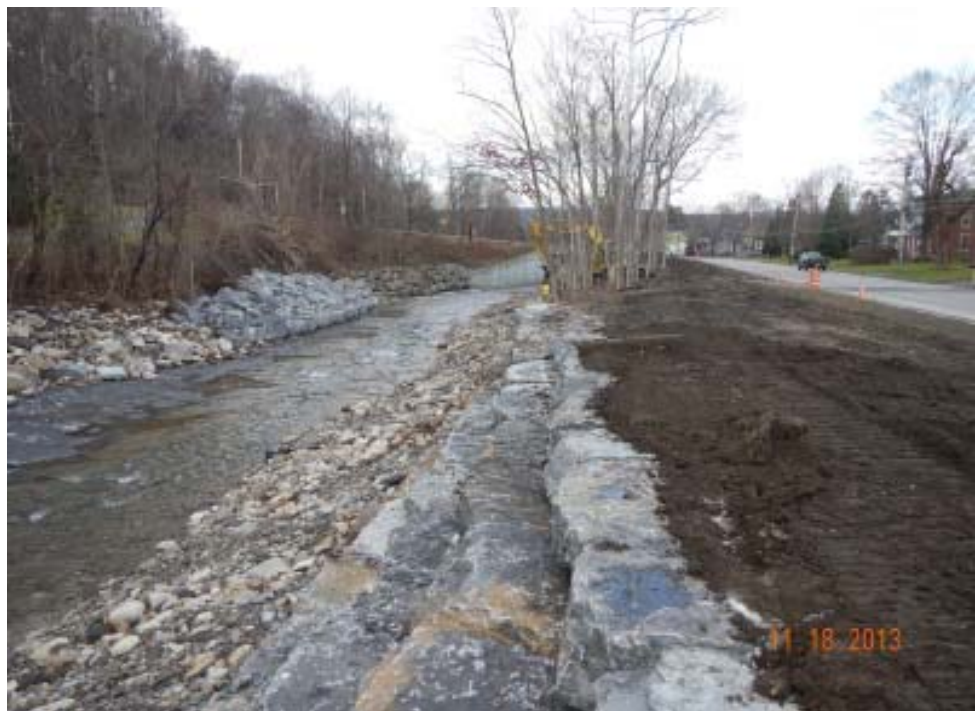
PHOTO NO.:

Looking downstream Fulmer Creek towards the Route 28 bridge (STA 58+00), at this location the channel has overtopped and flowed towards the village, creating flood damage. An stacked rock wall and earthen berm is under construction in the photo along the right bank.

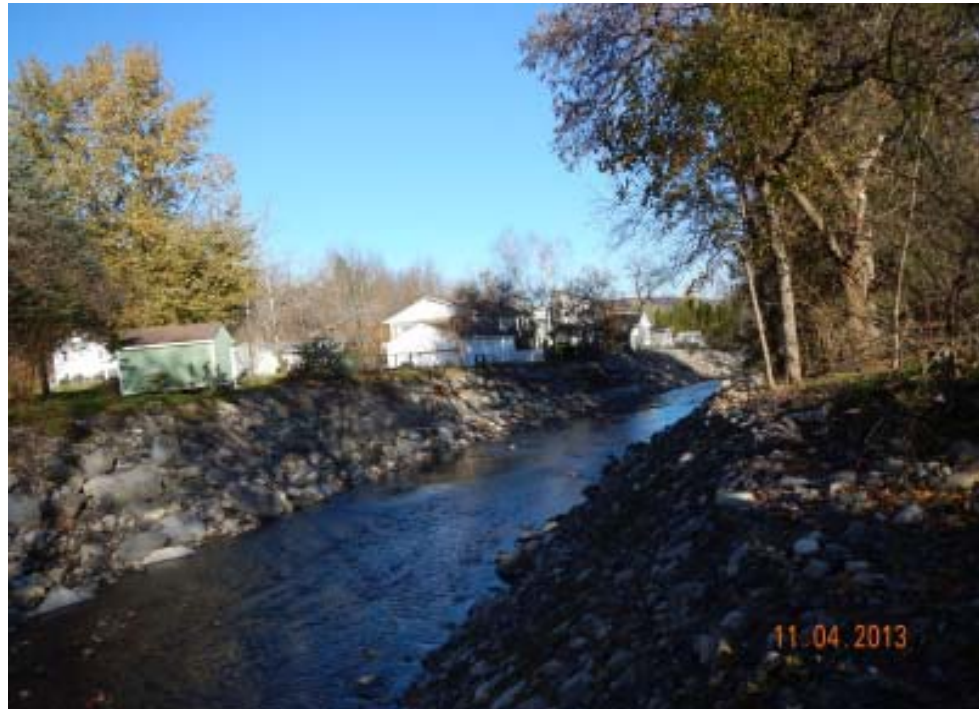
PHOTO NO.:

Recently redged channel just upstream of Devondorf Street, near STA 36+00, an example of the undersized channel along this section of Fulmer Creek.

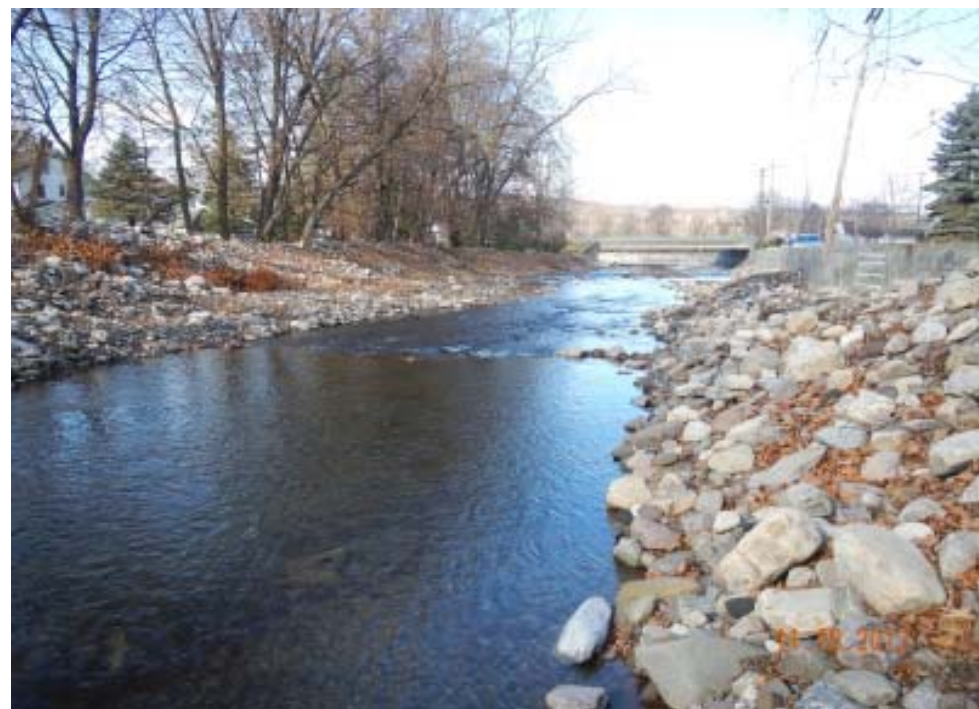
PHOTO NO.:

View from the end of Charles Street (STA 28+00), looking downstream towards the W Main Street bridge (STA 25+00). This section of channel is overly wide and ice and debris jams occur in this area.
