EMERGENCY TRANSPORTATION INFRASTRUCTURE RECOVERY
WATER BASIN ASSESSMENT
AND FLOOD HAZARD MITIGATION ALTERNATIVES

SAUQUOIT CREEK
ONEIDA COUNTY, NEW YORK

April 2014

MMI #5231-01

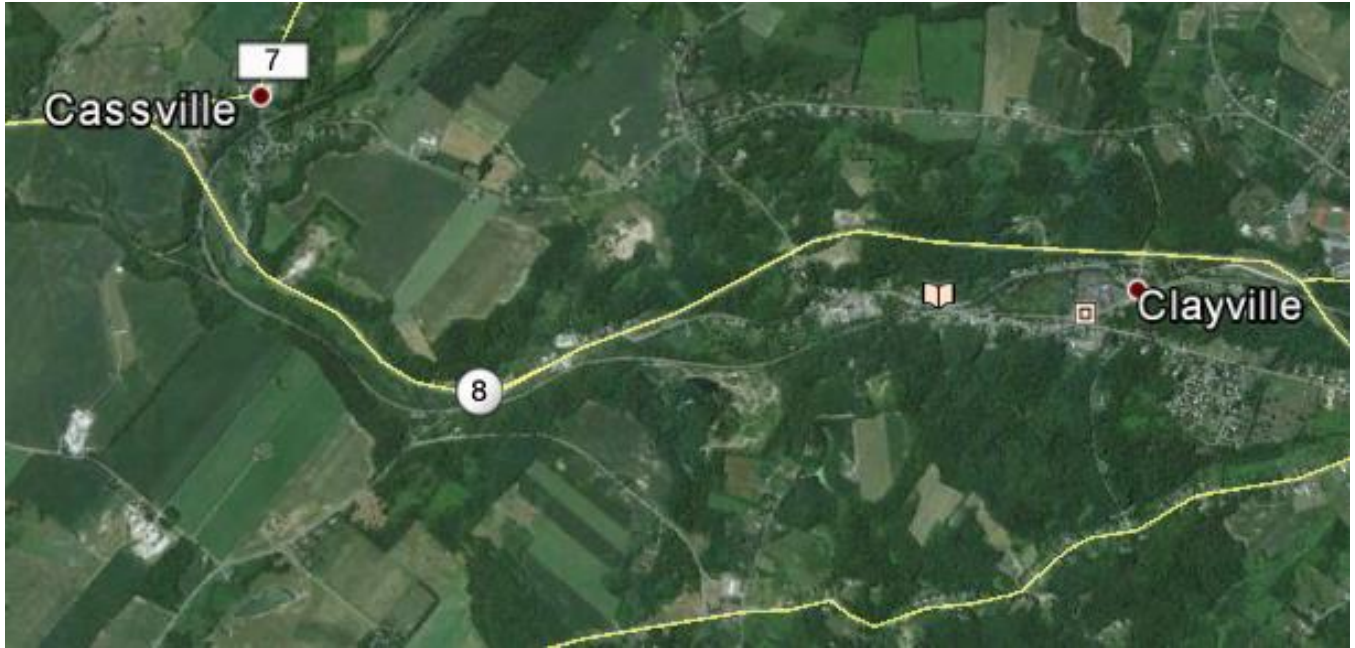
High-Risk Area #1: Failing Dams in the Upper Sauquoit Creek Basin (STA 903+00 to 726+00)

Site Description: Extending from Summit Road in Cassville at STA 903+00 downstream to Main Street in Clayville at STA 726+00, are several low head dams that are in various stages of disrepair. These have created unstable channels with eroding channel bed and banks as well as high sediment load.

- Remove low head dams to restore and stabilize this section of Sauquoit Creek.

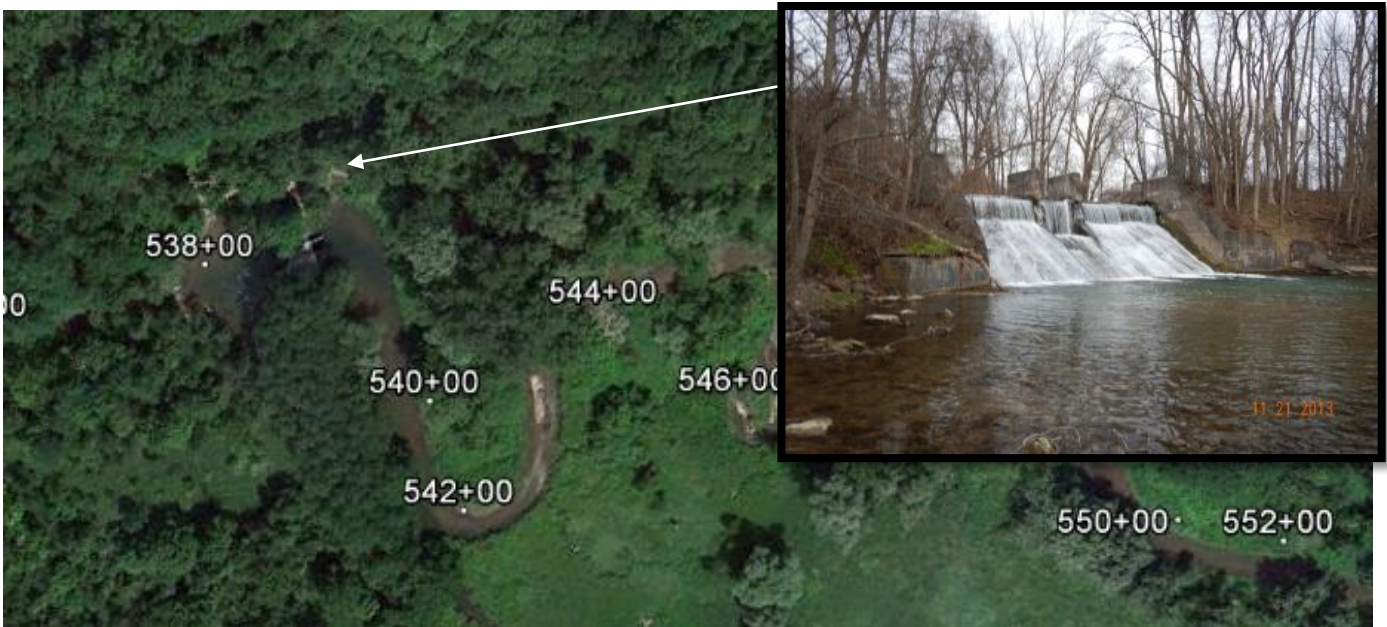
High-Risk Area #2: Dam in Poor Condition (STA 538+00)

Site Description: This dam is located in a remote area between Route 8 and the railroad line and is in poor condition. The dam is holding back a substantial amount of water as well as sediment posing a threat to downstream communities. Immediate action should be taken to inspect the dam for structural integrity.

- Further analysis is needed to guide the decision of whether dam repair/rehabilitation or dam, removal is the best course of action. Sediment quality and potential flood protection are key issues that need to be explored. No action will eventually lead to complete failure of this structure.

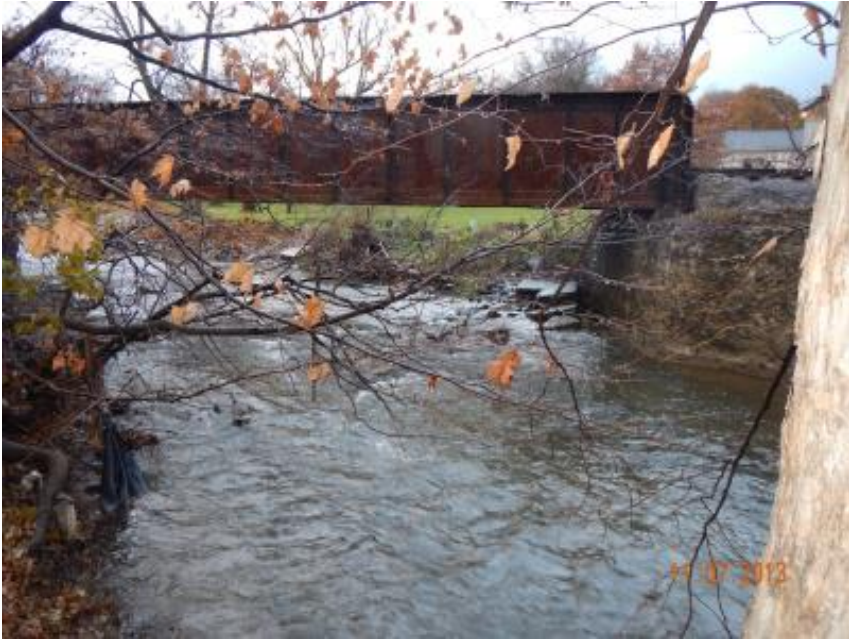
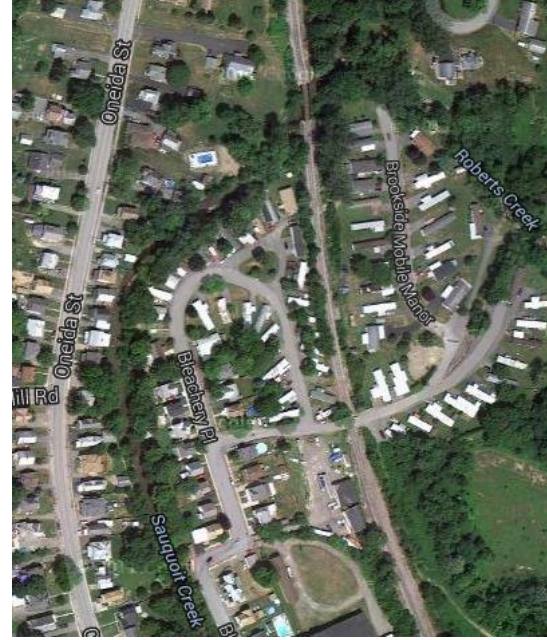
High-Risk Area #3: Brookside Mobile Manor (STA 478+00 to STA 455+00)

Site Description: The Brookside Manor Trailer Park area is a tightly developed section along the banks of Sauquoit Creek and has experienced heavy flooding in the past. Undersized bridges, a low head dam, and inadequate channel are the primary contributions to flooding issues in this reach.

- Replace the Bleachery Avenue bridge at STA 472+00, remove the low head dam immediately upstream, and undertake channel modifications in this reach.
- Replace the Railroad Bridge at STA 455+50.

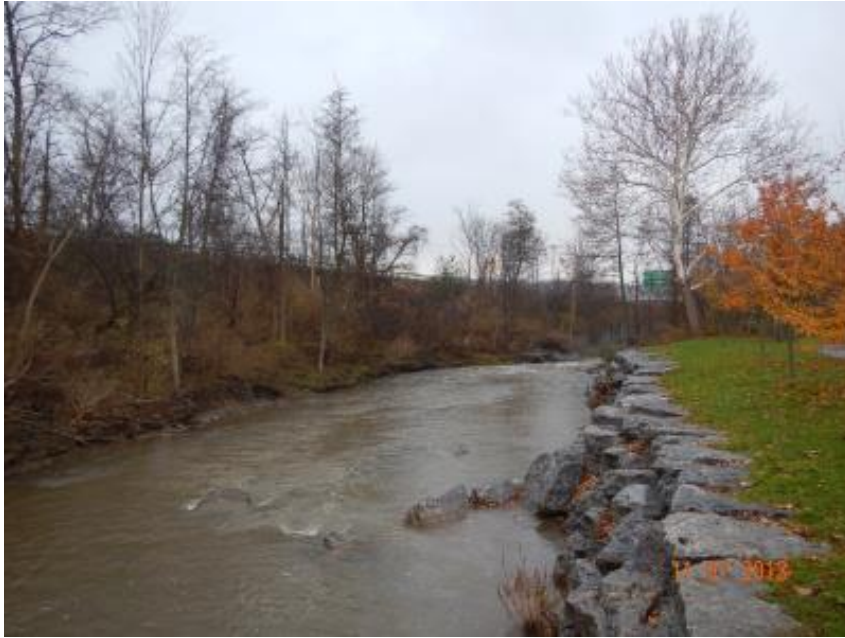
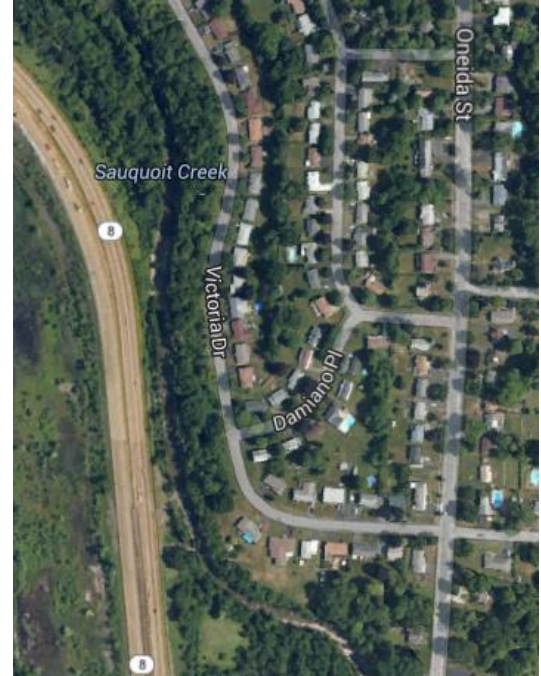
High-Risk Area #4: Flooding Near Victoria Drive (STA 330+00 to 262+00)

Site Description: Beginning at STA 330+00, adjacent to Victoria Drive, Sauquoit Creek overtops its banks and causes flood damage to homes along the drive. Floodwaters also overtop the banks downstream at STA 300+00 and 291+00, causing flooding of homes along Brookline Drive. The photograph below shows the repaired bank with a stacked rock wall along Brookline Drive and an aerial image of the floodprone section of Victoria Road.

- Restore the channel and floodplain through this reach including widening of banks of Sauquoit Creek to incorporate a floodplain bench. This could affect up to 6,000 feet of channel, with roadway and property impacts.

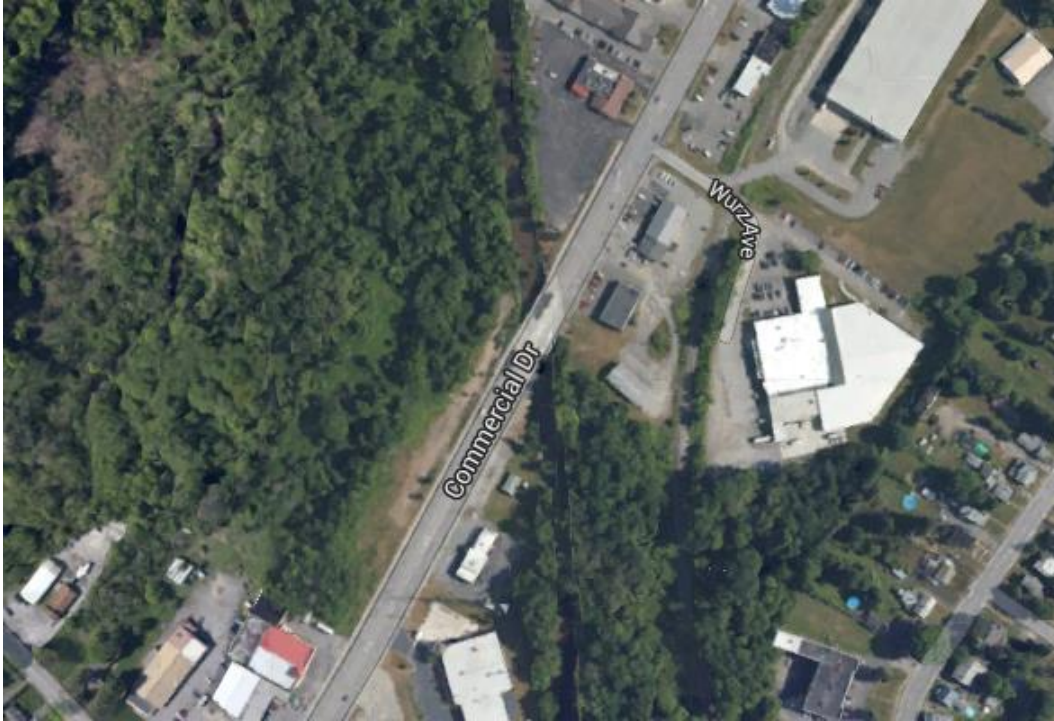
High-Risk Area #5: Undersized Bridge at STA 165+00

Site Description: The Commercial Drive bridge crossing at STA 165+00 acts as a constriction to floodwaters. The bridge is poorly aligned with the channel, which further reduces the capacity of the bridge. The impacted area includes several commercial structures, a park, and several homes.

- Replace the Commercial Drive Bridge with a larger structure that spans the full bankfull width of the creek.

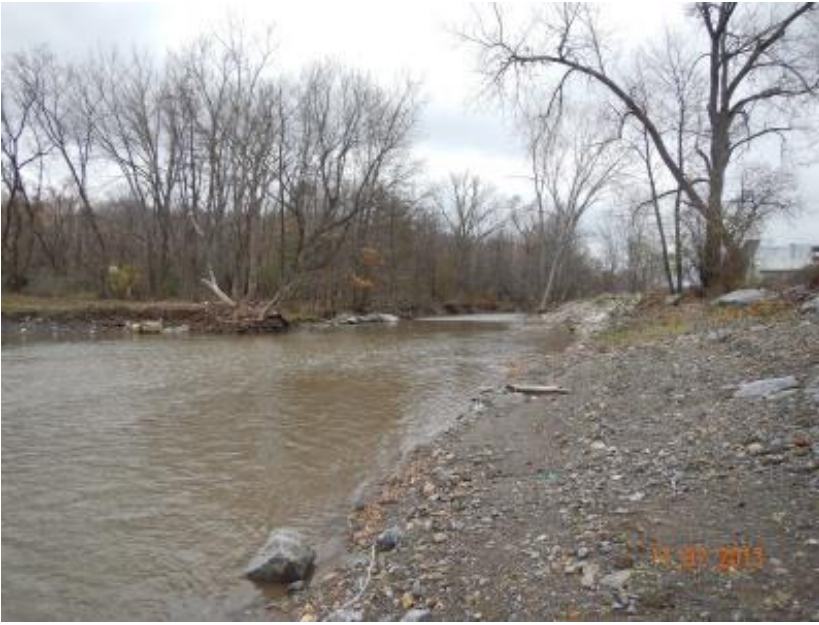
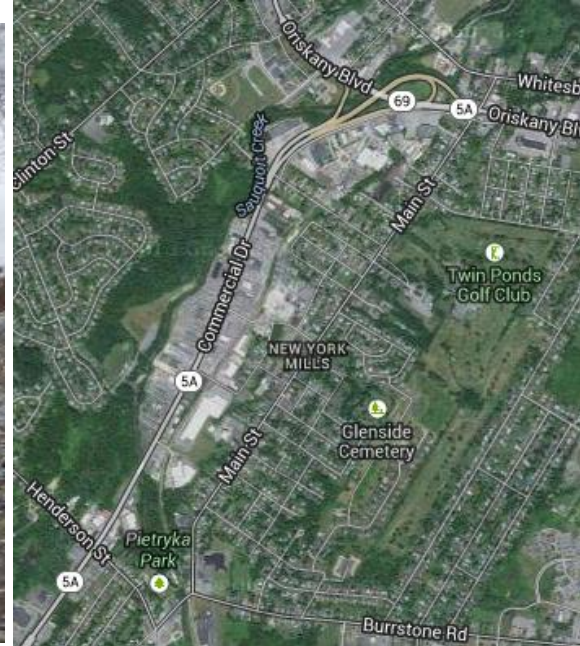
High-Risk Area #6: Commercial Drive (STA 176+00 to STA 0+00)

Site Description: The highly commercialized area from Commercial Drive downstream to the confluence with the Mohawk River experiences severe flooding during high magnitude storm events. High concentration of development in combination with inadequately sized channels create the conditions for the extreme flooding that occurs.

- Replace undersized bridges including the railroad bridge at STA 62+75, Main Street Bridge at STA 80+00, Oriskany Boulevard Bridge at STA 92+00, and the Route 5A on-ramp Bridge at STA 97+50.
- Create a floodplain bench from STA 105+00 to STA 151+45.

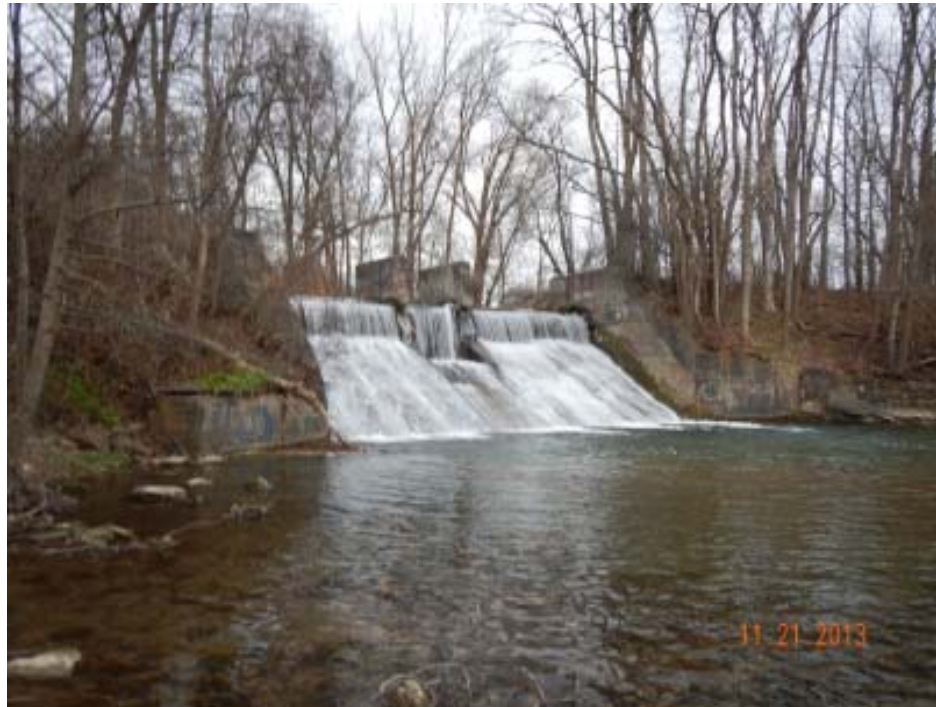
Located at station 538+00, this dam is in poor condition posing a risk to downstream development.

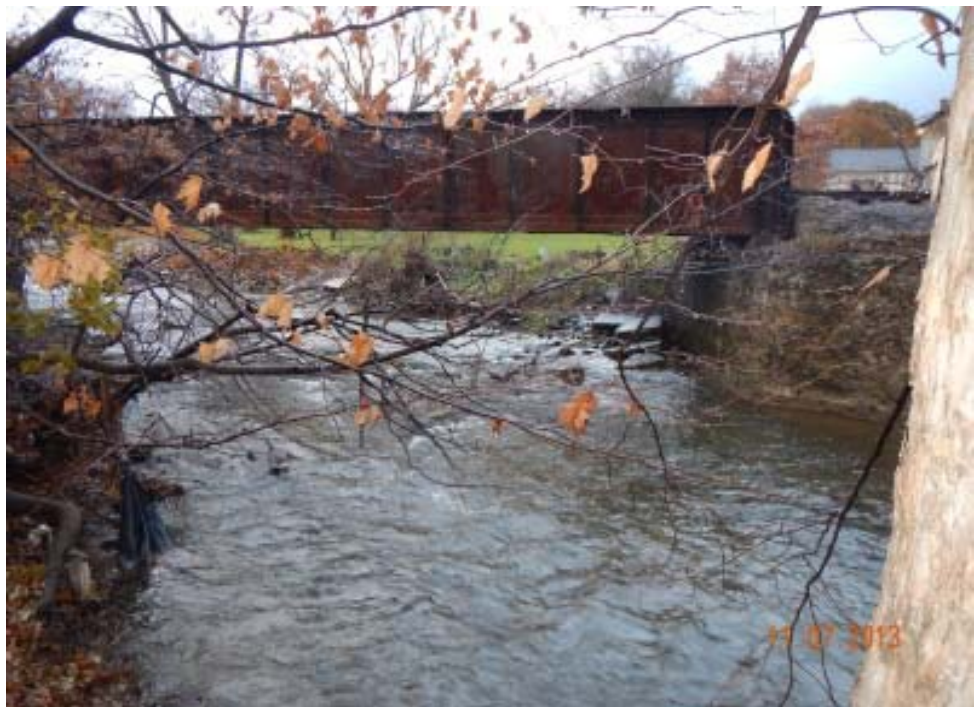
2

An upstream railroad bridge around station 456+00 adjacent to a tightly developed area. Represents one of the undersized railroad bridges along Sauquoit Creek.

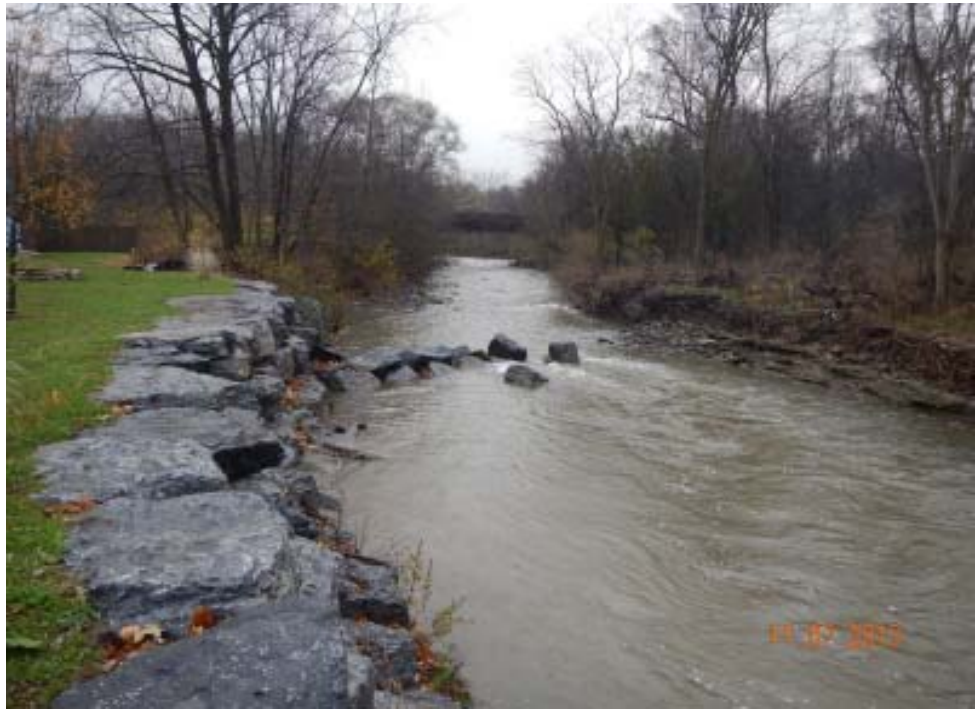
3

A look upstream from station 300+00 where a stone reventment wall was installed to deter incising of the channel banks.

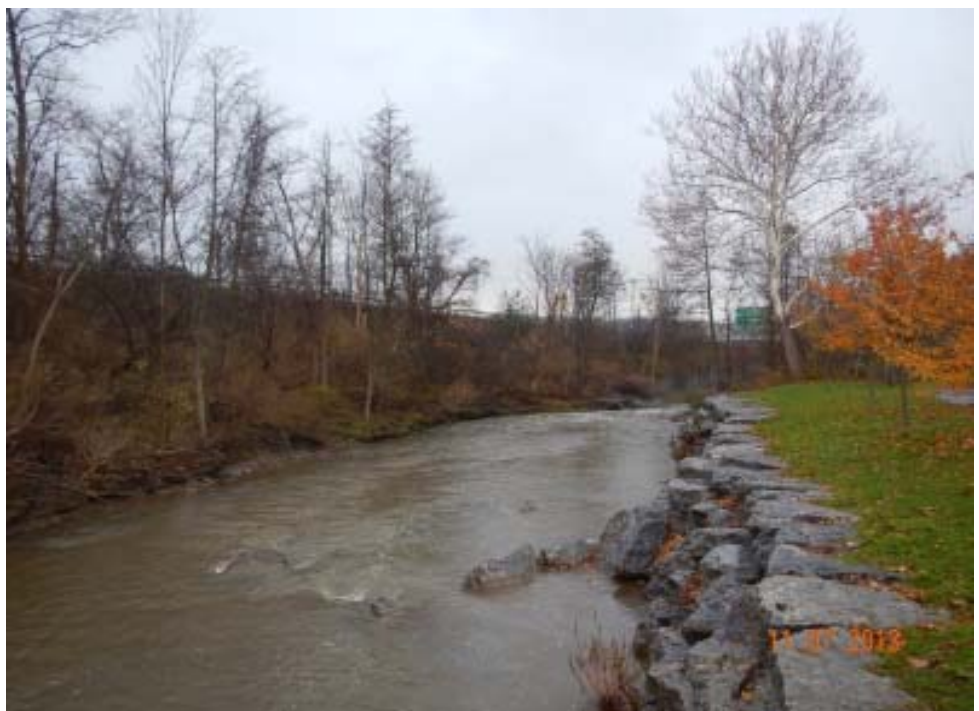
4

Looking downstream from the same location as Photo 2, the area just downstream at station 291+00 is reported as jumping its banks during peak flows.

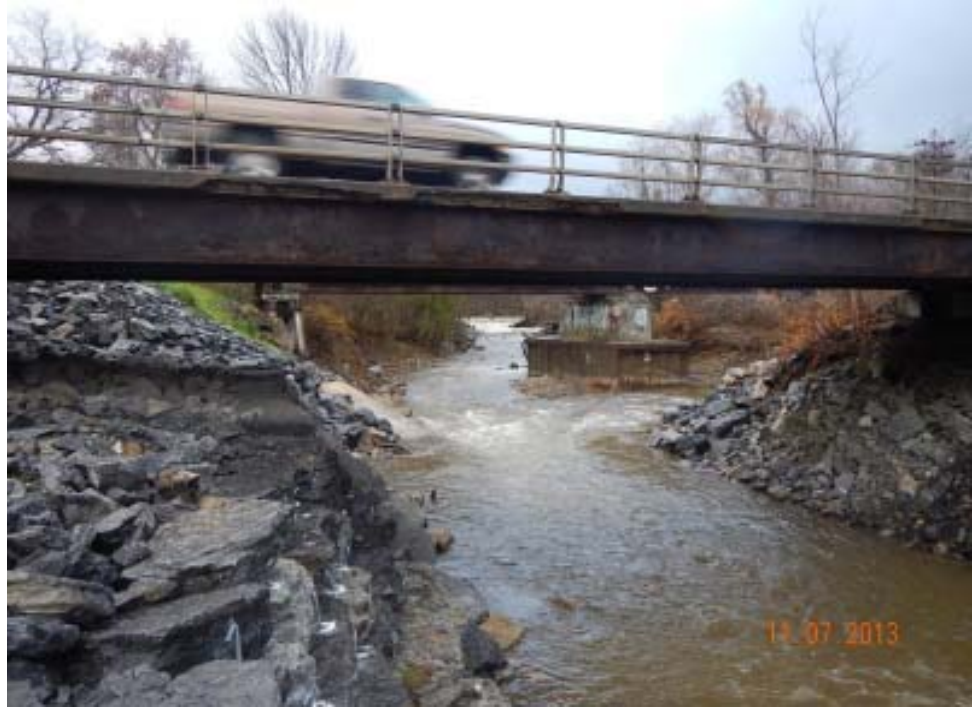
5

Photo taken looking upstream from station 236+00 at the Chenango Road crossing which is believed to cause hydraulic constriction.

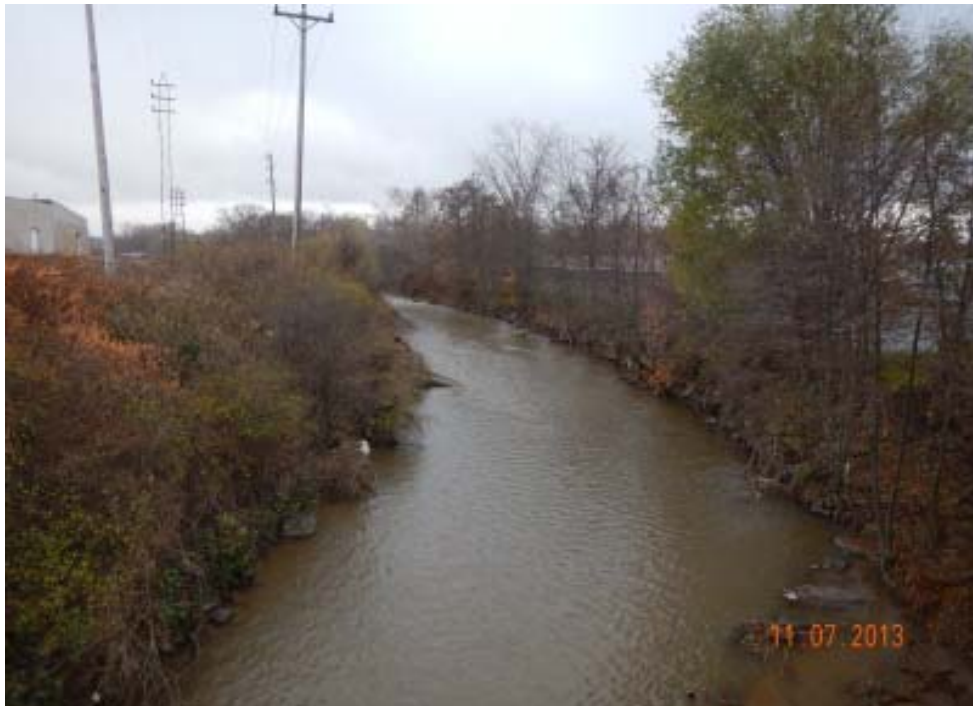
6

Located at the Clinton Street crossing, station 187+00, upstream is a recently installed flood control berm and downstream the heavily developed Commercial Drive that experiences severe flooding.

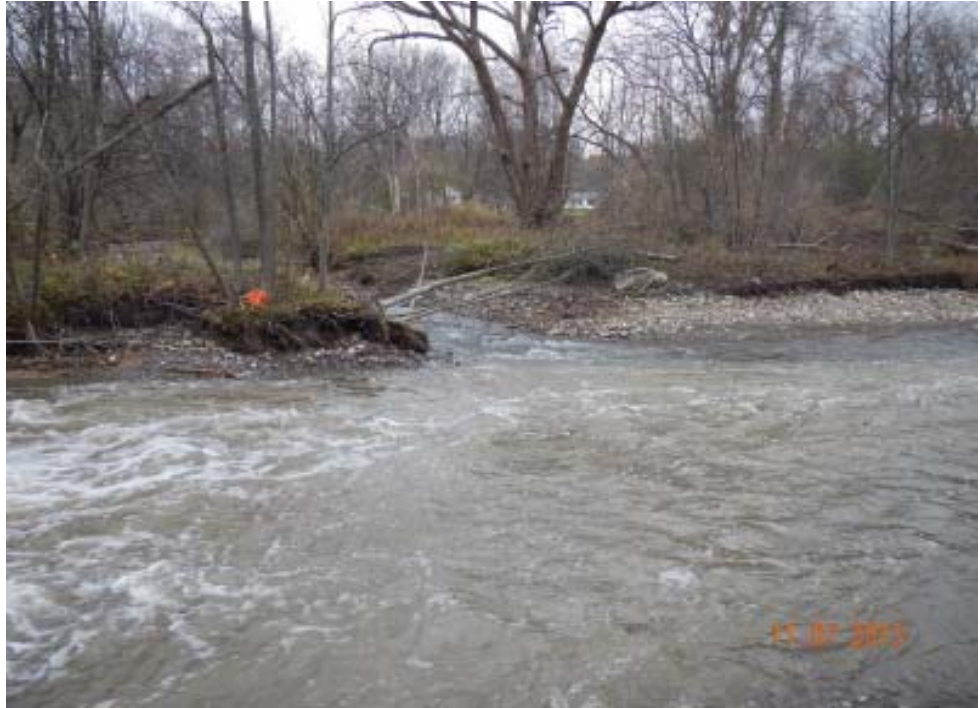
The convergence of Mud Creek and Sauquoit Creek behind Commercial Drive at station 157+00.

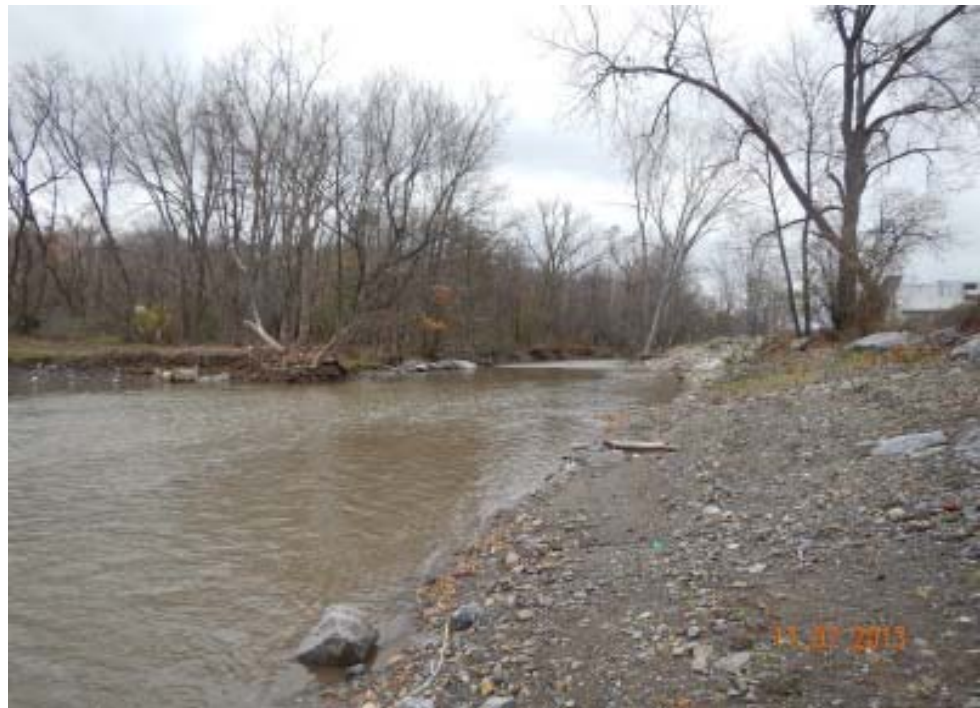
8

Just downstream of Mud Creek's mouth, this area of car dealerships along Commercial Drive, experiences severe flooding exacerbated by the input of Mud Creek.

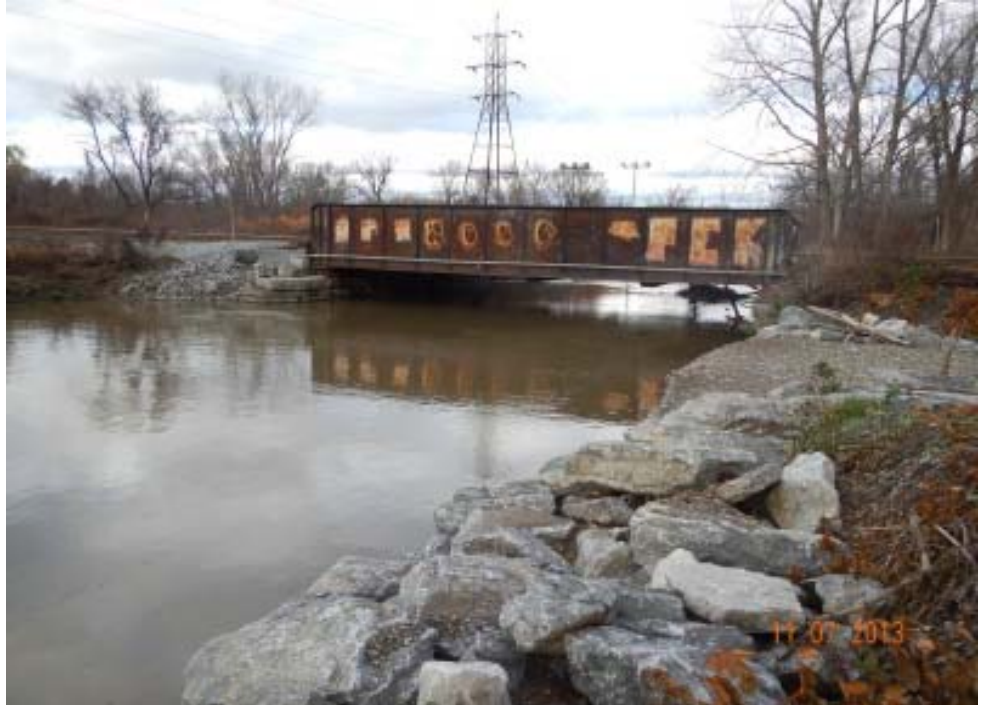
This low railroad bridge crossing at station 63+00 is an example of an undersized bridge crossing.
