**EMERGENCY TRANSPORTATION INFRASTRUCTURE RECOVERY**  
**WATER BASIN ASSESSMENT**  
**AND FLOOD HAZARD MITIGATION ALTERNATIVES**

**WEST CANADA CREEK**  
**HERKIMER COUNTY, NEW YORK**

April 2014

MMI #5231-01

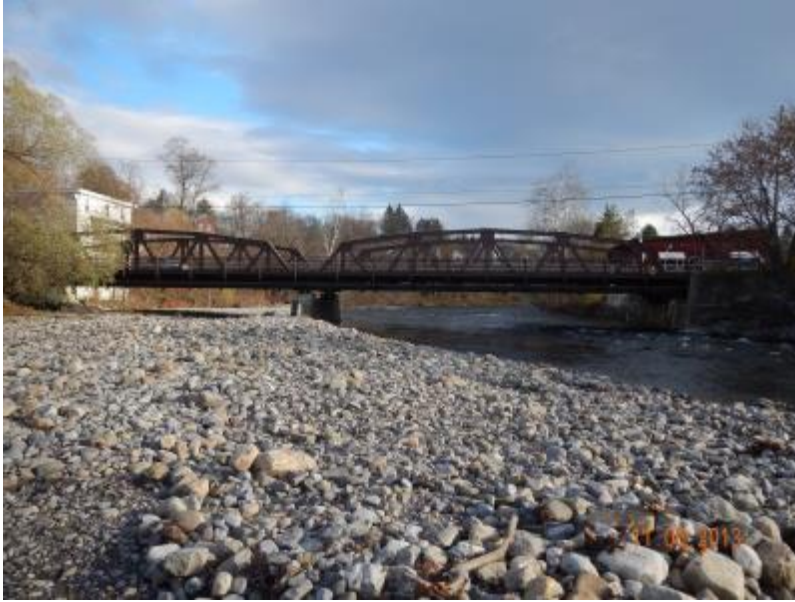
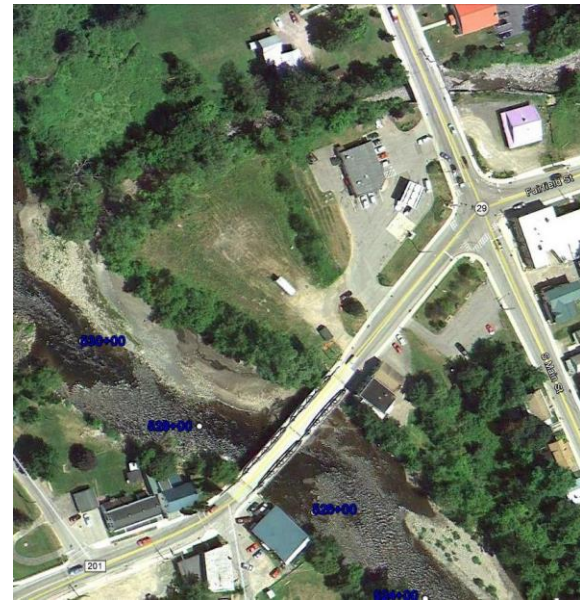
## High-Risk Area #1: High Volume Aggradation Zone (STA 523+00 to 532+00)

A large cobble sediment bar was observed under the Route 28 bridge in Middleville (STA 527+00). The sediment is almost entirely blocking the left (eastern) span of the bridge. The source of the sediment is Maltanner Creek, which enters West Canada Creek just upstream of the Route 28 bridge on the left (east) bank.

Substantial accumulations of sediment have formed in two specific areas of West Canada Creek. A large lateral sediment bar has formed between STA 532+00 and STA 523+00, upstream of and under the bridge over West Canada Creek at Bridge Street (Route 28) in Middleville. The sediment is composed primarily of cobble and is almost entirely blocking the left (eastern) span of the bridge, substantially reducing the hydraulic capacity of the channel as it passes under the bridge. This reduction in channel capacity has resulted in an increase in water surface elevations upstream of the Route 28 bridge and has contributed to flooding of homes along Fishing Rock Road. The source of the sediment is primarily Maltanner Brook, which enters West Canada Creek at STA 532+00, just upstream of the Route 28 bridge on the left side.

**Site Description:** Located under the left (northeast) span of the Route 29 Bridge over West Canada Creek in Middleville, just downstream of Maltanner Creek, a lateral cobble sediment bar has formed. Under high velocity flows, these materials are carried from Maltanner Creek and deposited in the channel, effectively decreasing channel capacity and exacerbating flood conditions.

Alternative 1-2: Remove Excess Sediment from Channel in Middleville (STA 523+00 to STA532+00)

- Remove aggregated sediment from the channel bar and relocate outside of floodplain.

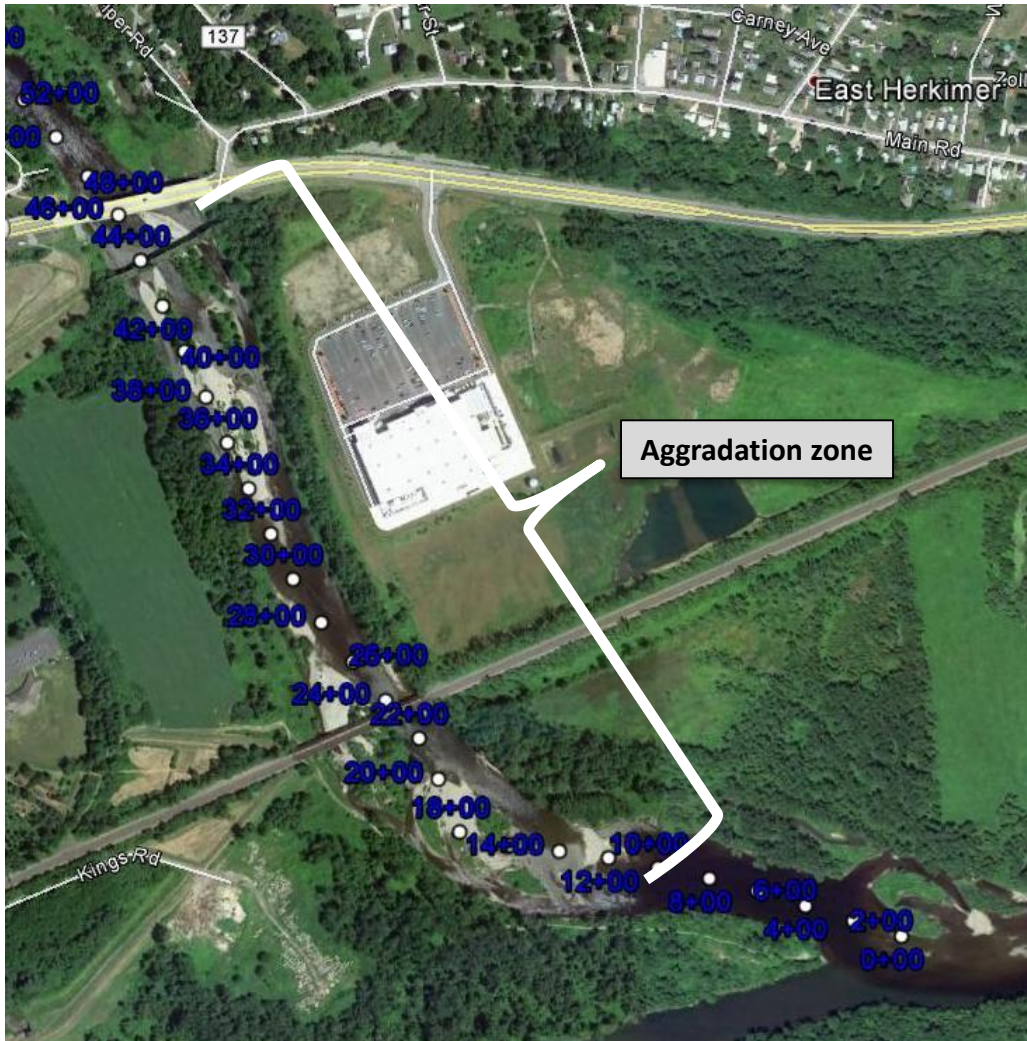
## High-Risk Area #2: Aggradation Zone (STA 0+00 to STA 46+00)

A substantial accumulation of coarse-grained sediment has also formed in the channel near the outlet of West Canada Creek, downstream of the East State Street (Route 5) bridge, from STA 46+00 downstream to STA 10+00. Aggradation is occurring at this location as flow velocities decrease where the creek flattens and widens and enters the backwater effect of the Mohawk River. Ice jams occur in this area and contribute to flooding. Due to the physical characteristics of this reach of West Canada Creek, it will continue to act as a dynamic section of channel where sediment bars form and the channel shifts its location.

**Site Description:** A substantial accumulation of coarse grained sediment has formed in the channel near the outlet of West Canada Creek, downstream of the East State Street (Route 5) Bridge, from STA 46+00 downstream to STA 10+00. Aggradation is occurring at this location as flow velocities decrease where the creek flattens and widens and enters the backwater effect of the Mohawk River. Ice jams occur in this area, and contribute to flooding.

Alternative 1-3: Remove Excess Sediment on Lower West Canada Creek (STA 0+00 to STA 46+00)

- Remove aggregated sediment from the channel and relocate outside of floodplain.

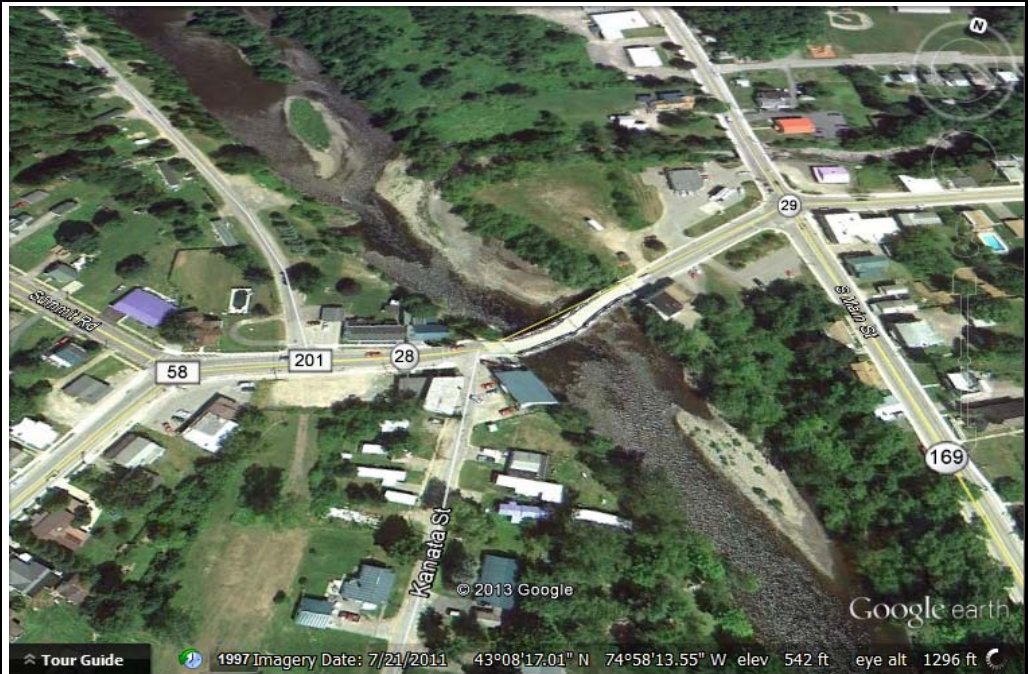
Aerial photograph from Google Earth showing Route 28 bridge. Maltanner Creek enters West Canada Creek just upstream of the bridge, bringing sediment with it. A sediment bar has formed which extends through the bridge and has begun extending downstream of the bridge as well.

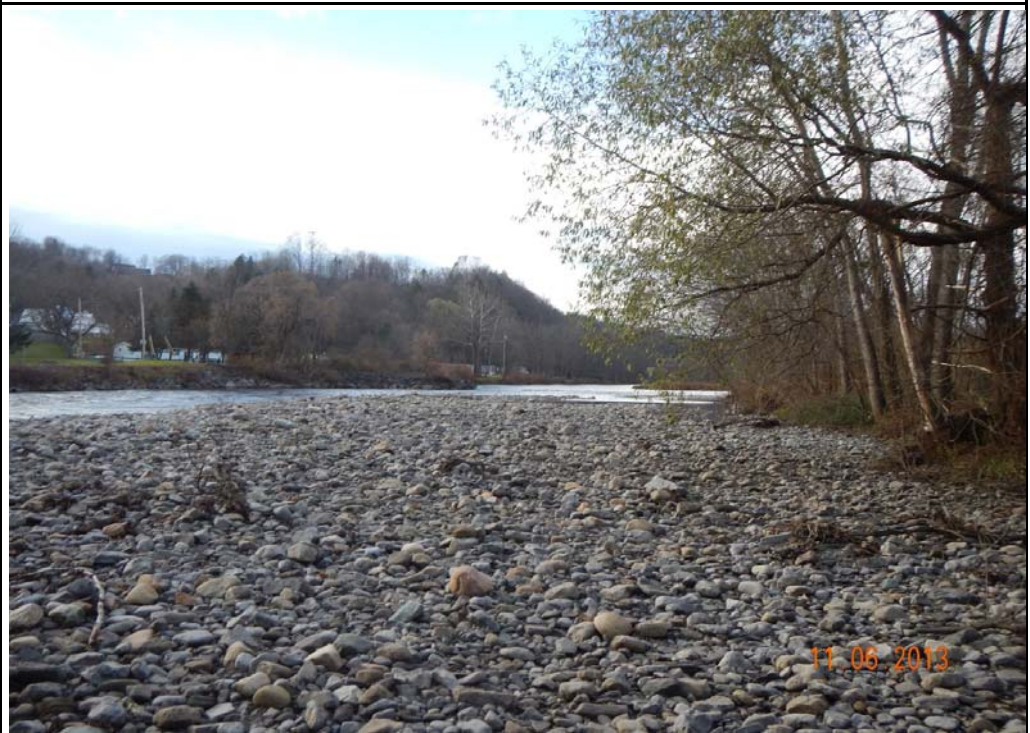
**2**

A representative photograph of the sediment bar. The sediment seems uniform in size, ranging from coarse sand to small cobbles.

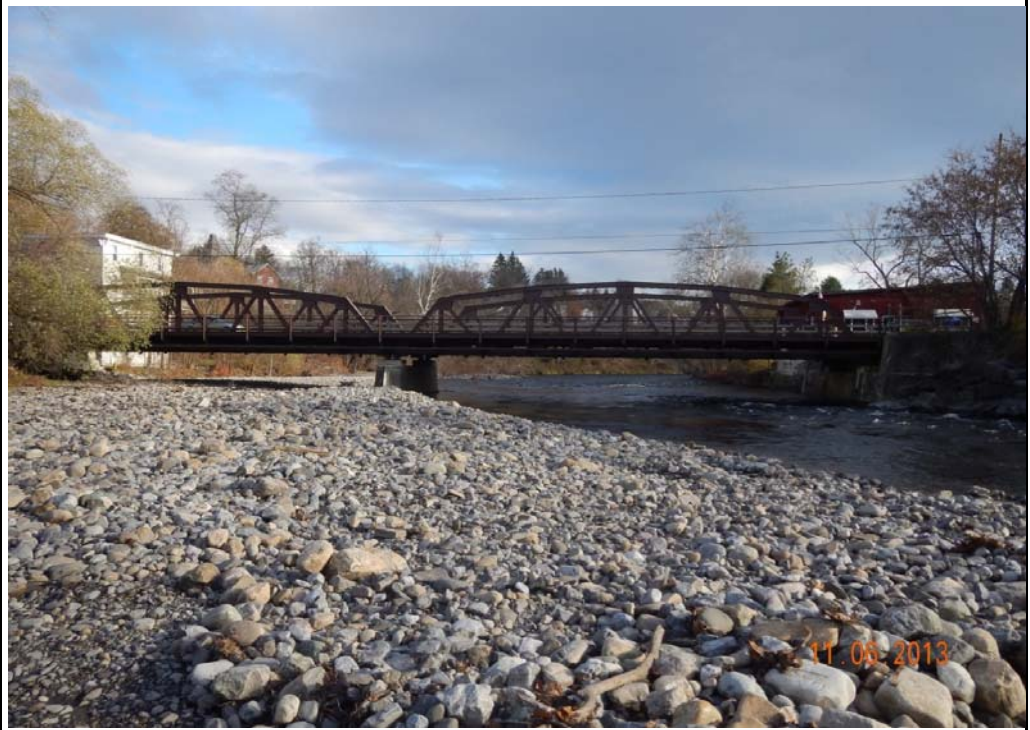
The sediment bar extends to the bridge, and limits the capacity of the bridge to carry flows. The bar extends to the central pier, affecting the hydraulic capacity of the entire eastern span, and limiting the bridge opening by almost half.
