EMERGENCY TRANSPORTATION INFRASTRUCTURE RECOVERY WATER BASIN ASSESSMENT AND FLOOD HAZARD MITIGATION ALTERNATIVES

ORISKANY CREEK ONEIDA COUNTY, NEW YORK

April 2014

MMI #5231-01

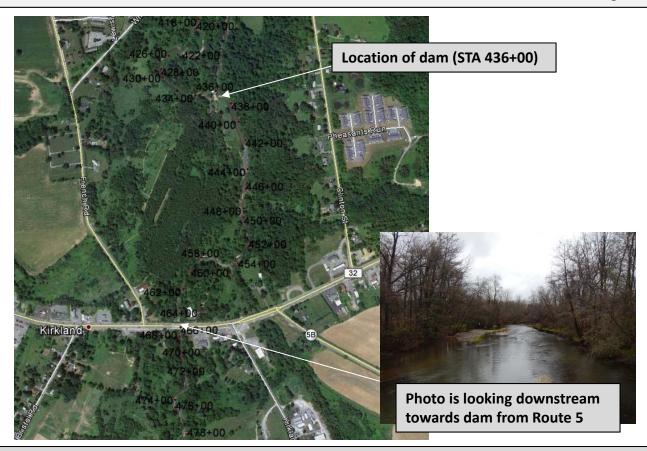
High-Risk Area #2: Low Head Dam at STA 436+00

Site Description: This dam is located approximately 3,000 feet downstream of Route 5 in Kirkland. The dam is acting to significantly increase water surface elevations through Kirkland extending upstream of the Route 5 Bridge. A sediment bar has formed upstream of the dam. The hydraulics in this reach are complex and include the backwater from the dam as well as numerous under-sized downstream bridges.

- Remove the dam, thus reducing water surface elevations in the vicinity of Route 5 during flood events. Removal of the dam would have additional benefit of improving aquatic connectivity. Accumulated sediments behind the dam would need to be either stabilized or removed.
- If dam removal is considered, analysis of the hydraulics of the downstream bridges must be taken into consideration when evaluating flood mitigation improvements.

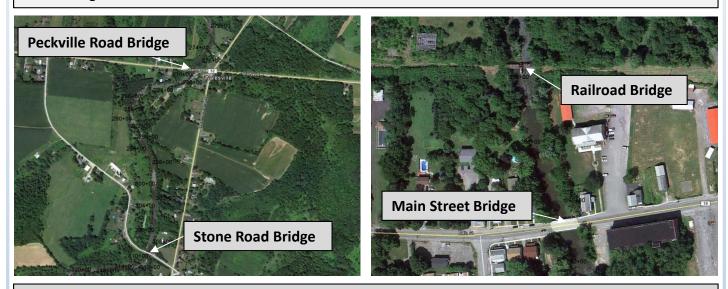
High-Risk Area #2: Undersized Bridges Downstream of Kirkland

Site Description: Undersized bridges downstream of Kirkland contribute to flooding conditions in the area. These include the Main Street Bridge (STA 390+00), an abandoned railroad bridge (STA 385+00), the Peckville Road Bridge (STA 310+00), and the Stone Road Bridge (STA 278+00). The backwater from these bridges reaches the dam at STA 436+00.

- Replace undersized bridges at Main Street (STA 390+00), the abandoned railroad (STA 385+00), Peckville Road (STA 310+00), and Stone Road (STA 278+00).
- When evaluating the hydraulics for any one of these structures, the hydraulics of the others should be considered as well as the effects of the upstream dam. This reach of Oriskany Creek is complex and changes from one structure affect the hydraulics of the others and vice versa.

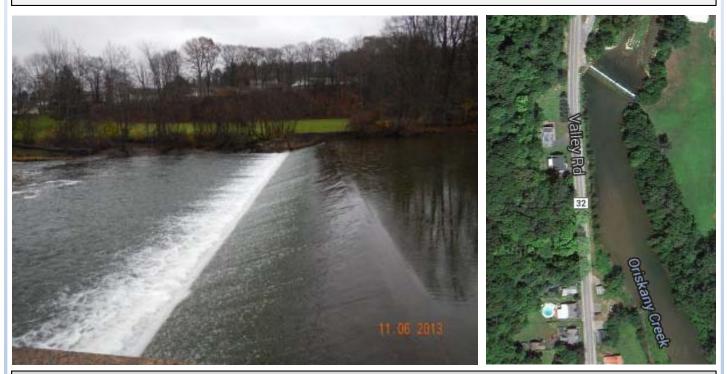
High-Risk Area #3: Dam at STA 81+50

Site Description: According to the FEMA profile, the dam at STA 81+50 creates an increase in water surface elevation upstream of the dam by more than 5 feet during the 10-year flood event, which is contributing to flooding and flood-related damages along Valley Road. In flood events larger than the 10-year frequency flood, the backwater effect caused by hydraulic constrictions at the Utica Street Bridge (at STA 56+50, approximately 2,500 feet downstream of the dam) reaches upstream of the dam and combines with the backwater effect of the dam to raise water surface elevations through this reach.

- Remove the dam to reduce water surface elevations along Valley Road during moderate flood events.
- Stabilize or remove accumulated sediments behind the dam.

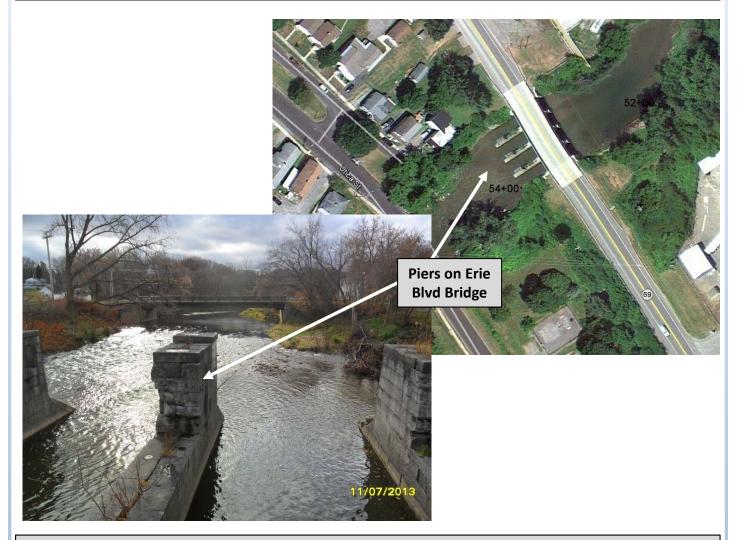
High-Risk Area #3: Modification/Removal of Piers at Erie Boulevard Bridge

Site Description: The Erie Boulevard (Route 69) Bridge at STA 53+50 is the site of frequent jams of woody debris that contribute to flooding problems in Oriskany.

• Modify the Erie Boulevard Bridge to reduce the geometry and number of piers to reduce the frequency of debris jams and improve hydraulic capacity at the bridge.

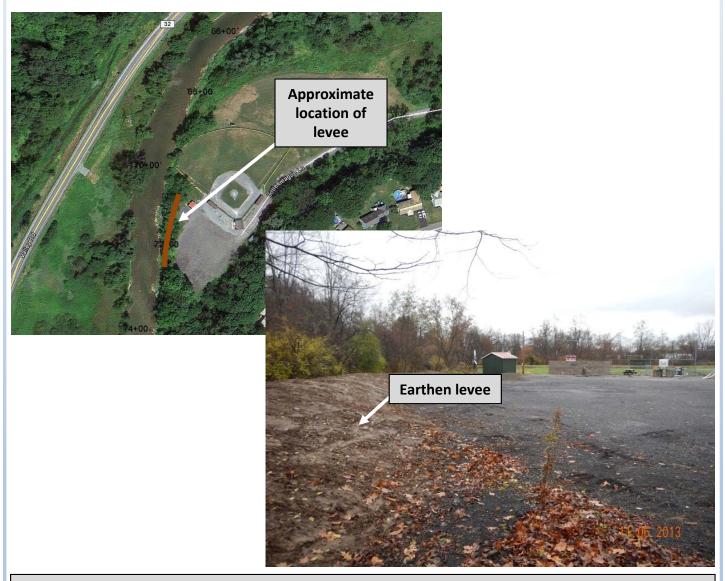
High-Risk Area #3: Removal of Levee at Little League Field

Site Description: During field inspections, a recently constructed earthen levee was observed between the Little League fields and Oriskany Creek, approximately between STA 72+00 and STA 69+00. The levee separates Oriskany Creek from its natural floodplain, thus reducing flood storage and potentially exacerbating flooding at points further downstream.

• Completely remove the levee.

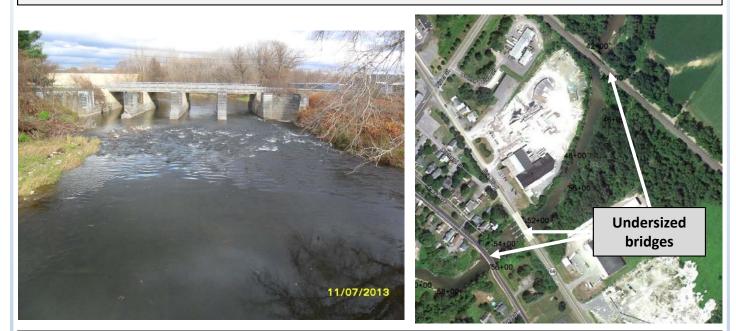
High-Risk Area #3: Undersized Bridges in Oriskany

Site Description: Bridges at Utica Street (STA 56+50), Erie Boulevard (STA 53+50), and the railroad (STA 43+50) serve as hydraulic constrictions during flood flows.

- Remove or replace one or a combination of these three bridges to provide the largest flood mitigation. Due to the close proximity of Utica Street and Erie Boulevard, it may be feasible and cost effective to replace one of these bridges with a larger structure and remove the other, routing traffic over the one remaining bridge.
- The hydraulic analysis and design will need to take into account the backwater effect of the Mohawk River.

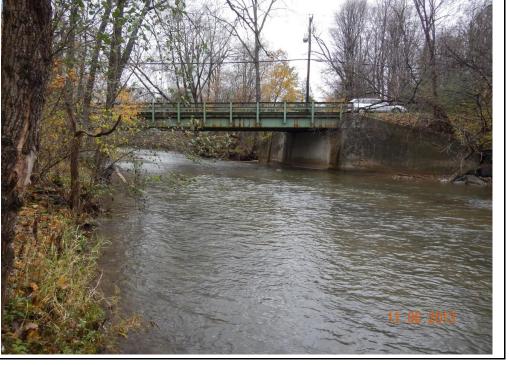
Norton Avenue Bridge (STA 554+00) viewed from downstream. This bridge is undersized and creates a hydraulic constriction.

Tier 1: Replace undersized bridges at Route 315 (STA 936+50) and Norton Avenue (STA 554+00) with structures that are large enough to span the creek's bankfull width and convey flood flows without causing a hydraulic constriction. The Route 315 bridge is one of the bridges identified for replacement in Governor Cuomo's Scour Critical Bridge Replacement Program. According to the Governor's website, "*This bridge carries NY Route 315 over Oriskany Creek in the Town of Marshall, Oneida County. The highway at this location carries an average of 1,980 vehicles a day. This 51 ft. span steel jack arch bridge on high concrete abutments founded on rock was constructed in 1930, connects Waterville with Deansboro. The bridge connects residential and business districts."*

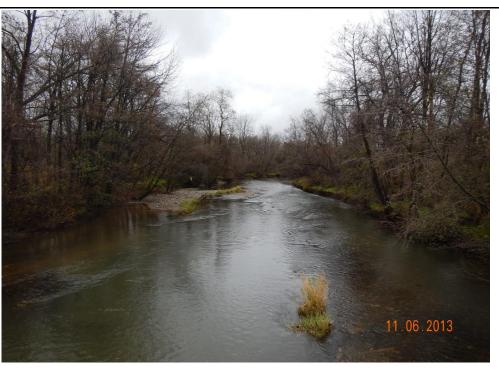
4

At Route 5 Bridge in Kirkland (STA 466+00) looking downstream towards low head dam. The dam causes an increase in water surface elevations through this area.
