EMERGENCY TRANSPORTATION INFRASTRUCTURE RECOVERY
WATER BASIN ASSESSMENT
AND FLOOD HAZARD MITIGATION ALTERNATIVES

FULMER CREEK
HERKIMER COUNTY, NEW YORK

April 2014

MMI #5231-01

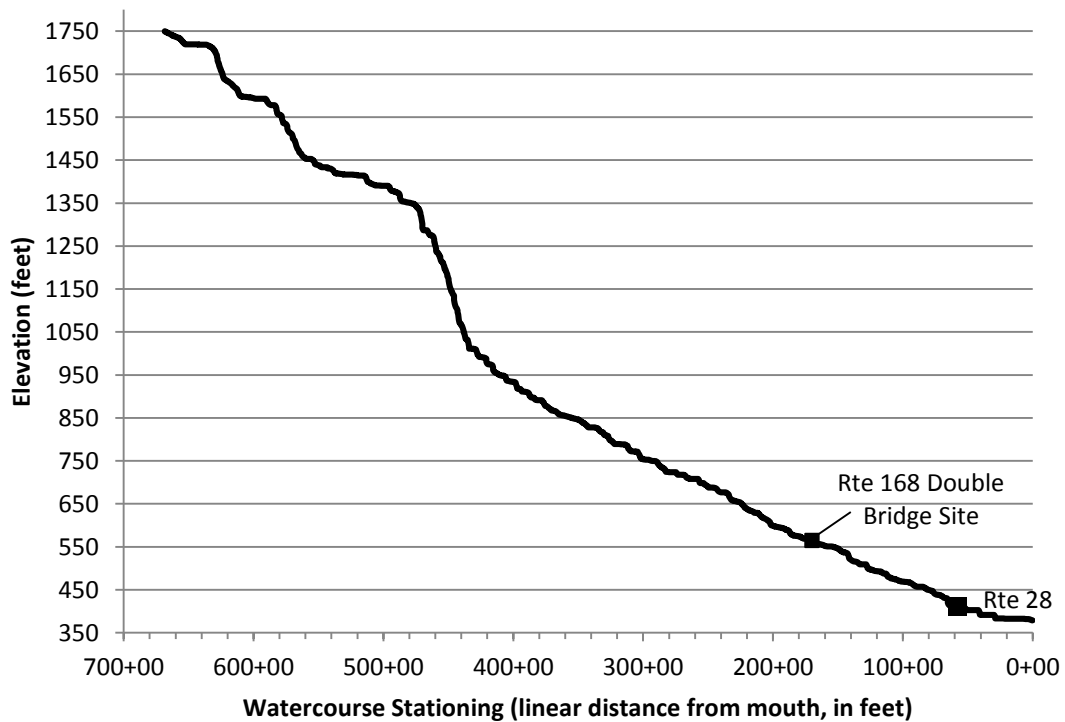
FIGURE 4
Fulmer Creek Channel Profile

Figure 4 presents a profile of Fulmer Creek, showing the watercourse elevation versus the linear distance from the mouth of the watercourse. The Route 168 Double Bridge Site and the Route 28 crossing are shown on the profile to provide reference points. The creek drops a total of 1,370 vertical feet, from an elevation of 1,750 feet above sea level at its headwaters, to 380 feet at its outlet at the Mohawk River.

Steeper stream reaches, such as is those in the upper reaches of Fulmer Creek, have more energy, with higher velocities that can carry more sediment. As the slope declines downstream, the previously mobilized sediments are then deposited in lower gradient reaches lower in the watershed, where they fill the channel, reduce hydraulic capacity and exacerbate flooding.

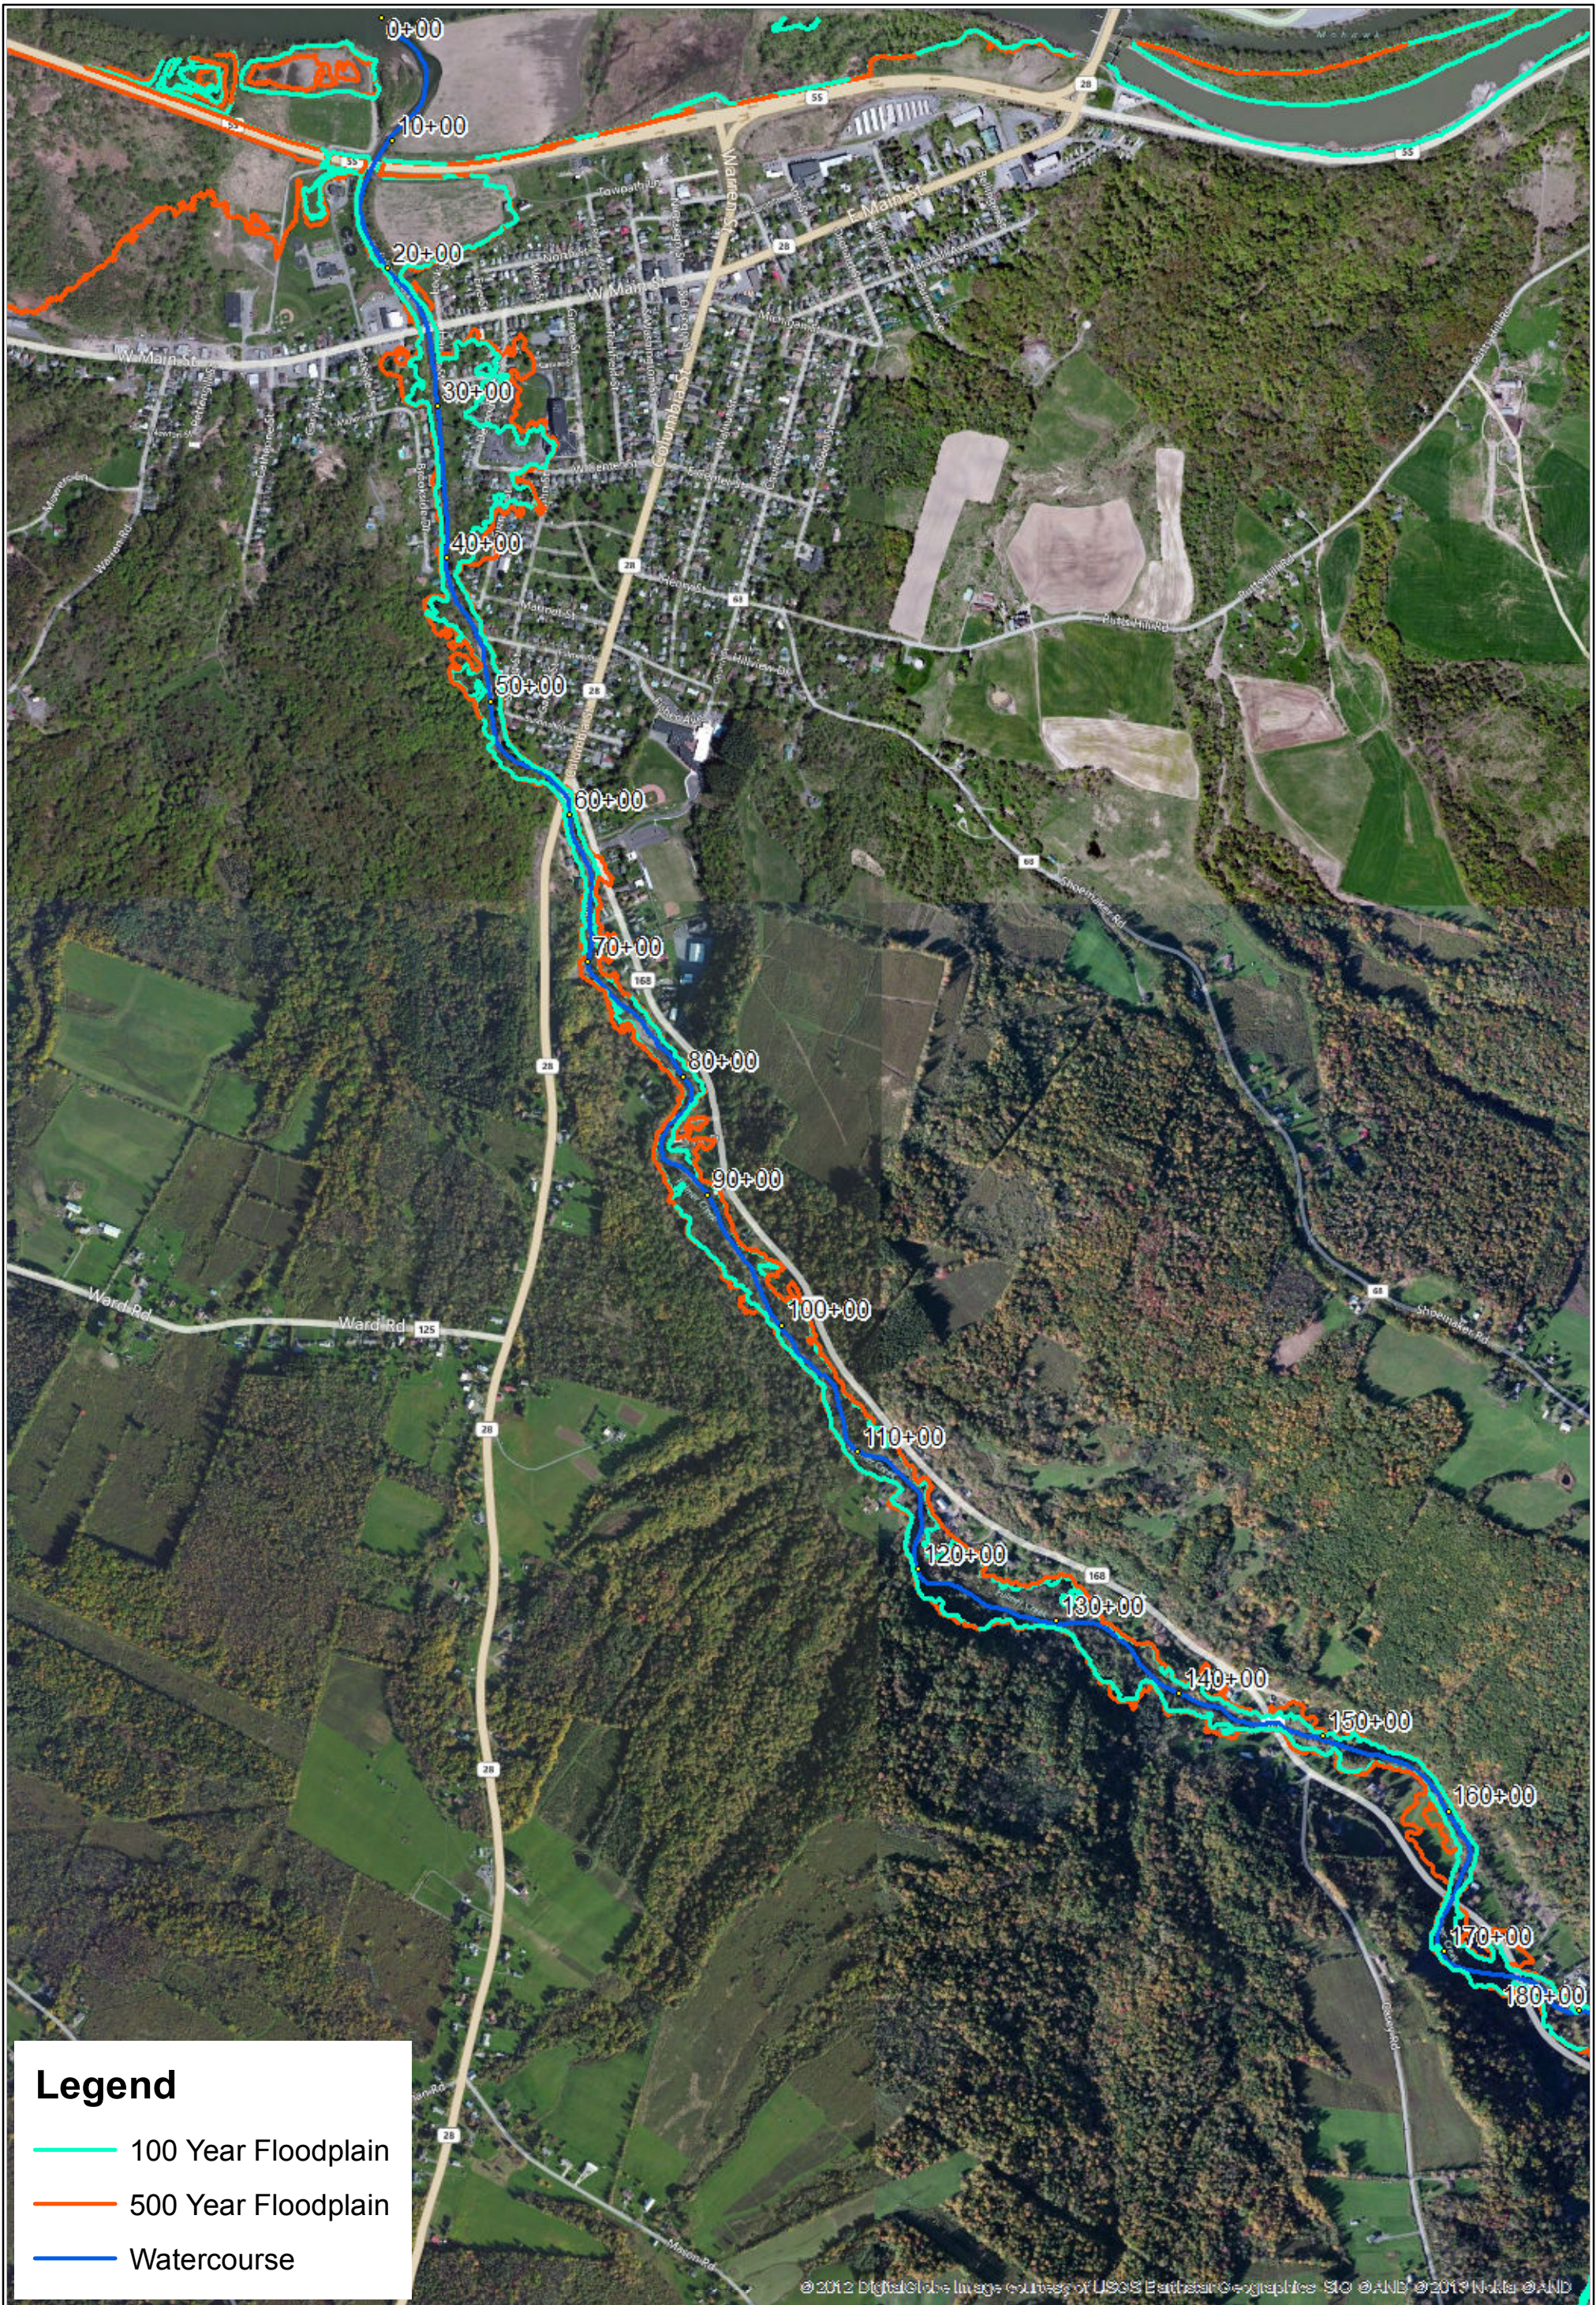
Figure 5: Fulmer Creek FEMA Floodzones

FEMA FIRM maps for Fulmer Creek are available for the village of Mohawk and the town of German Flatts. FEMA mapping (Figure 5) indicates that, during a 100-year frequency flood event, waters from Fulmer Creek inundate the trailer park on Fulmer

Drive (Leatherstocking Trailer Park) at STA 85+00 and the trailer park located between STA 69+00 and 65+00 (Creekside Trailer Park). The maps indicate that water from Fulmer Creek floods Route 168 at two locations, in the vicinity of STA 64+00 and STA 59+00. This condition has subsequently been altered with the construction of a landform near the Route 28 bridge. Local officials have also noted high water marks that indicate Fulmer Creek has inundated Route 168 at several points upstream, such as near the Town Barn and Leatherstocking Trailer Park. Further downstream, an extensive area between STA 41+00 and STA 27+00, including Firman Street, West Center Street, Devendorf Street, and Charles Street are flooded on the right bank, while some of the homes along Brookside Drive and Petrie Avenue are flooded on the left bank.

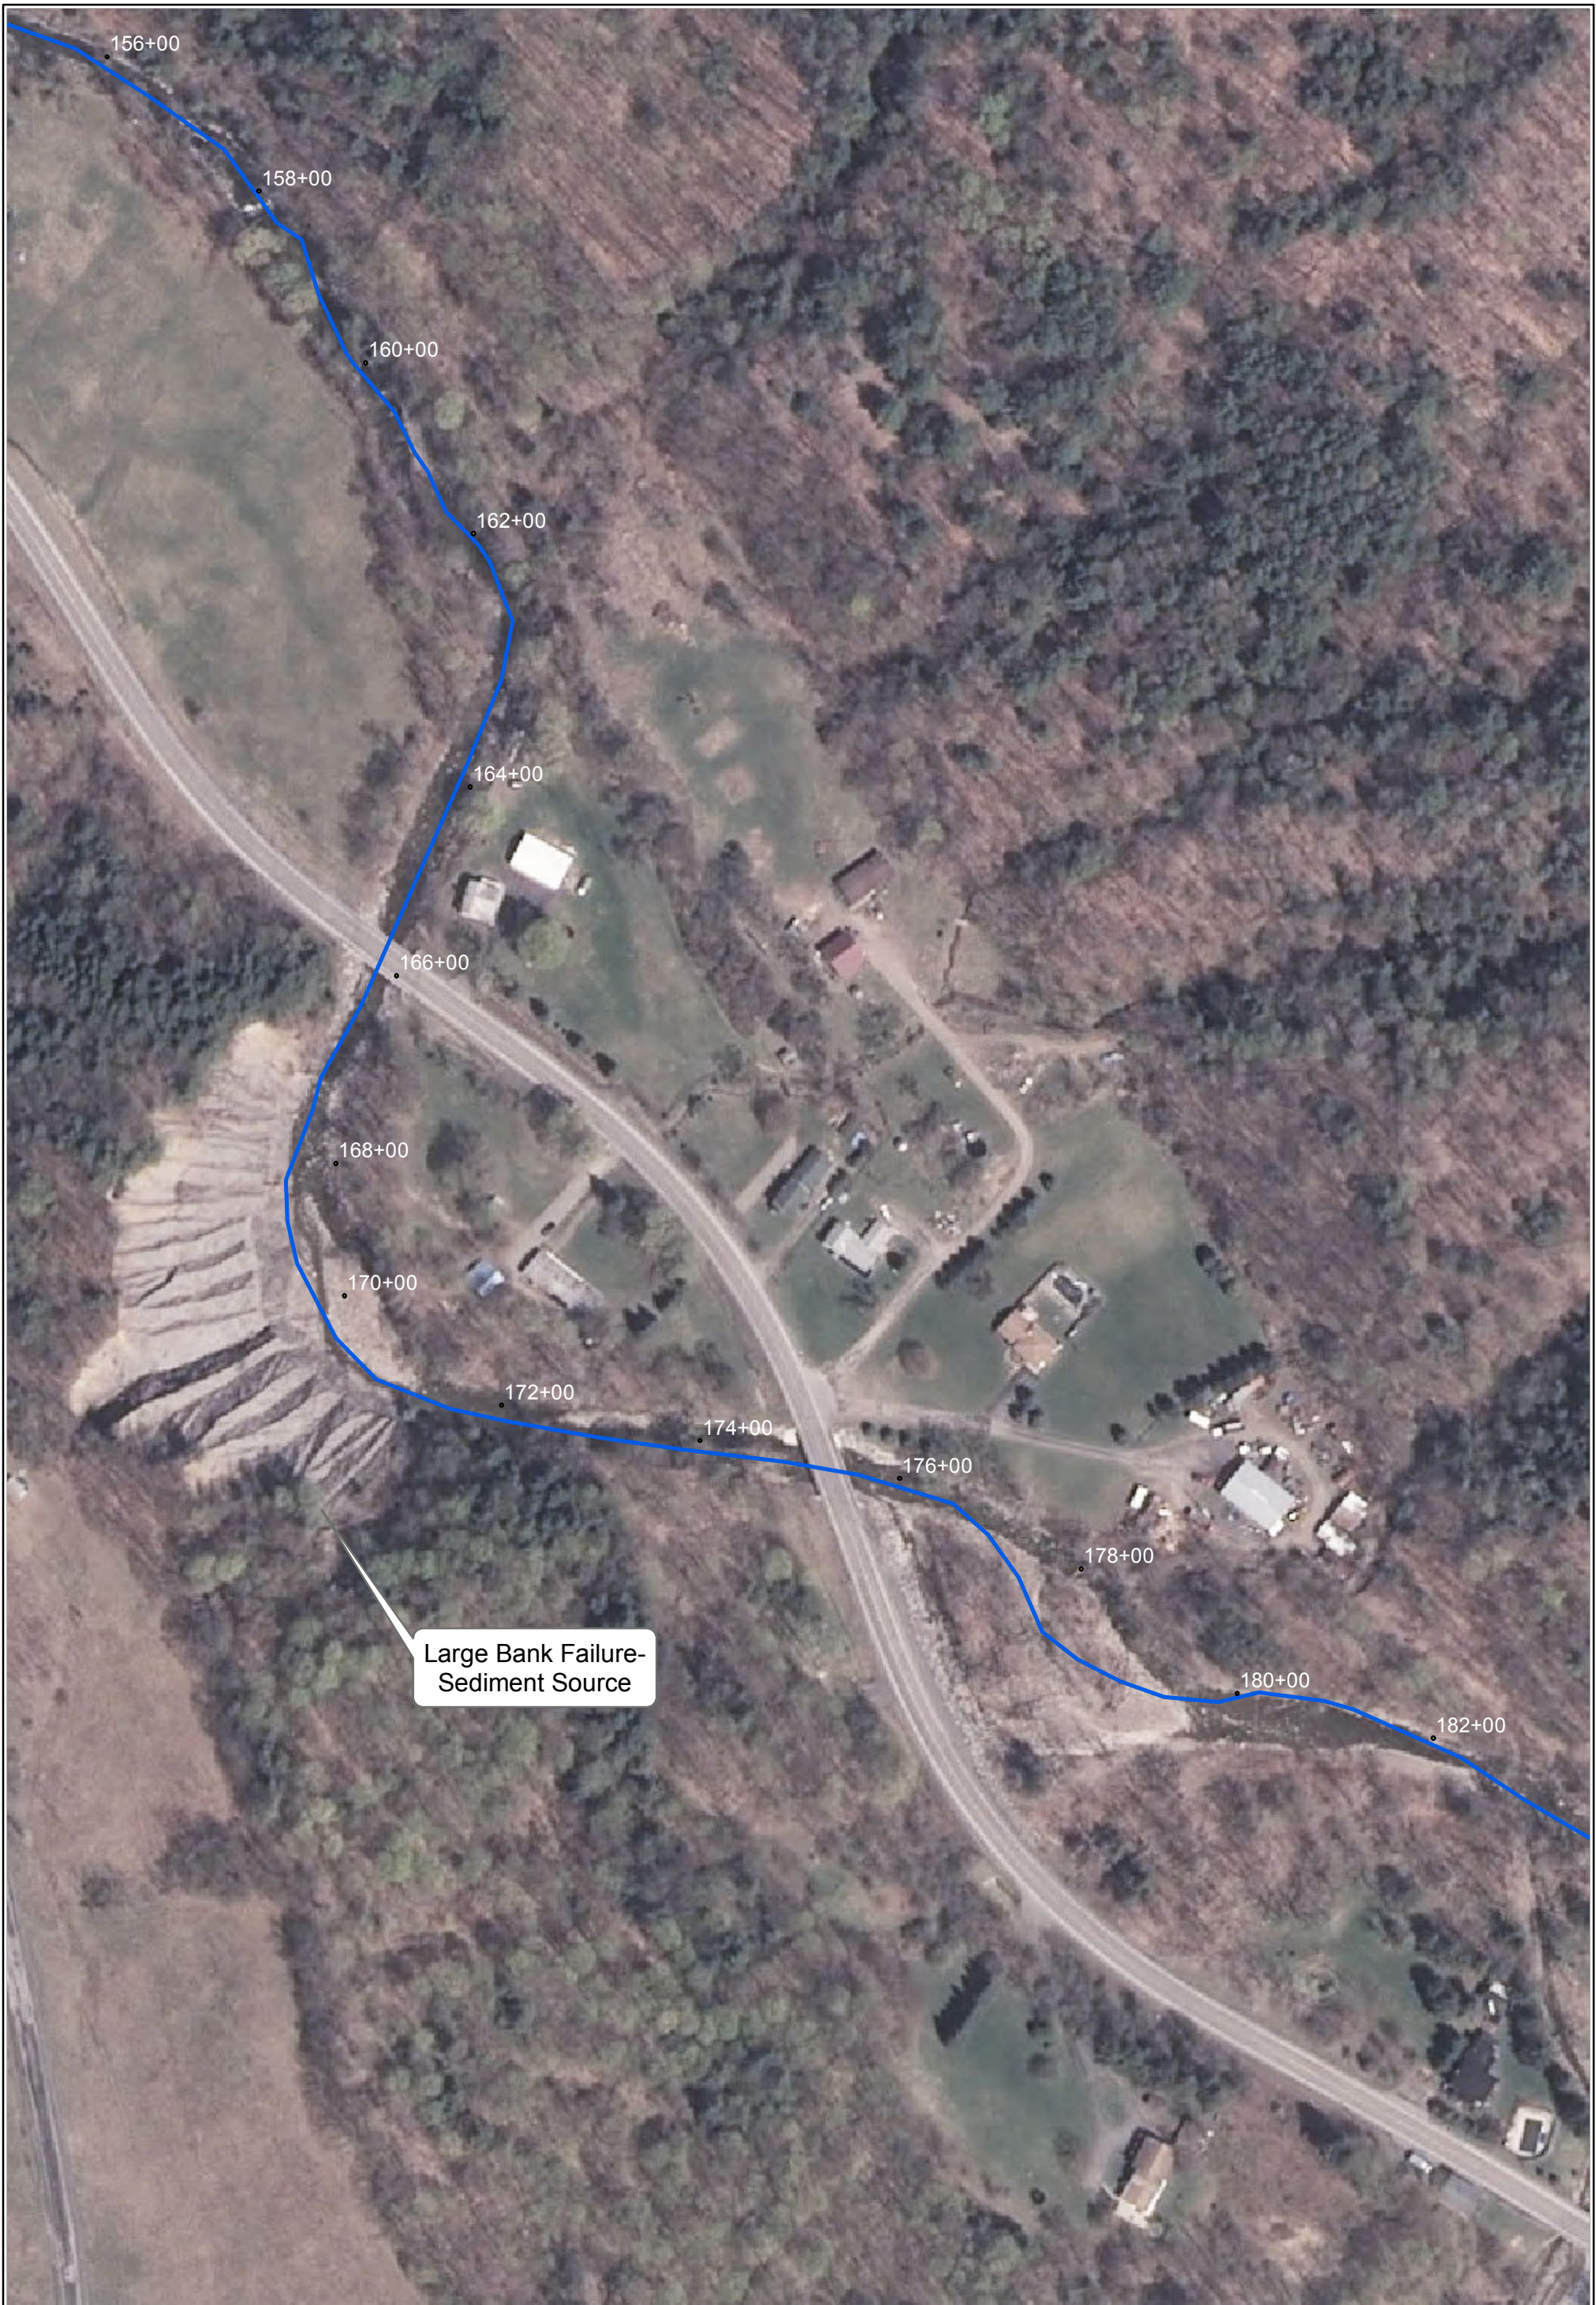
Figure 6: Fulmer Creek High Risk Area #1

Figure 6 is a location plan of High Risk Area #1. This area, labeled in previous reports as the Route 168 Double Bridge Site, is the most visually remarkable site along Fulmer Creek. It consists of a high bank failure adjacent to Route 168 that is actively contributing fine and coarse grained sediments and threatening the home and property located at the top of the bank failure on Casey Road. The affected reach occurs between STA 162+00 and STA 182+00. In this area, Fulmer Creek crosses under Route 168 at STA 175+00, passes below the high bank failure on a sharp right bend between STA 171+00 and STA 167+00, then crosses under Route 168 again at STA 166+00.

This alternative involves moving the Fulmer Creek channel eastward away from the bank failure, and stabilizing the channel to eliminate erosion at the toe of the bank. This alternative is presented in Figure 7, and involves the following actions:

- a) Acquiring and removing the existing house at the base of the bank failure;
- b) Moving the creek channel eastward, away from the bank failure;
- c) Constructing a revetment wall 600 feet in length along the channel at the outside of the bend along the toe of the slope;
- d) Diverting runoff at the top of the slope to prevent further erosion of the slope;
- e) Creating a floodplain bench on the inside of the bend; and
- f) Seeding the slope to promote the growth of vegetation to further stabilize the slope.

Relocating the active flow of water away from the failing bank will eliminate the driving force that is causing erosion and allow the bank to begin self-stabilizing. In order to accomplish this, an 850-foot reach of Fulmer Creek would be relocated up to 175 feet to the east. This will require the procurement removal of an existing home, but will provide enough room to construct a low wall or riprap bank along the base of the high bank failure to protect it from future erosion.

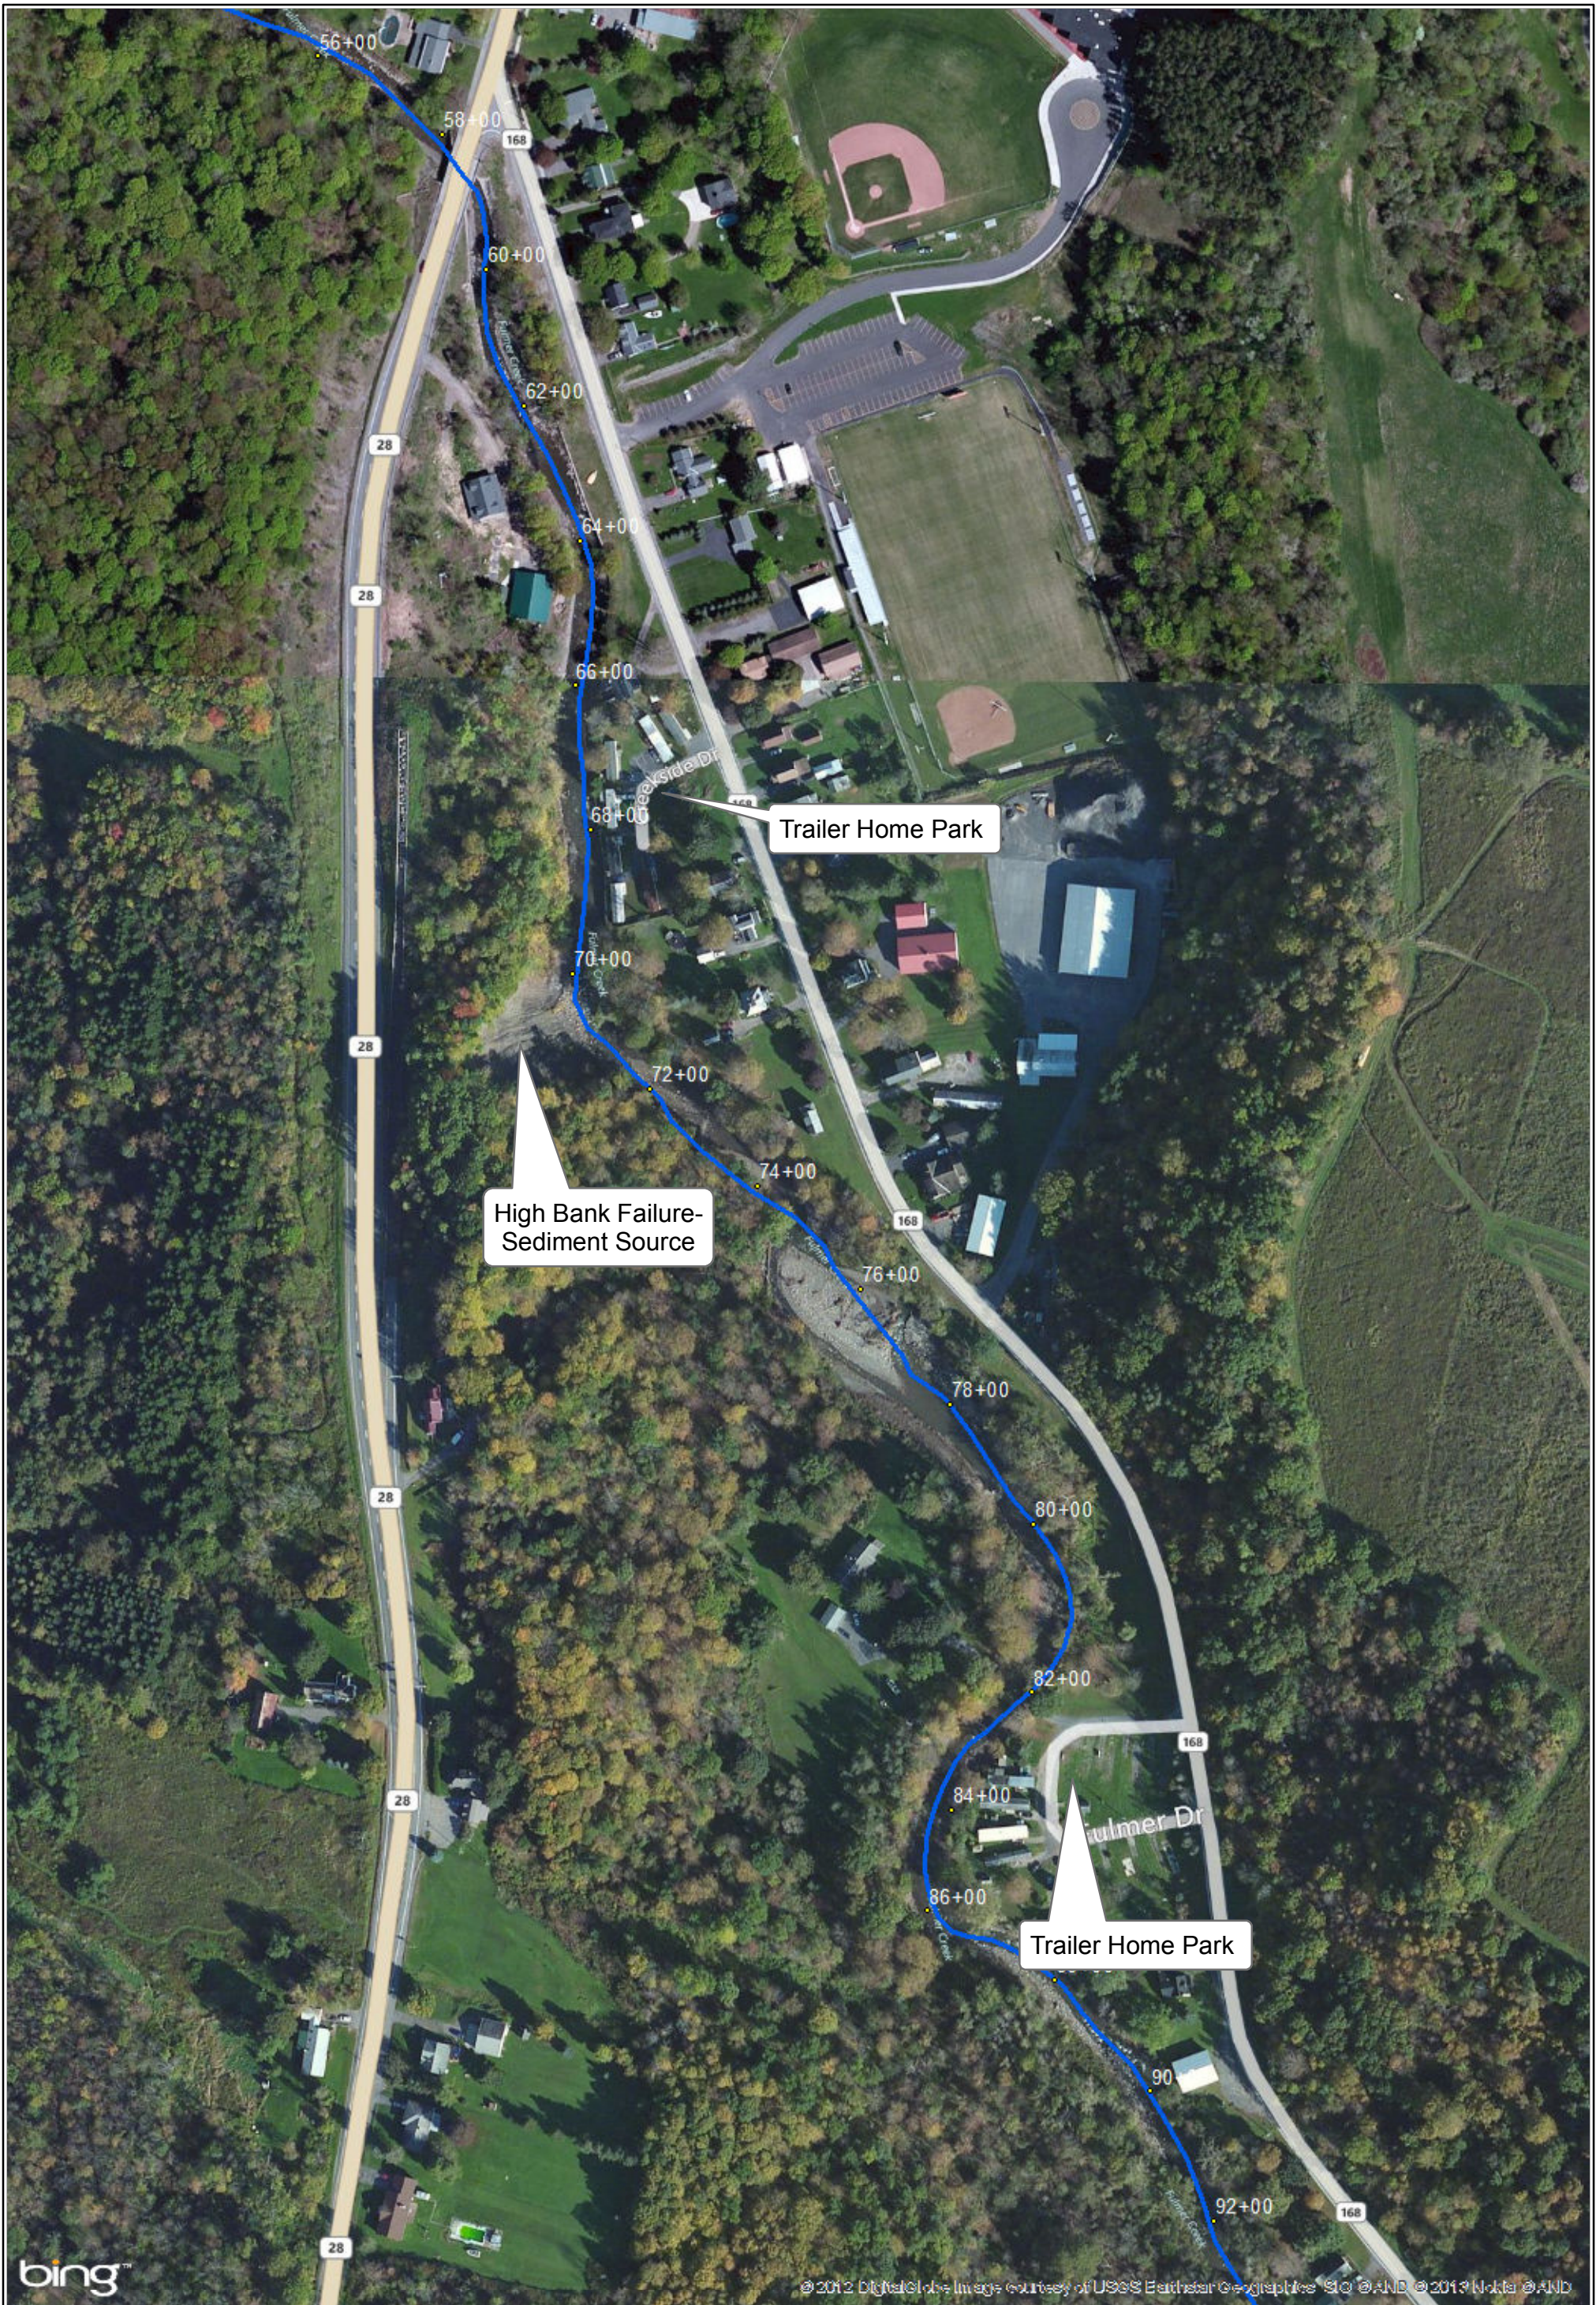
Figure 8: Fulmer Creek High Risk Area #2

Figure 8 is a location plan of High Risk Area #2. This reach includes the Leatherstocking Trailer Park on Fulmer Lane Drive at STA 91+00, downstream to where Fulmer Creek

To avoid repetitive loss to these mobile homes, and to maintain the safety of their occupants, relocation is recommended. Floodplain development can endanger the lives and homes of those who live there. Additionally, the presence of these structures in the floodplain encroaches on the natural flood storage and worsens flooding conditions for those upstream and downstream. There is also a concern about the buoyancy of these structures during floods and the associated threat to life and property downstream.

Development in the floodplain can be better managed through improved policy and land use laws enacted locally. Many communities prohibit development in the floodplain as a matter of acceptable land use.

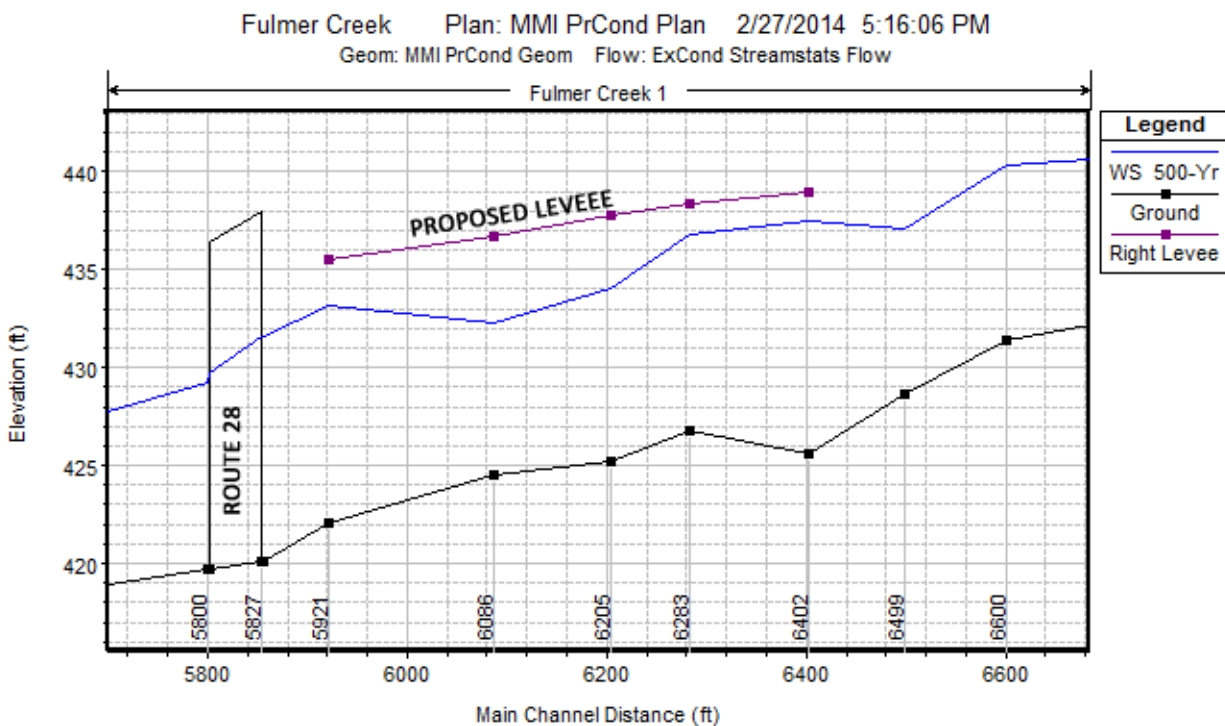
**FIGURE 9
Fulmer Creek HEC-RAS Modeling Results**

Based upon modeling results using *StreamStats* flow data, the current design of the berm appears to be sufficient to prevent water from overtopping the banks of Fulmer Creek upstream of the Route 28 bridge for flows up to and including the 500-year flood event. Figure 9 presents a profile of Fulmer Creek upstream of the Route 28 bridge for the 500-year flow, under fully constructed conditions.

Despite modeling results, local reports indicate that water has overtopped the banks of Fulmer Creek upstream of STA 66+00, damaging residences, businesses, and infrastructure within the Town of German Flatts and more extensively in the Village of Mohawk. Such damages have occurred outside of the delineated FEMA floodplain. This may be an indication that the FEMA flows are, in fact, underestimated. Possible additional flood mitigation measures include removal or relocation of retaining walls or other barriers that prevent the stream from accessing its floodplain, re-establishment or creation of natural buffer areas and flood benches, establishment of natural vegetation, and/or continuation of the flood control berm upstream of STA 66+00 adjacent to Route 168 but outside of the regulated floodplain.
