EMERGENCY TRANSPORTATION INFRASTRUCTURE RECOVERY
WATER BASIN ASSESSMENT
AND FLOOD HAZARD MITIGATION ALTERNATIVES

SAUQUOIT CREEK
ONEIDA COUNTY, NEW YORK

April 2014

MMI #5231-01

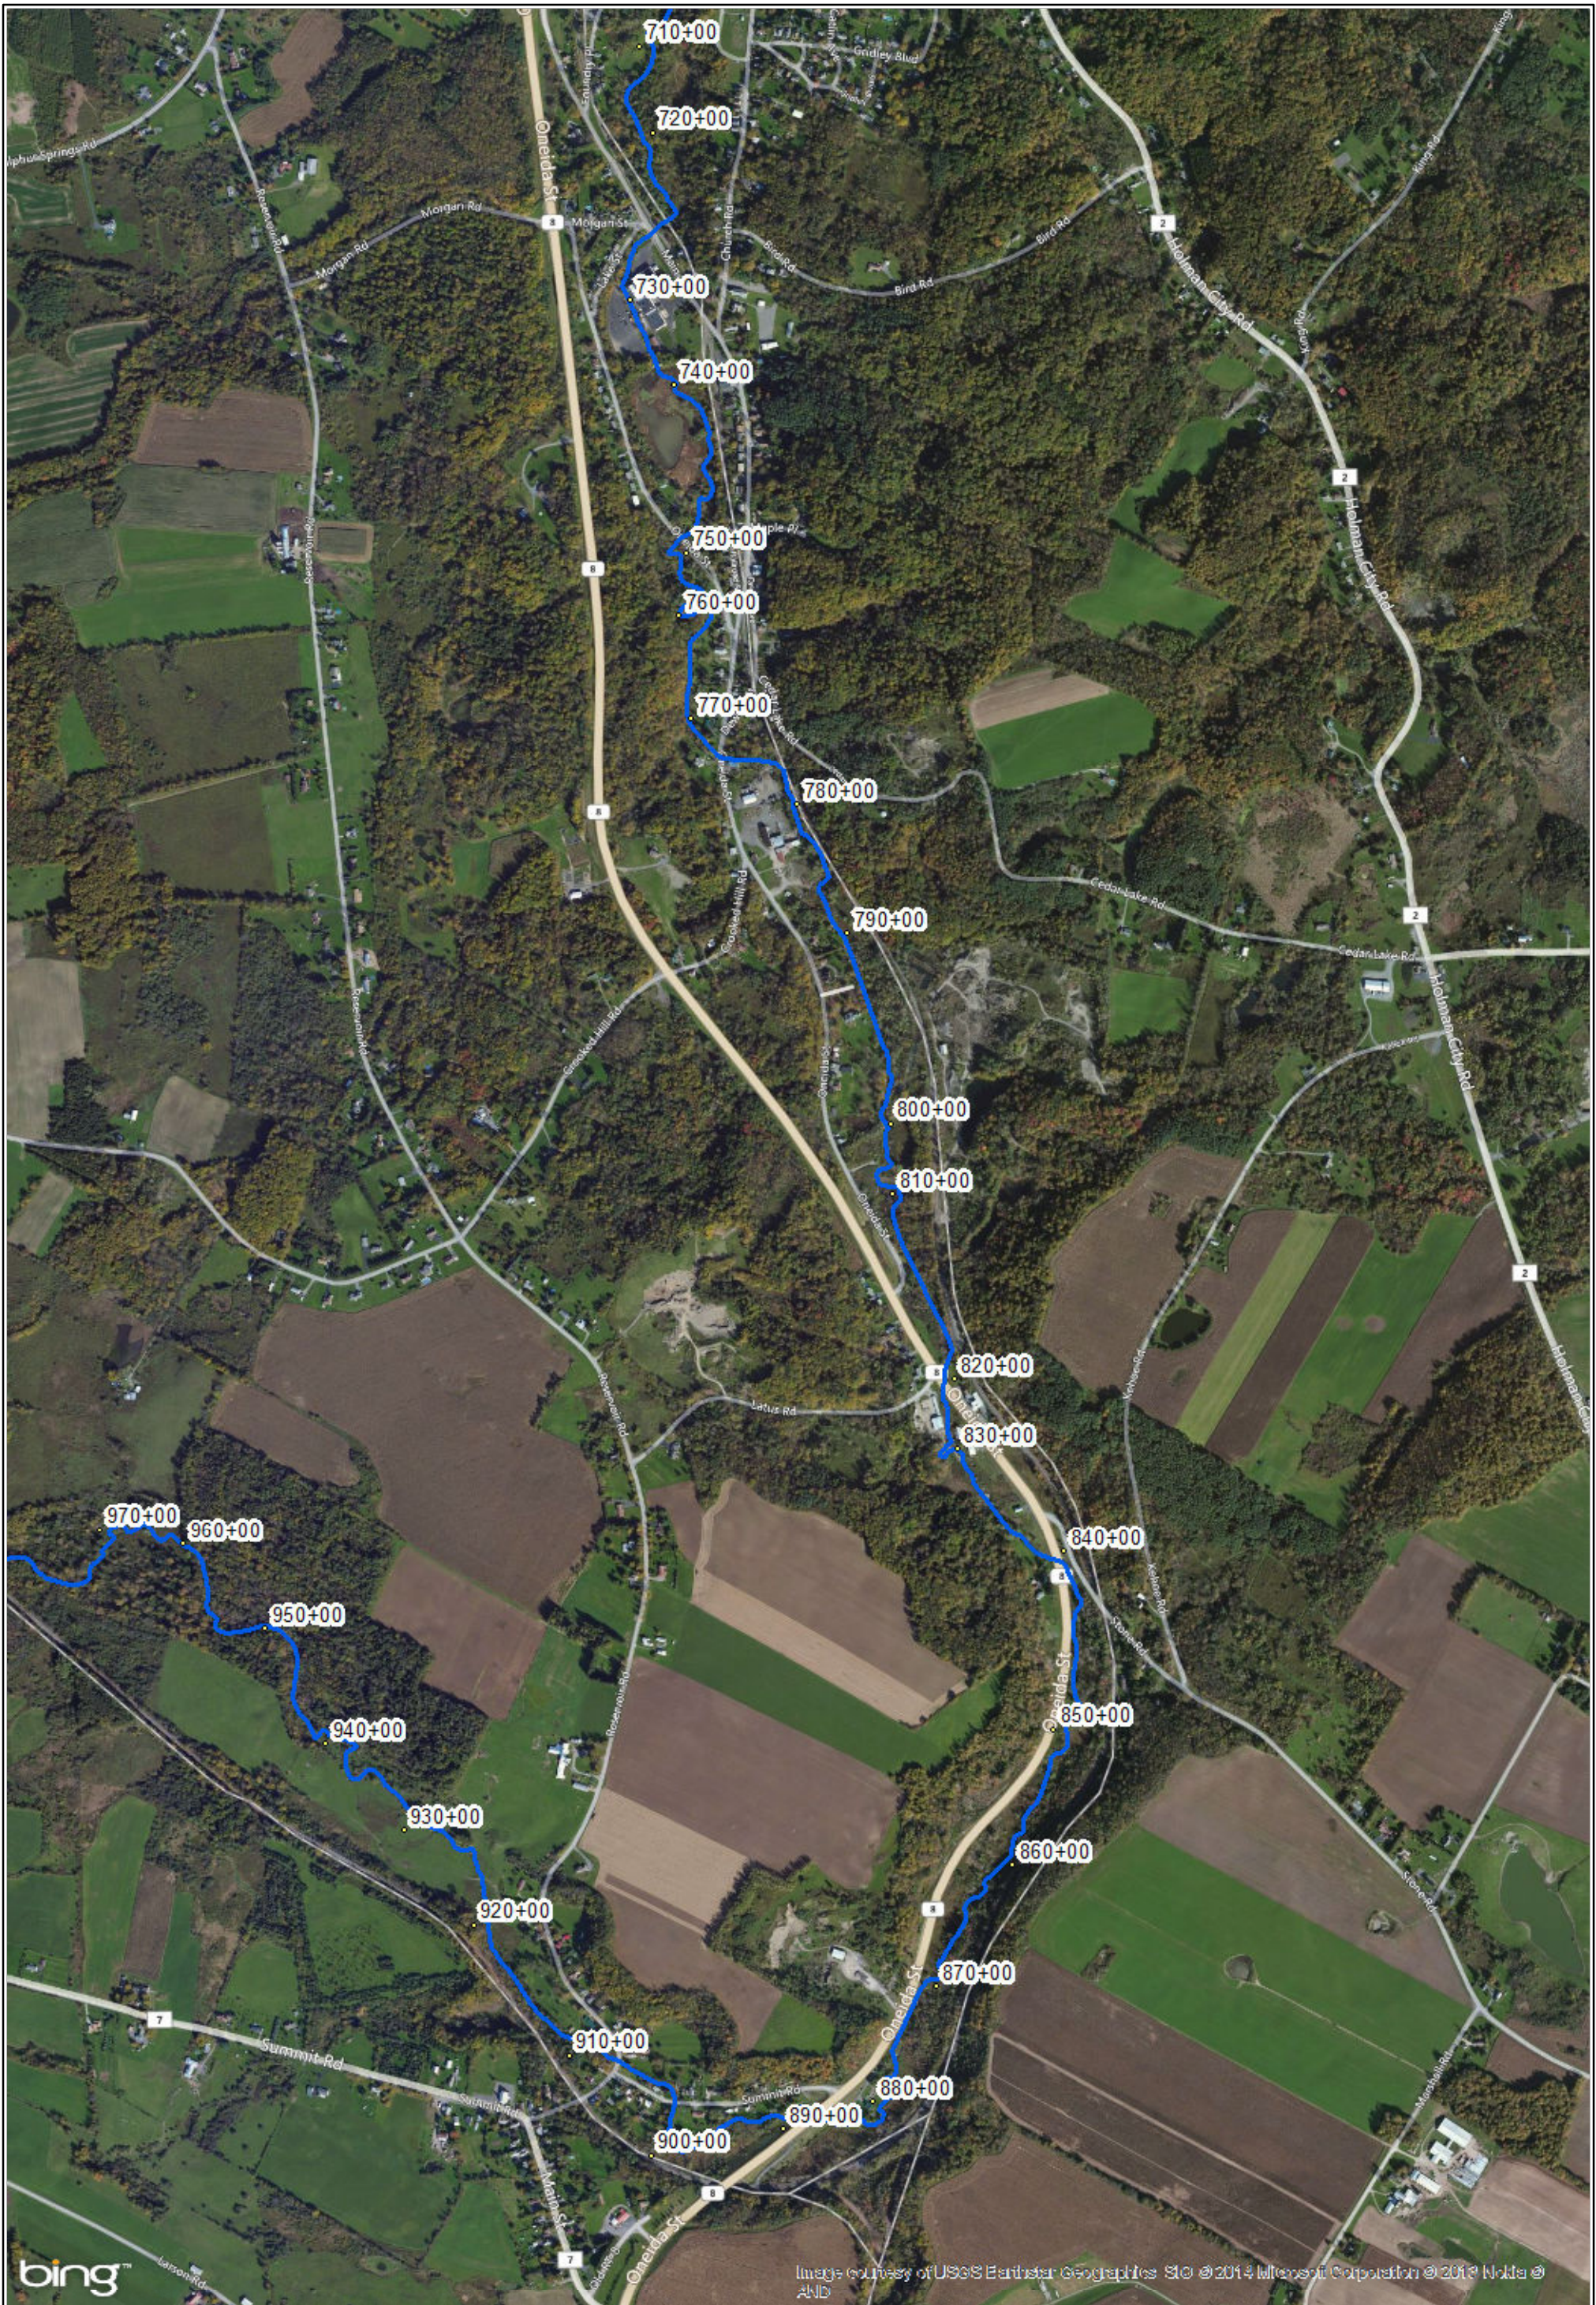
Figure 7: Sauquoit Creek High Risk Area #1

High Risk Area #1 is located in the upper Sauquoit Creek basin and extends from Summit Road in Cassville (STA 903+00) downstream to Main Street in Clayville (STA 726+00). The area is depicted in Figure 7. While this part of the Sauquoit basin is less densely developed, the creek channel and floodplain have been encroached upon by residential and industrial development and by the roads and railroad line that run adjacent to the creek. Sauquoit Creek has been channelized for portions of this reach.

At least eight low-head dams span the channel in this reach, associated with factories along its banks. These dams are in various stages of disrepair, and some have completely failed, leaving behind an unstable channel, an eroding channel bed and banks, and high sediment load. Other dams are still in place but appear to be in danger of failing. The continued failure of these dams will lead to an increasingly unstable channel, contributing to downstream sediment loads. Dams in this reach include the following:

Alternative 1-1: Remove Dams and Stabilize Channel

Full removal of low-head dams in the reach would help to restore and stabilize this section of Sauquoit Creek, would reduce water surface elevations upstream of the dams, and would prevent the uncontrolled downstream release of sediments that would occur in the event of dam failure. None of the dams appear to serve a useful purpose, and they do not impound enough water during high flow events to mitigate downstream flooding.

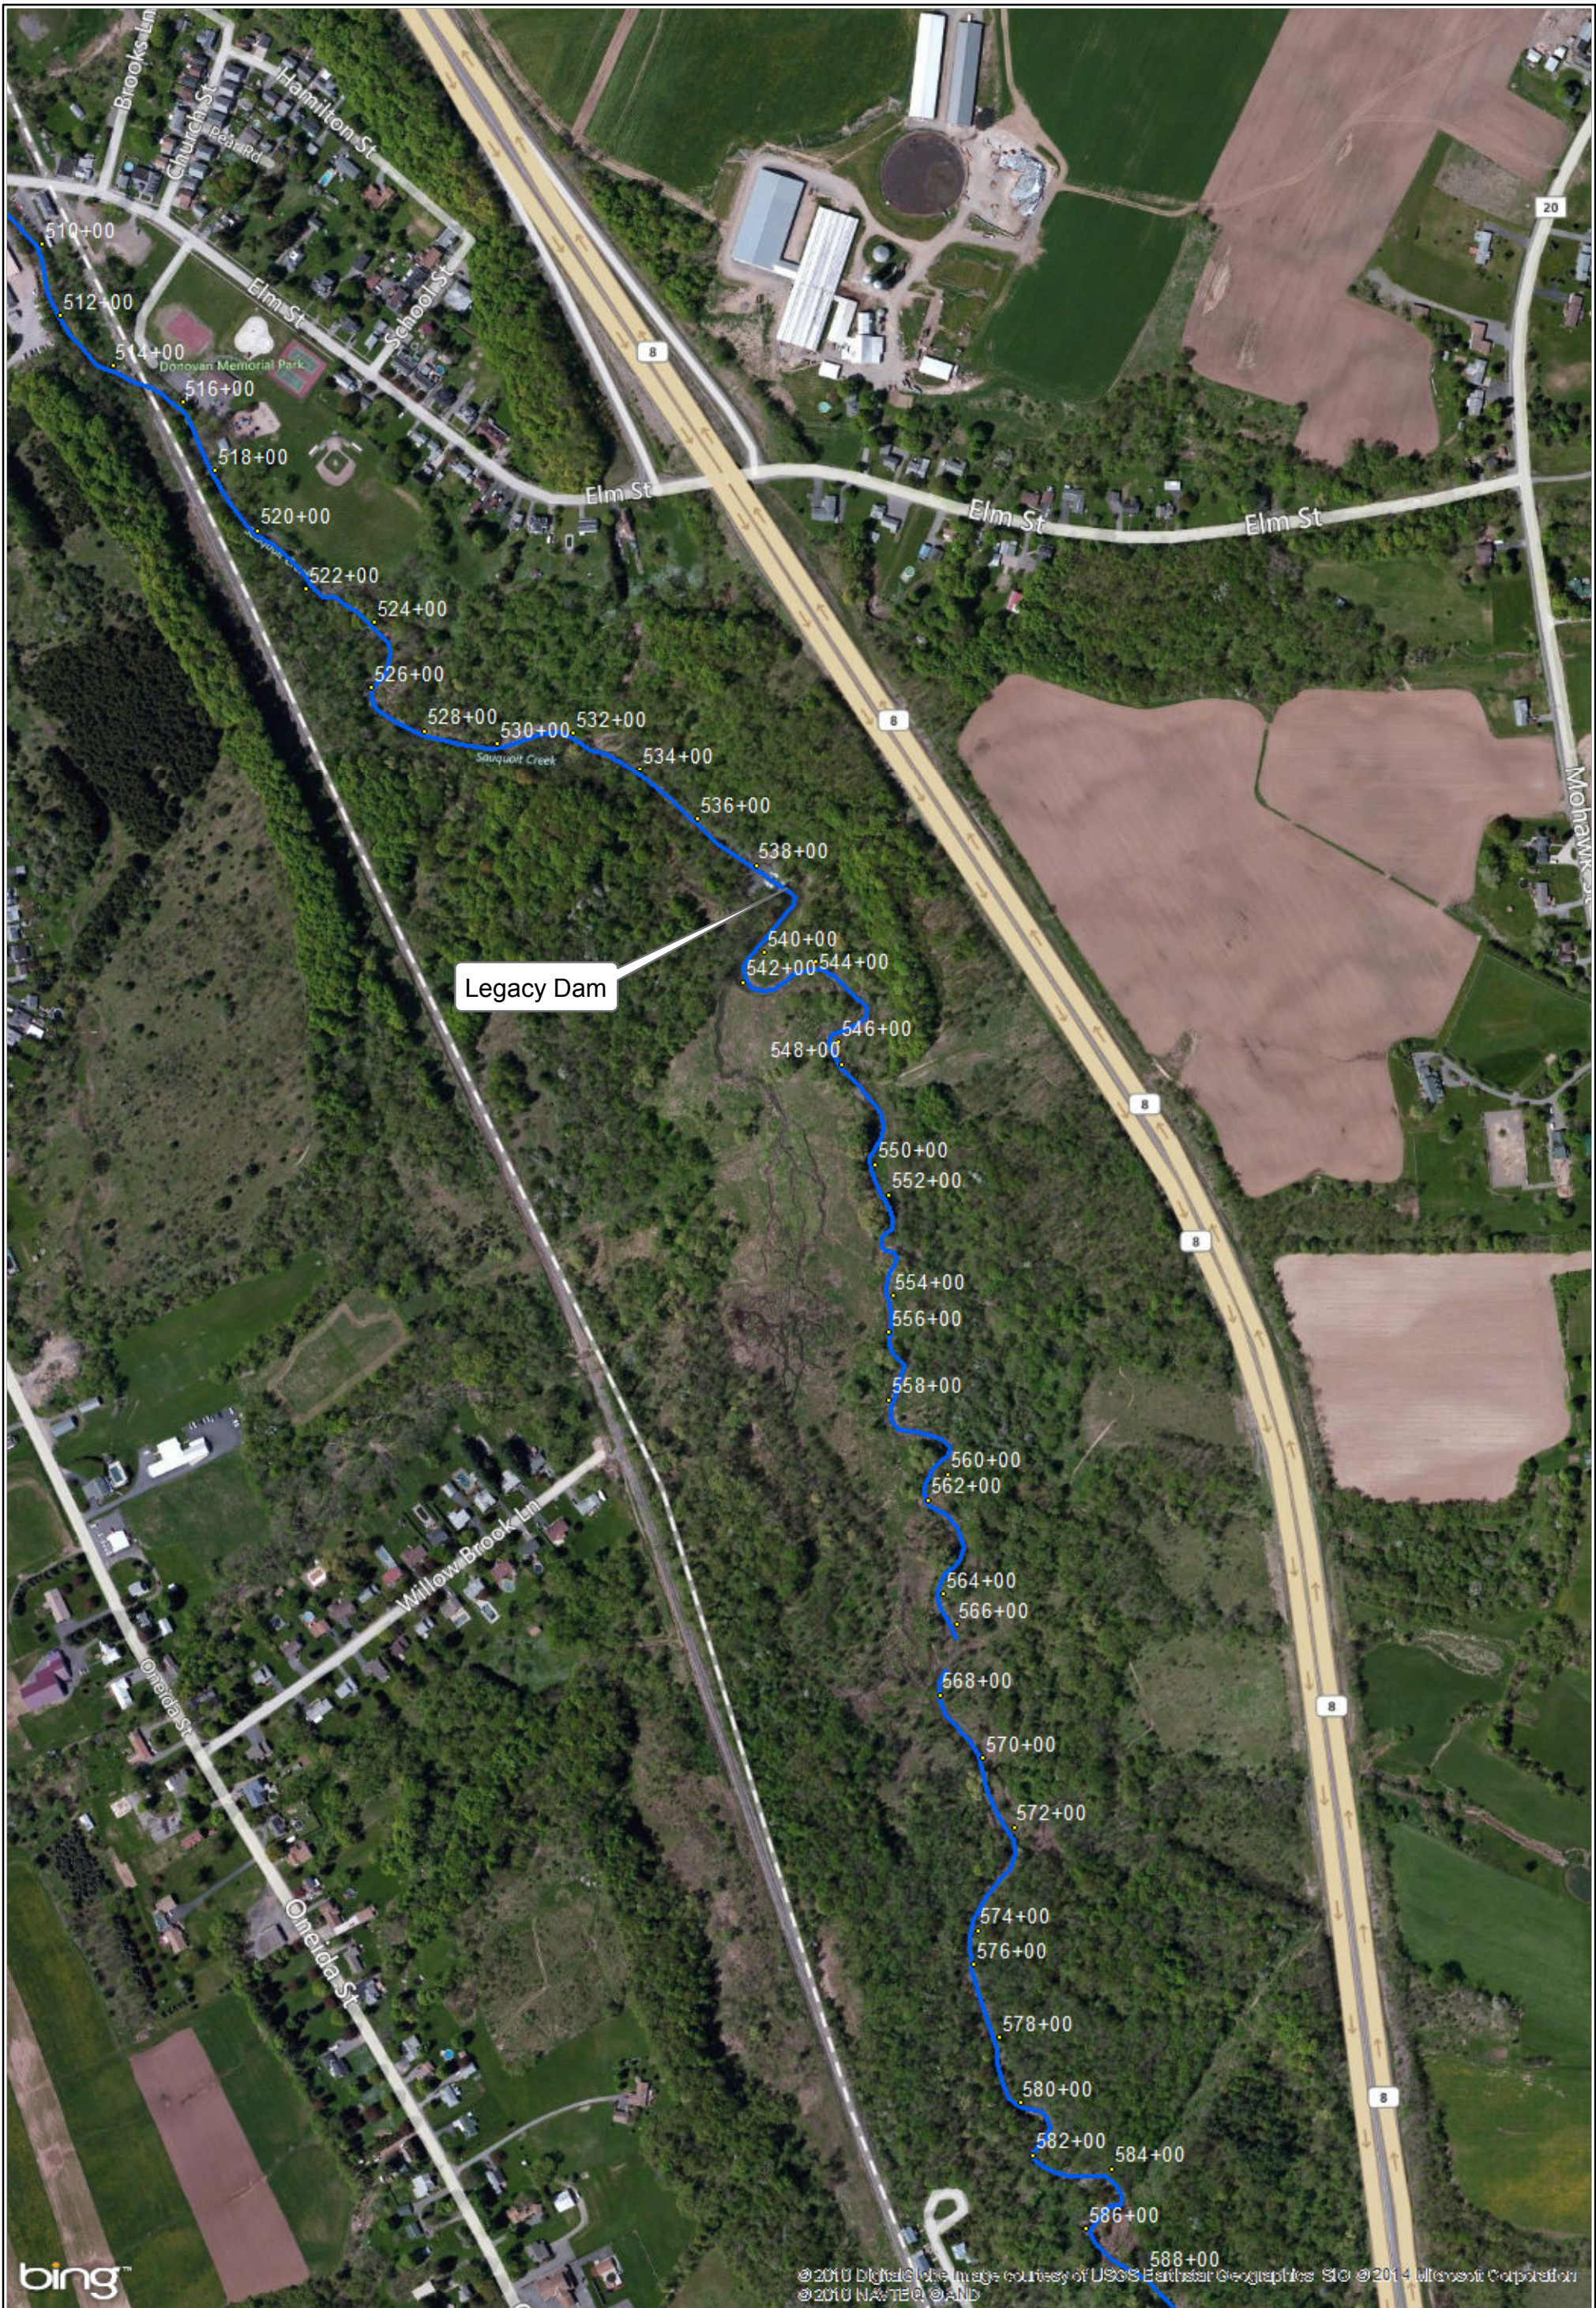
Figure 8: Sauquoit Creek High Risk Area #2

Figure 8 is a location plan of High Risk Area #2. This is an old concrete dam located in an undeveloped area in the upper watershed of Sauquoit Creek. This dam is located at STA 538+00, in a remote area between Route 8 on the east and railroad tracks on the west, just upstream of Elm Street and Donovan Memorial Park in the hamlet of Chadwicks.

Removal of the dam would provide an array of ecological benefits and is likely to be the most economical solution on a long-term basis by virtue of eliminating operation and maintenance costs. Preserving any type of flow regulation structure at this location will require periodic maintenance, will accumulate sediment that may require removal at a later date, and will always bear a certain risk of failure. However, the capital cost of dam removal and sediment management can also be very high. Dam removal has the potential to reduce any flood attenuation provided by the dam; however, without analysis, the magnitude of flood protection is unknown.

The composition of impounded sediments and the potential for contaminants is often the biggest cost element associated with dam removal. Sediment quality and potential flood protection currently provided are key issues that would need to be explored to fully evaluate the cost and feasibility of dam removal.

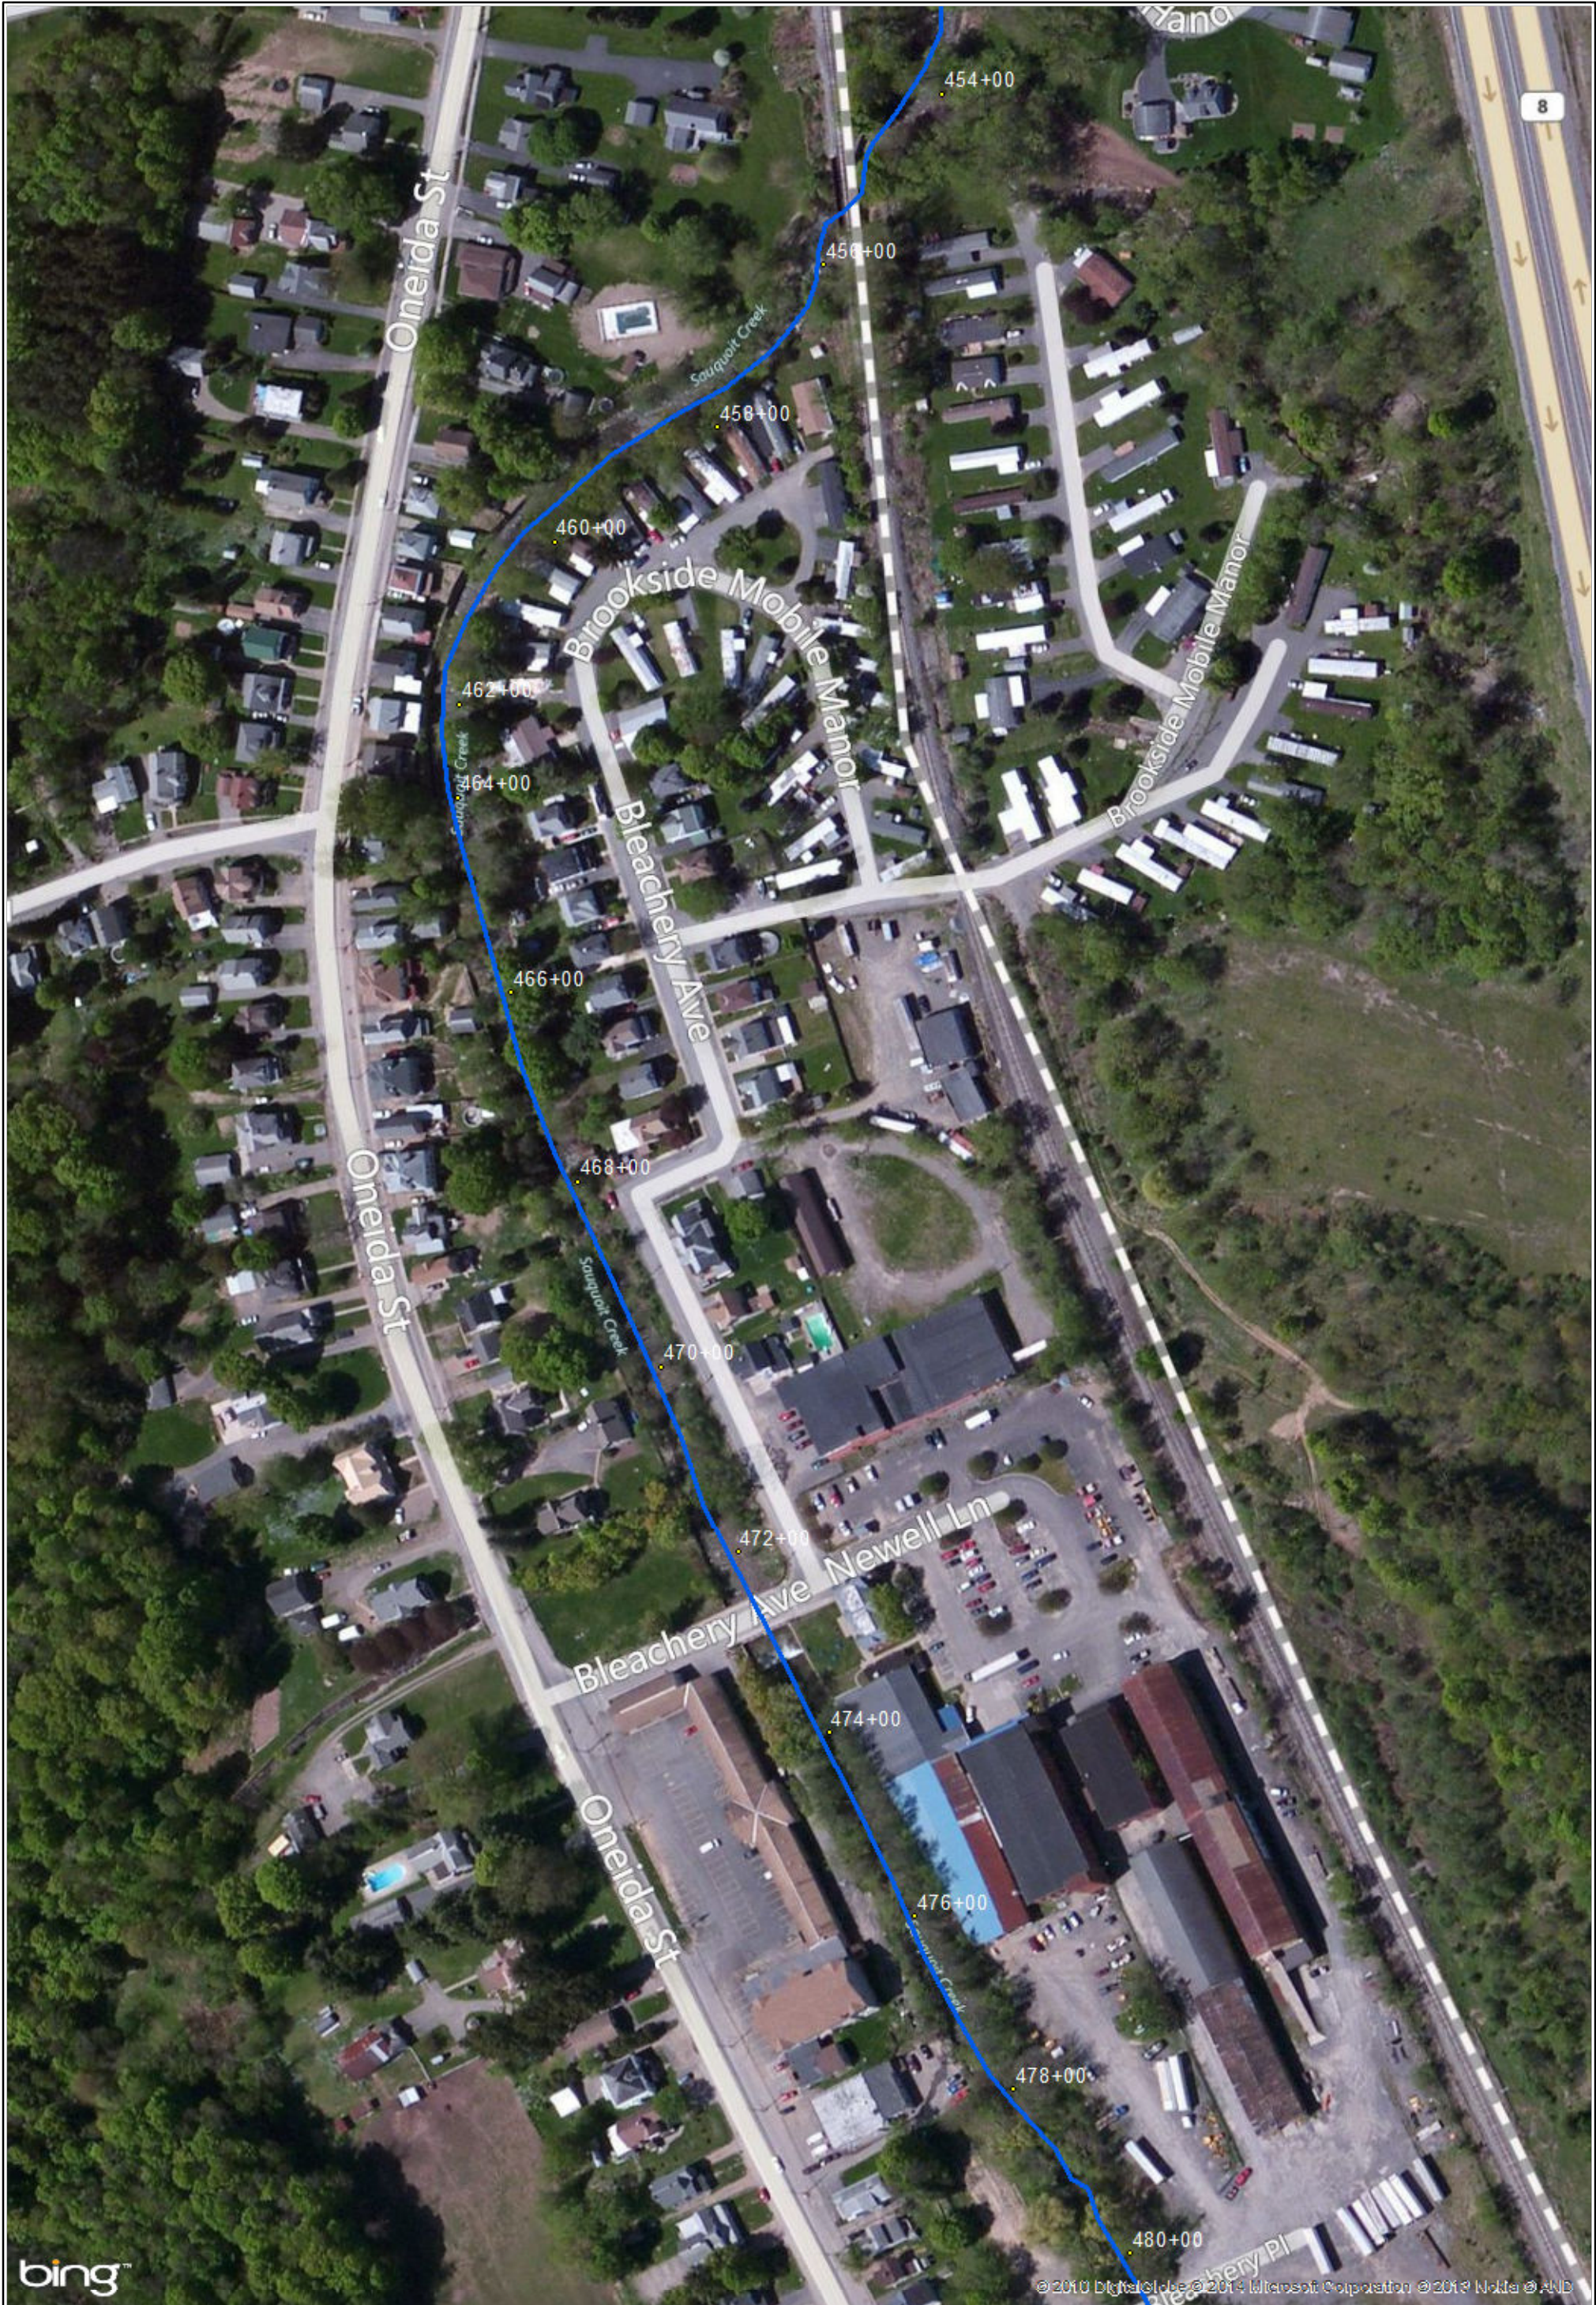
Figure 9: Sauquoit Creek High Risk Area #3

Figure 9 is a location plan of High Risk Area #3. This area begins at STA 478+00 and extends downstream to STA 455+00. It includes a densely developed area at the center of the hamlet of Chadwicks, including the Brookside Mobile Manor trailer park, a strip mall with two restaurants, an existing low-head run-of-river dam, and two undersized bridges at Bleachery Avenue and a railroad crossing. Community officials report that extensive flooding occurs in this area.

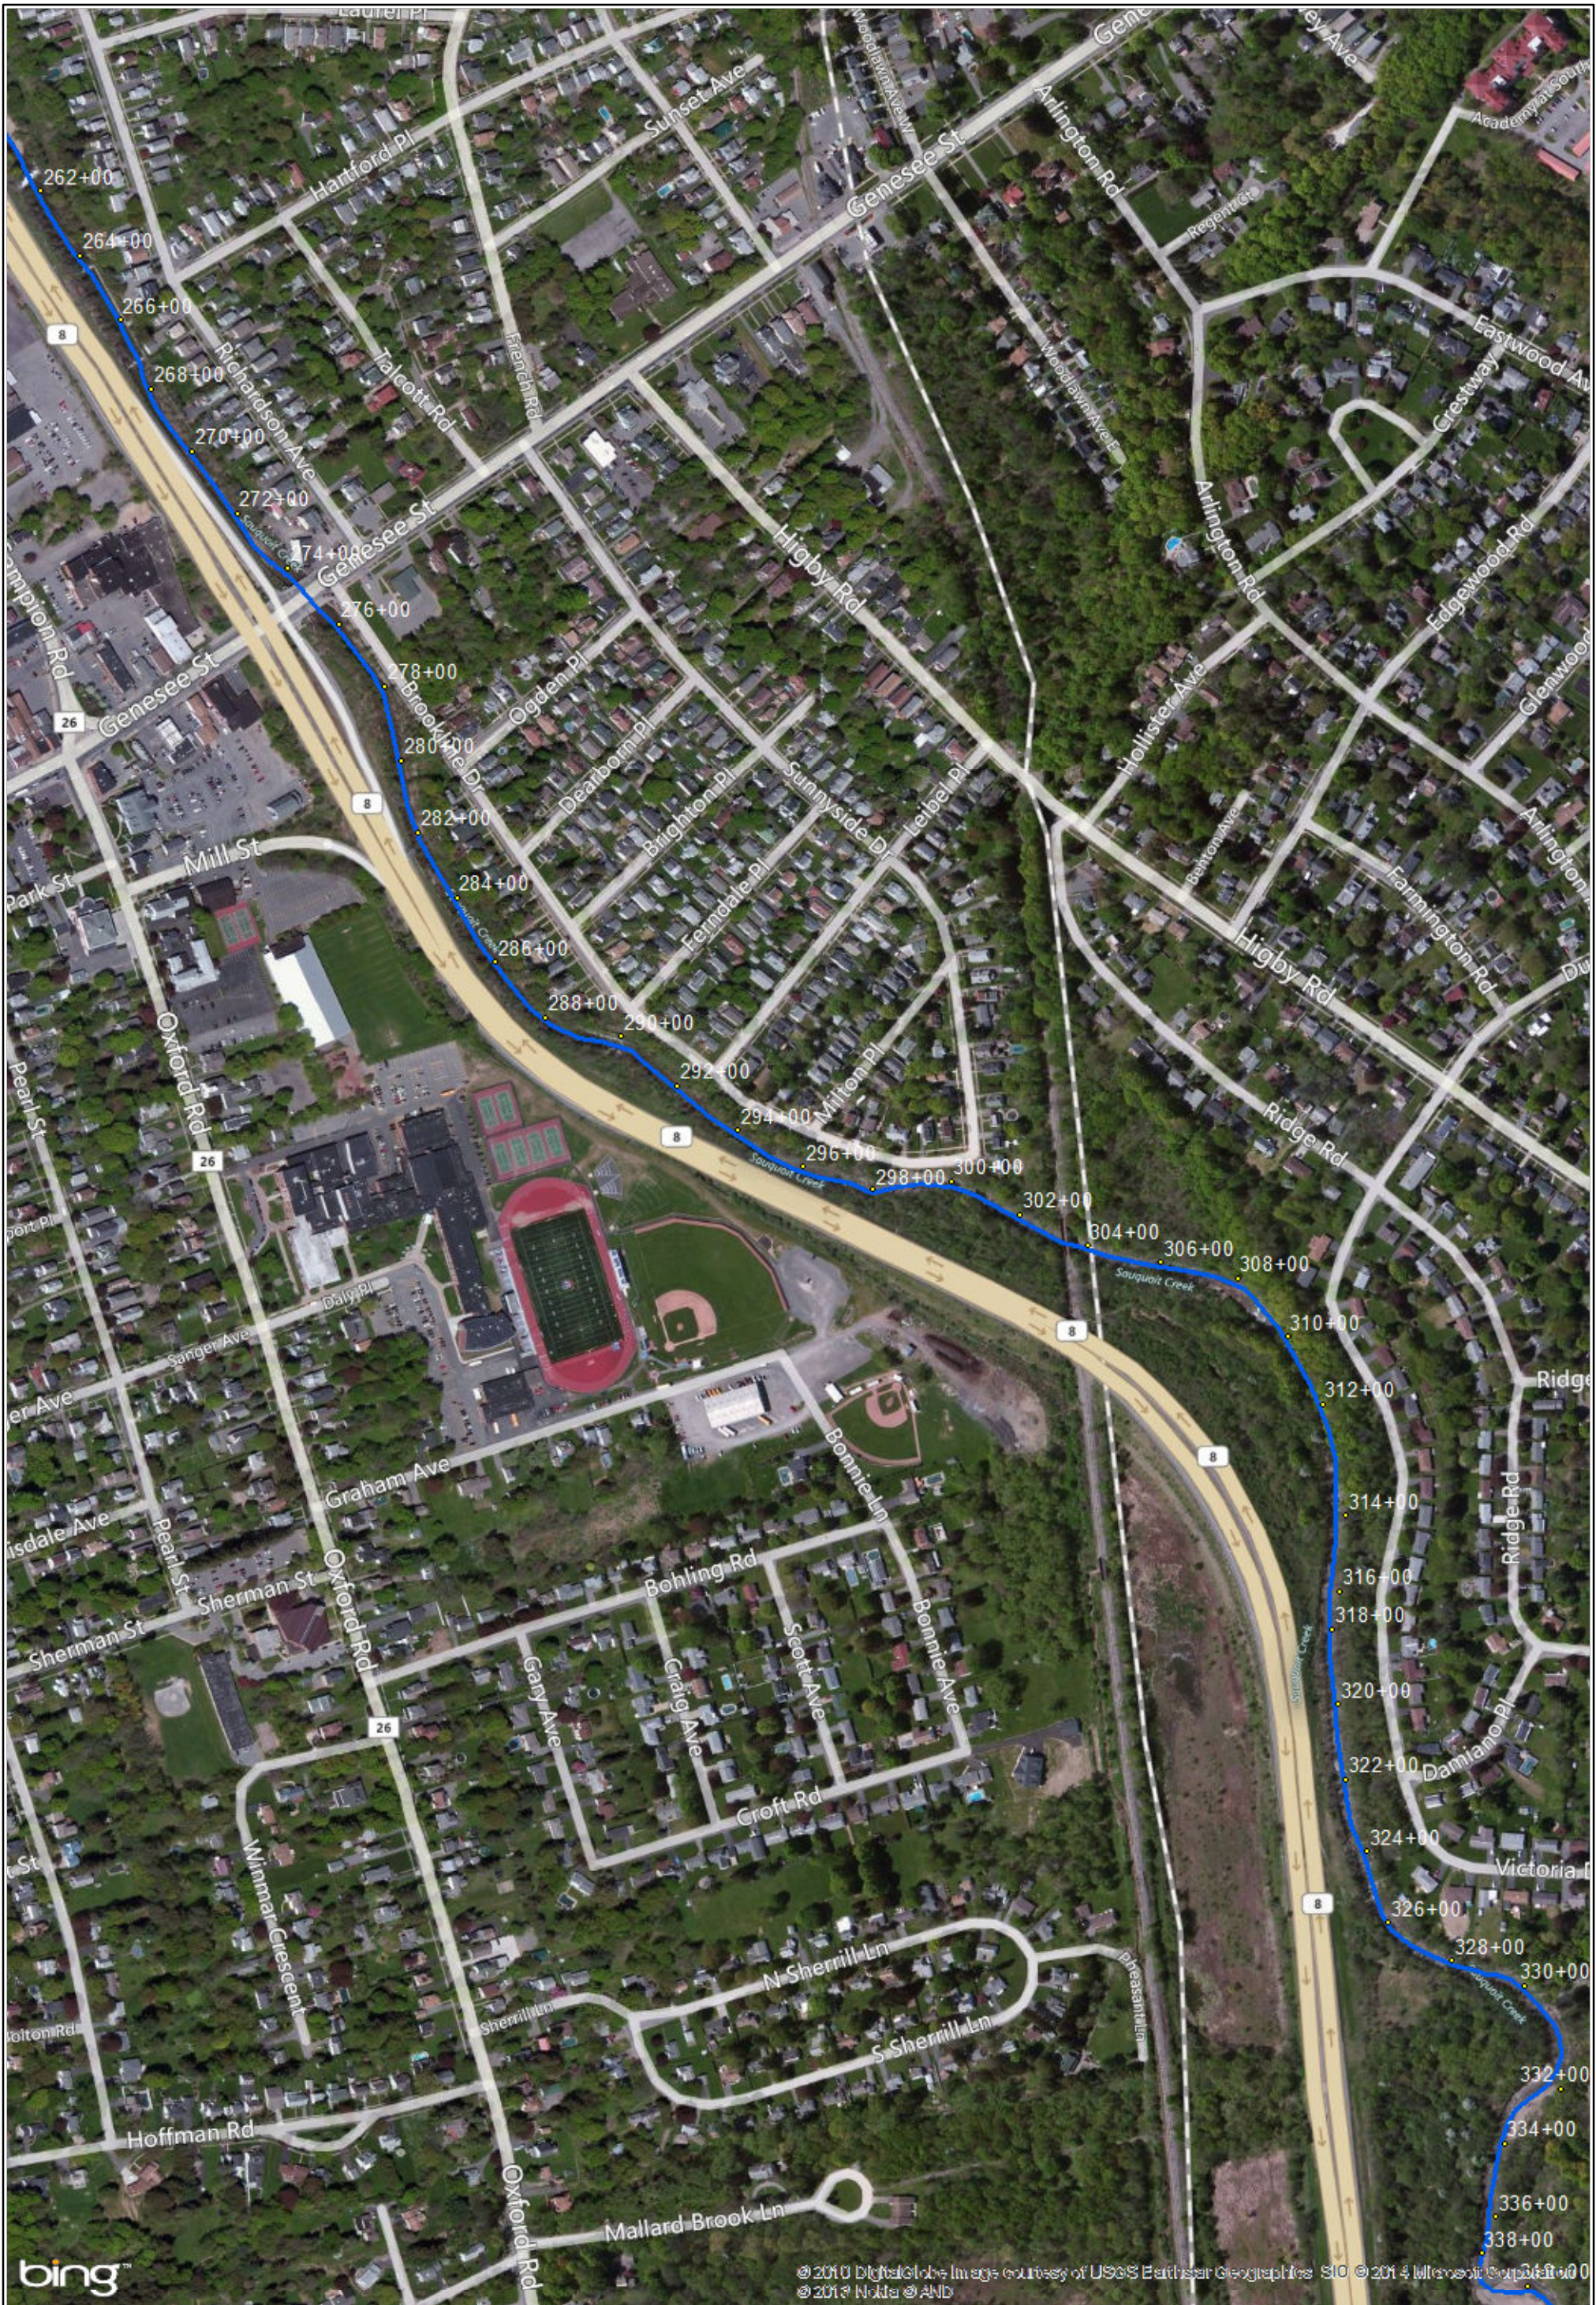
Figure 10: Sauquoit Creek High Risk Area #4

Figure 10 is a location plan of High Risk Area #4. In this area, Sauquoit Creek overtopped its right bank during the flooding in June 2013 near STA 330+00 and reportedly caused flood damage to houses north of the creek on Victoria Drive. The creek overtopped its banks at two other locations near STA 300+00 and STA 291+00 along Brookline Drive. The damaged banks at these locations were treated with stacked rock walls. The FEMA profile and maps show these areas to be located in the floodplain of the Sauquoit.

Alternative 4-1: Creation of Naturalistic Channel with Floodway

Restoration of the floodplain through this reach would involve widening the banks of the Sauquoit Creek to incorporate a floodplain bench. This could affect up to 6,000 linear feet of channel, cause roadway impacts, and require modification of at least 17 properties and the removal of at least 17 additional homes on the right bank of the creek.

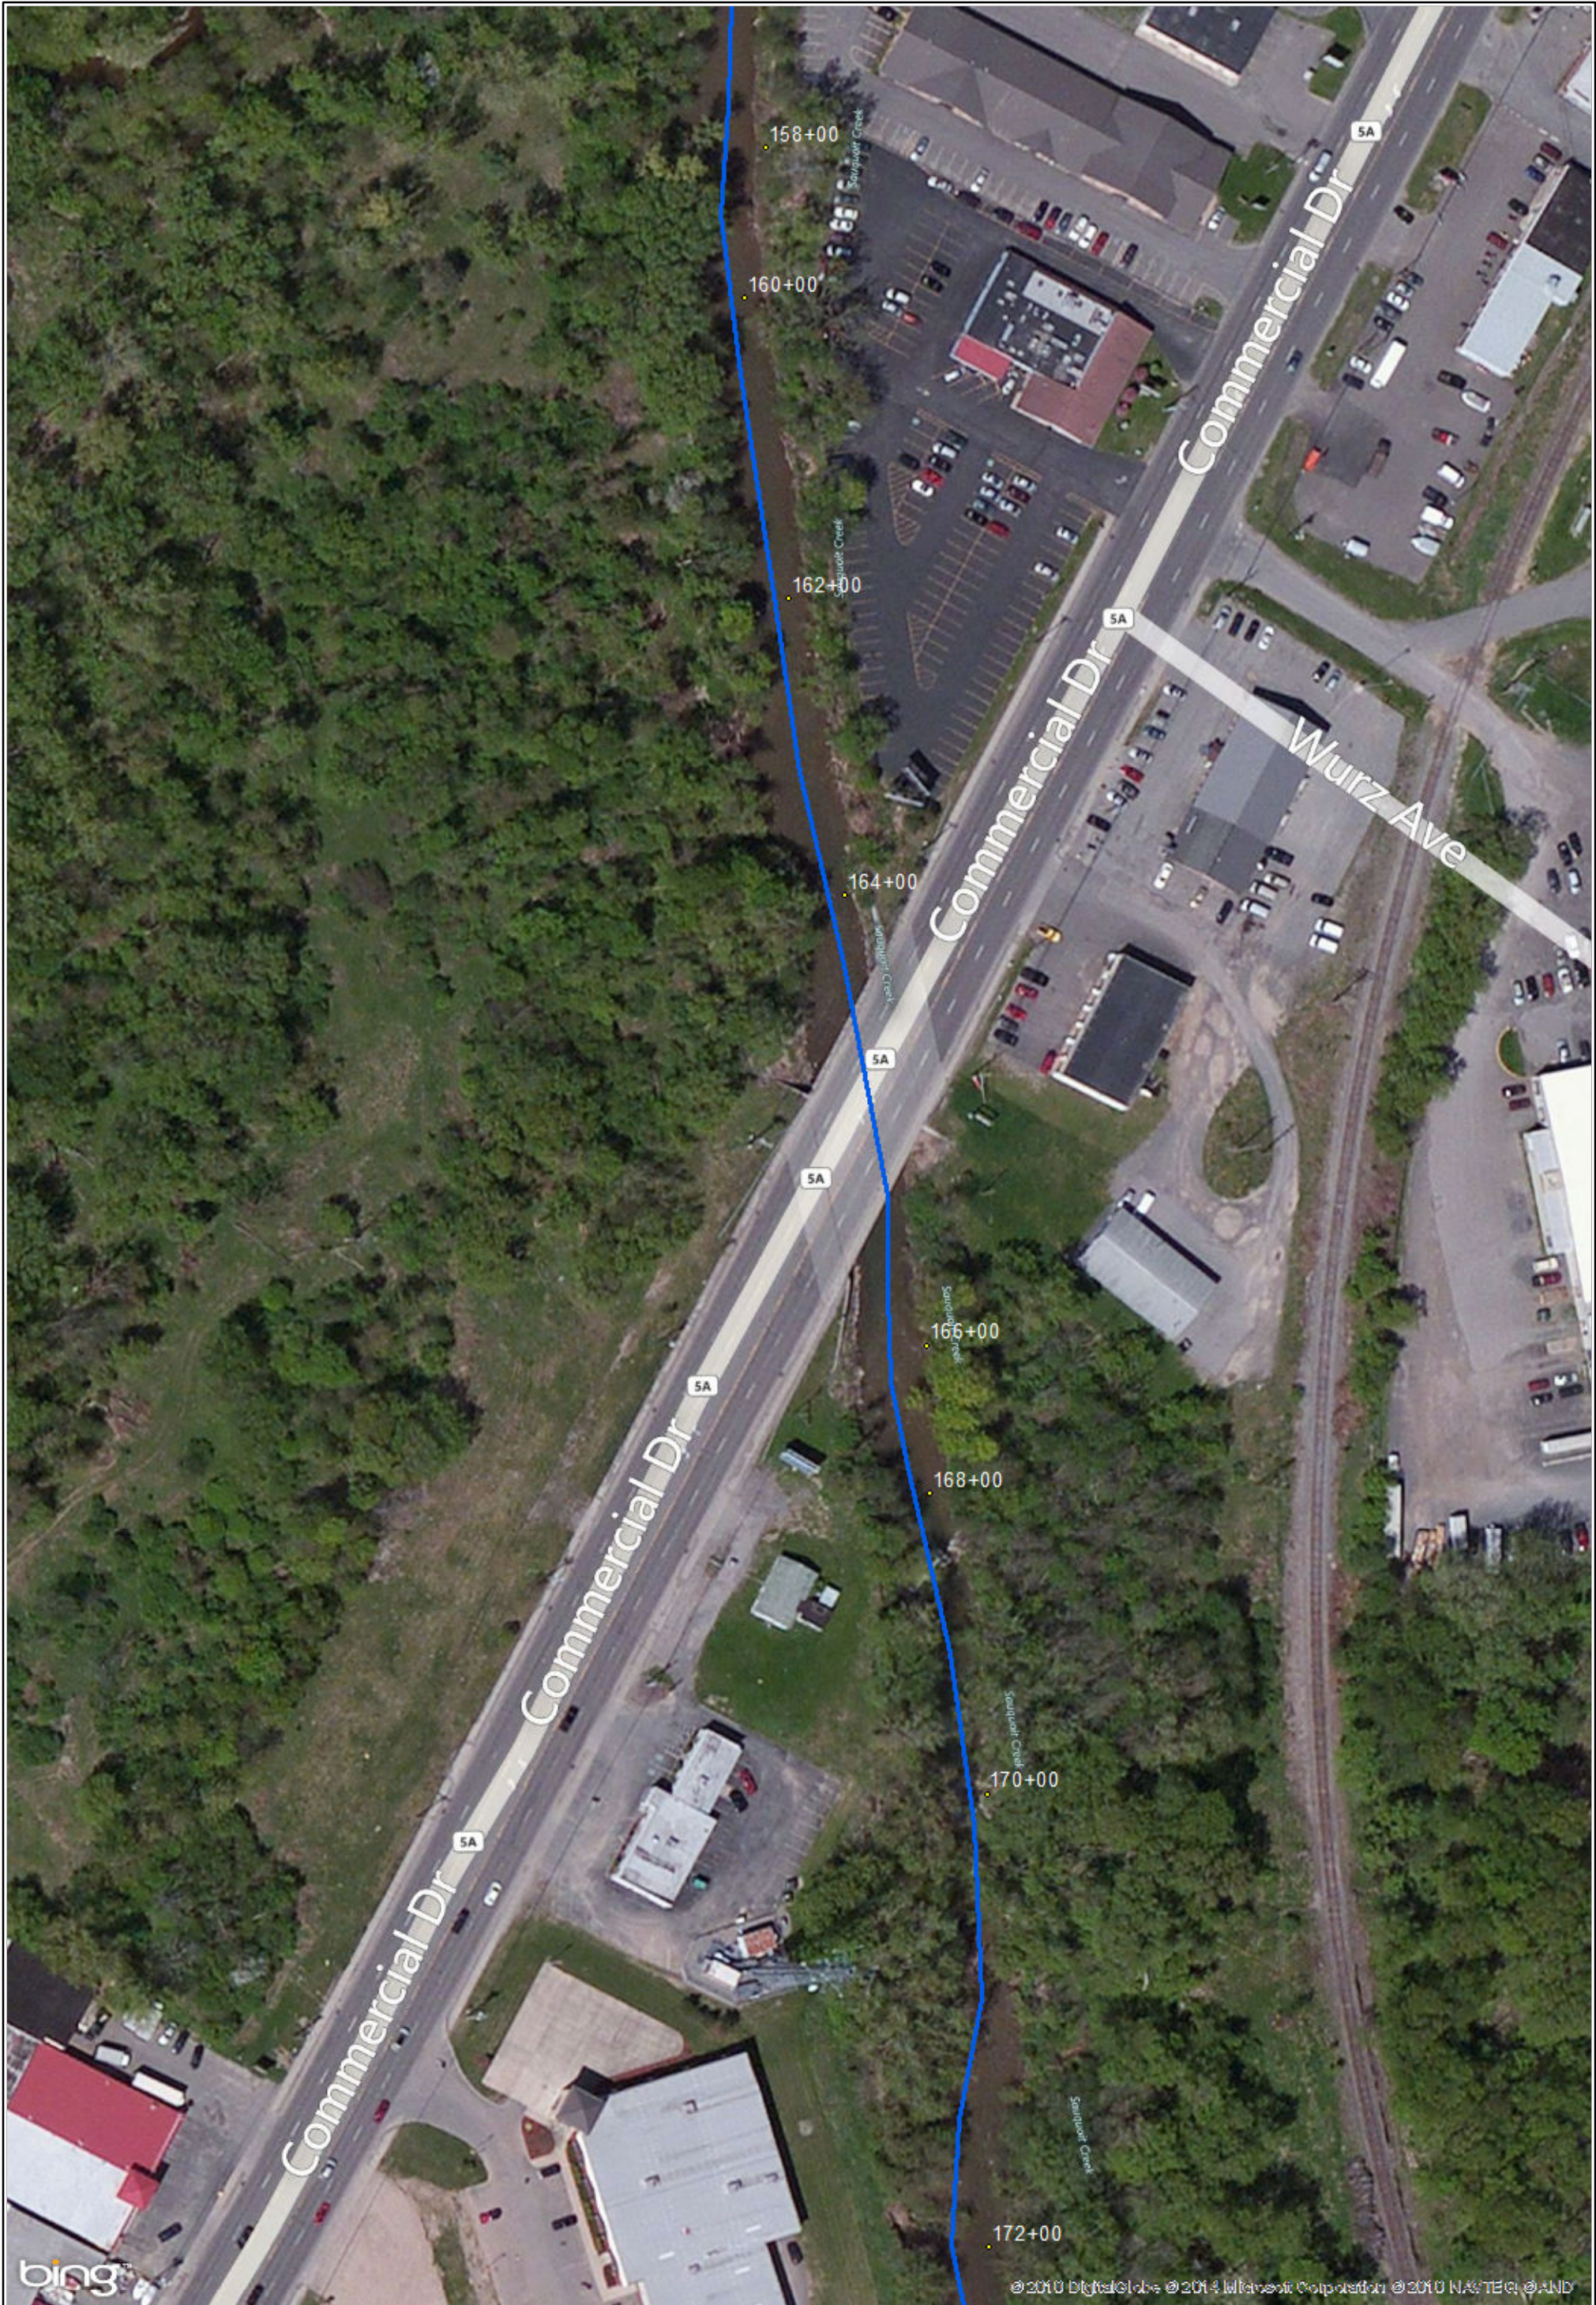
Figure 11: Sauquoit Creek High Risk Area #5

High Risk Area #5 is depicted on Figure 11. FEMA FIRMs indicate that extensive flooding occurs on the left bank of Sauquoit Creek in the area downstream of Clinton Street (STA 185+00) and upstream of Commercial Drive (STA 165+00), between the creek and Henderson Street. FEMA profiles indicate that there is a substantial increase in water surface elevations in this area during the 50-, 100-, and 500-year flow events as a result of the undersized bridge crossing at Commercial Drive.

Modeling by MMI indicates that the hydraulic constriction at this structure is not as significant as reported by FEMA but is a hydraulic constriction nonetheless. The bridge is poorly aligned with the channel, which further reduces the capacity of the bridge. The backwater effect extends upstream nearly to Clinton Street. The impacted area includes several commercial structures, a park, and several homes.
