EMERGENCY TRANSPORTATION INFRASTRUCTURE RECOVERY
WATER BASIN ASSESSMENT
AND FLOOD HAZARD MITIGATION ALTERNATIVES

SAUQUOIT CREEK
ONEIDA COUNTY, NEW YORK

April 2014

MMI #5231-01

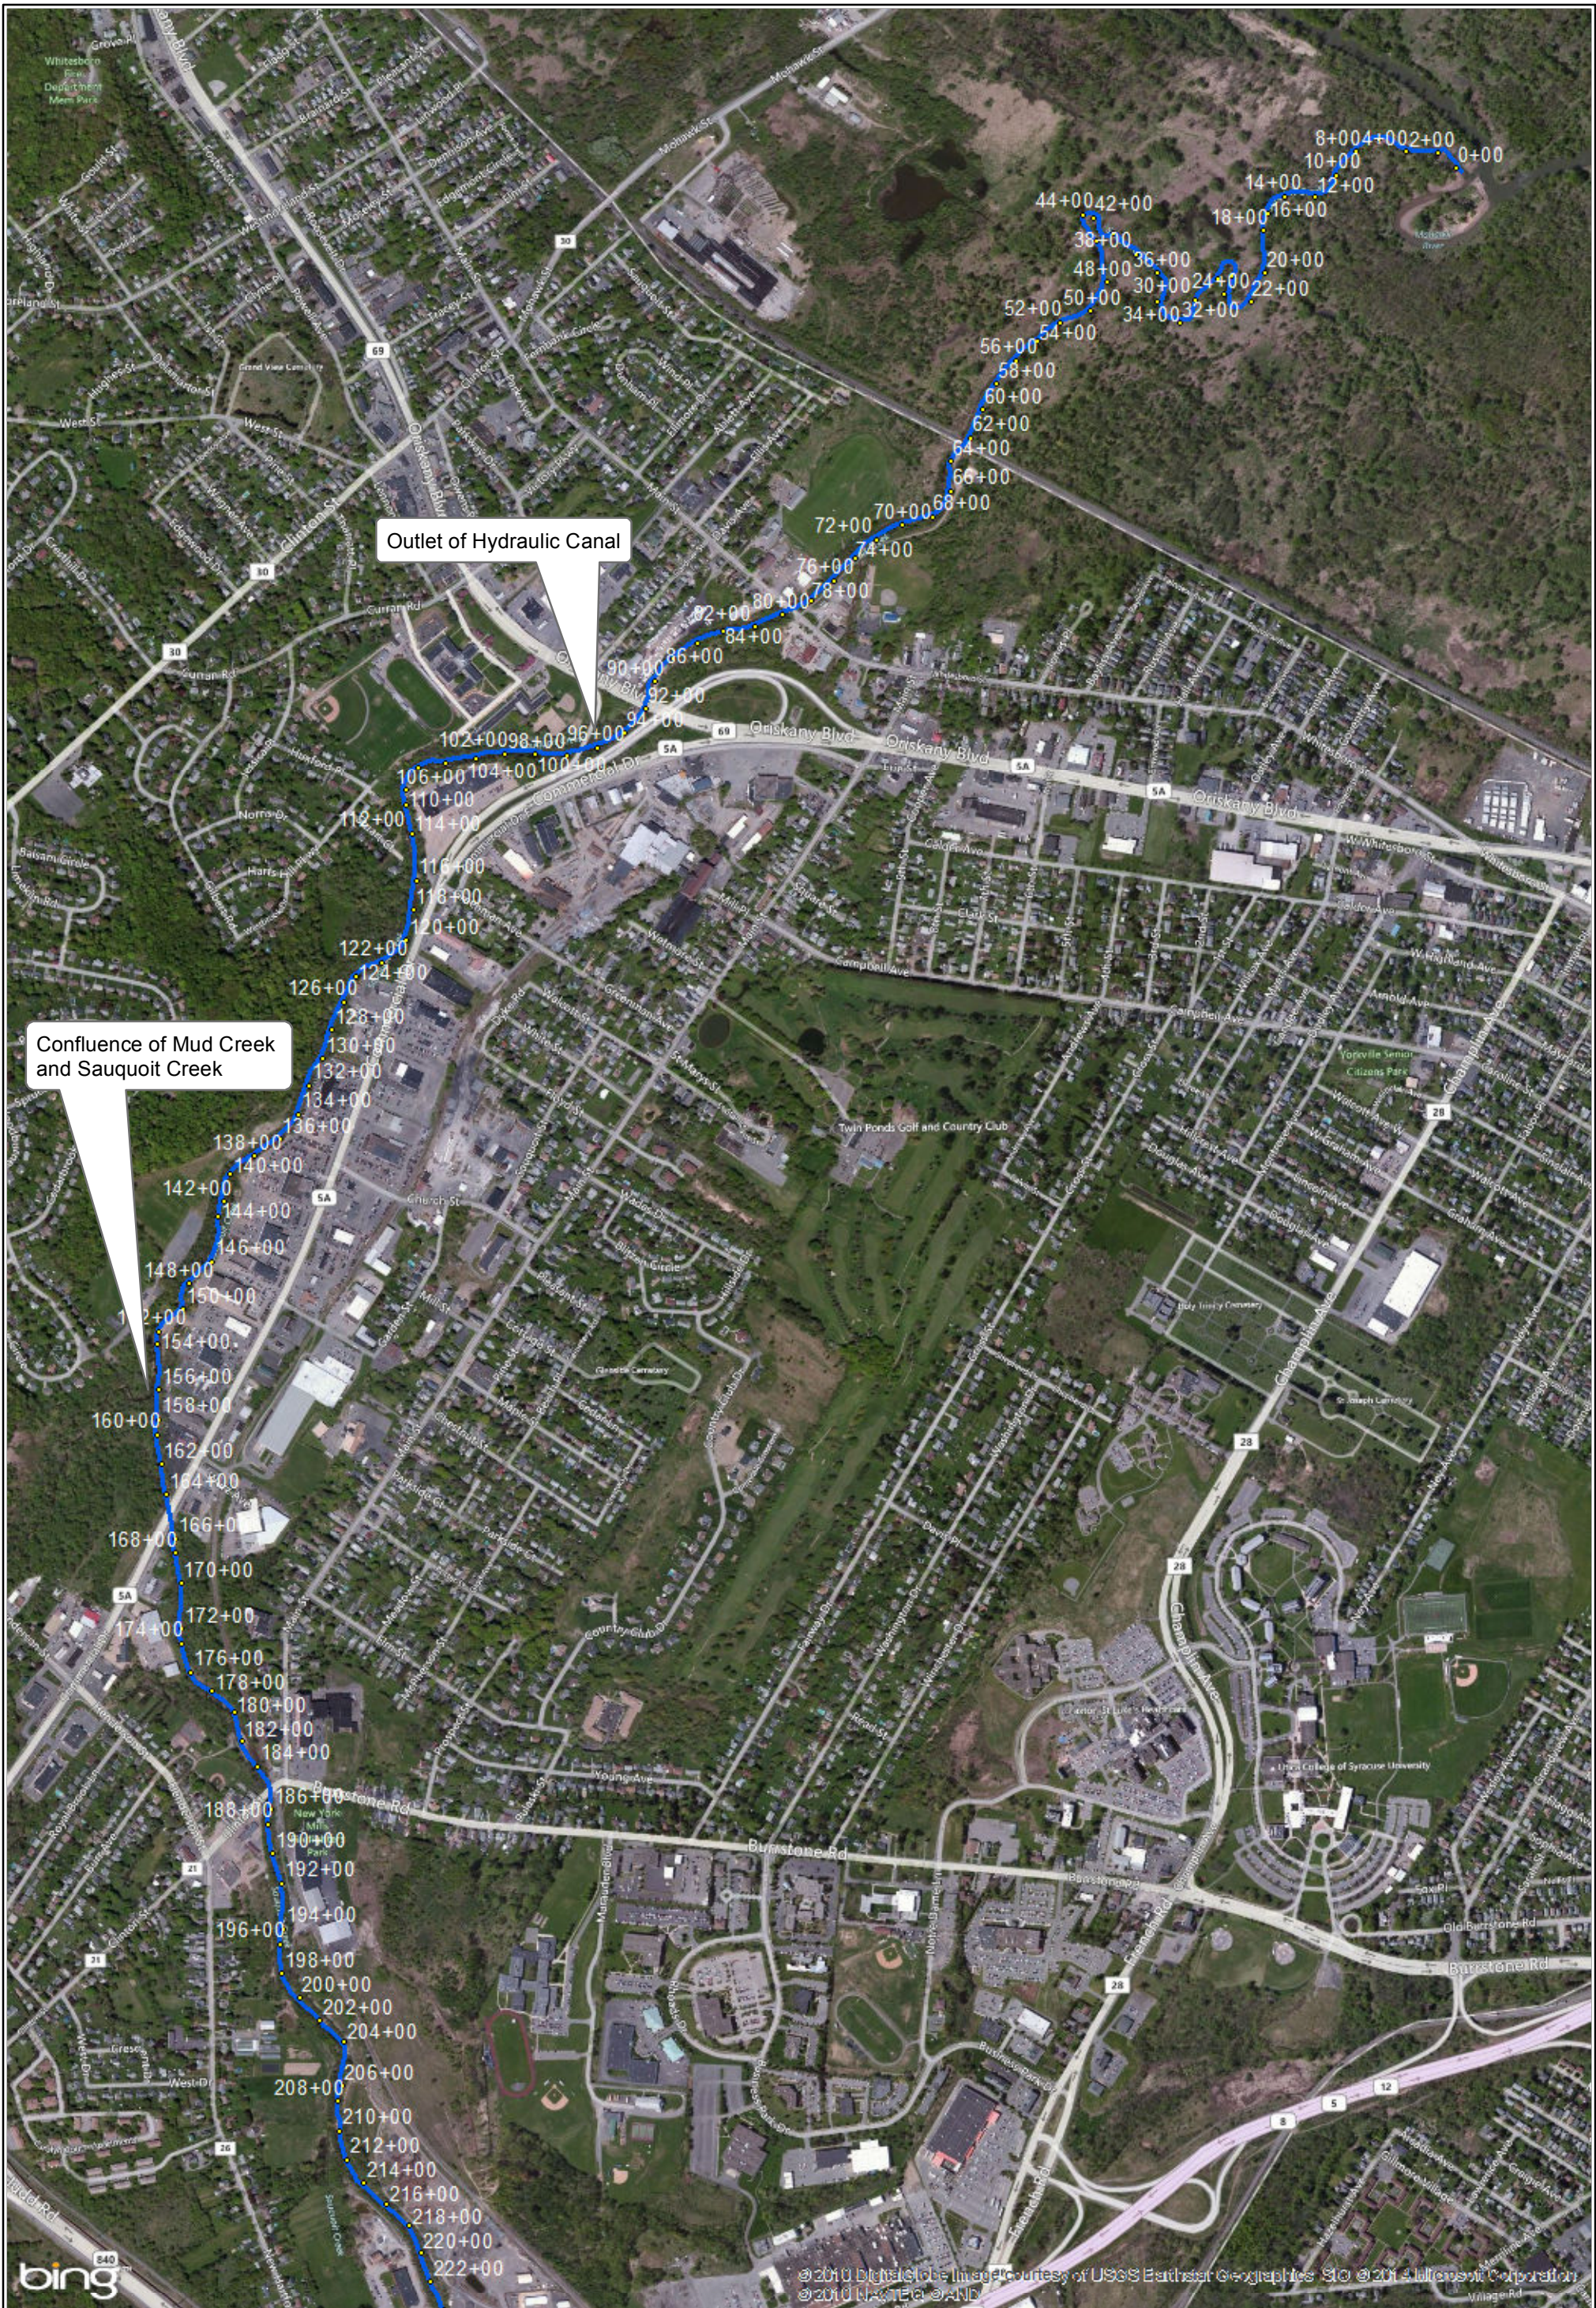
Figure 12: Sauquoit Creek High Risk Area #6

Figure 12 is a location plan of High Risk Area #6. This area extends from just upstream of Commercial Drive, at STA 176+00, downstream to the Mohawk River at STA 0+00. Mud Creek enters Sauquoit Creek at STA 157+00. This heavily developed corridor experiences extensive flooding of businesses, car dealerships, and the school in the vicinity of STA 104+00. Flooding is exacerbated at the outlet of a hydraulic canal, which reportedly backs up and contributes to flooding at STA 96+00. A stormwater outflow at the Main Street bridge also backs up during high flows, contributing to flooding. This reach is extremely flat, and small rises in water surface elevations can have marked impacts on the area of inundation.

Due to the combination of multiple undersized bridges, an undersized channel, heavily developed floodplain, and flat stream grade, there will be no simple, low-cost solution to widespread flood mitigation in this reach. The alternatives described below may well occur in multiple phases over a time frame that could span decades and cost many millions of dollars. The community may wish to approach flood mitigation through this reach as a master plan of improvements, including bridge replacement, channel alteration, sediment management, and individual property protection that occurs over time. The alternatives that follow focus on developing a long-term solution to accommodate the 100-year flood event, thus removing the vast majority of residents and businesses out of the floodplain.

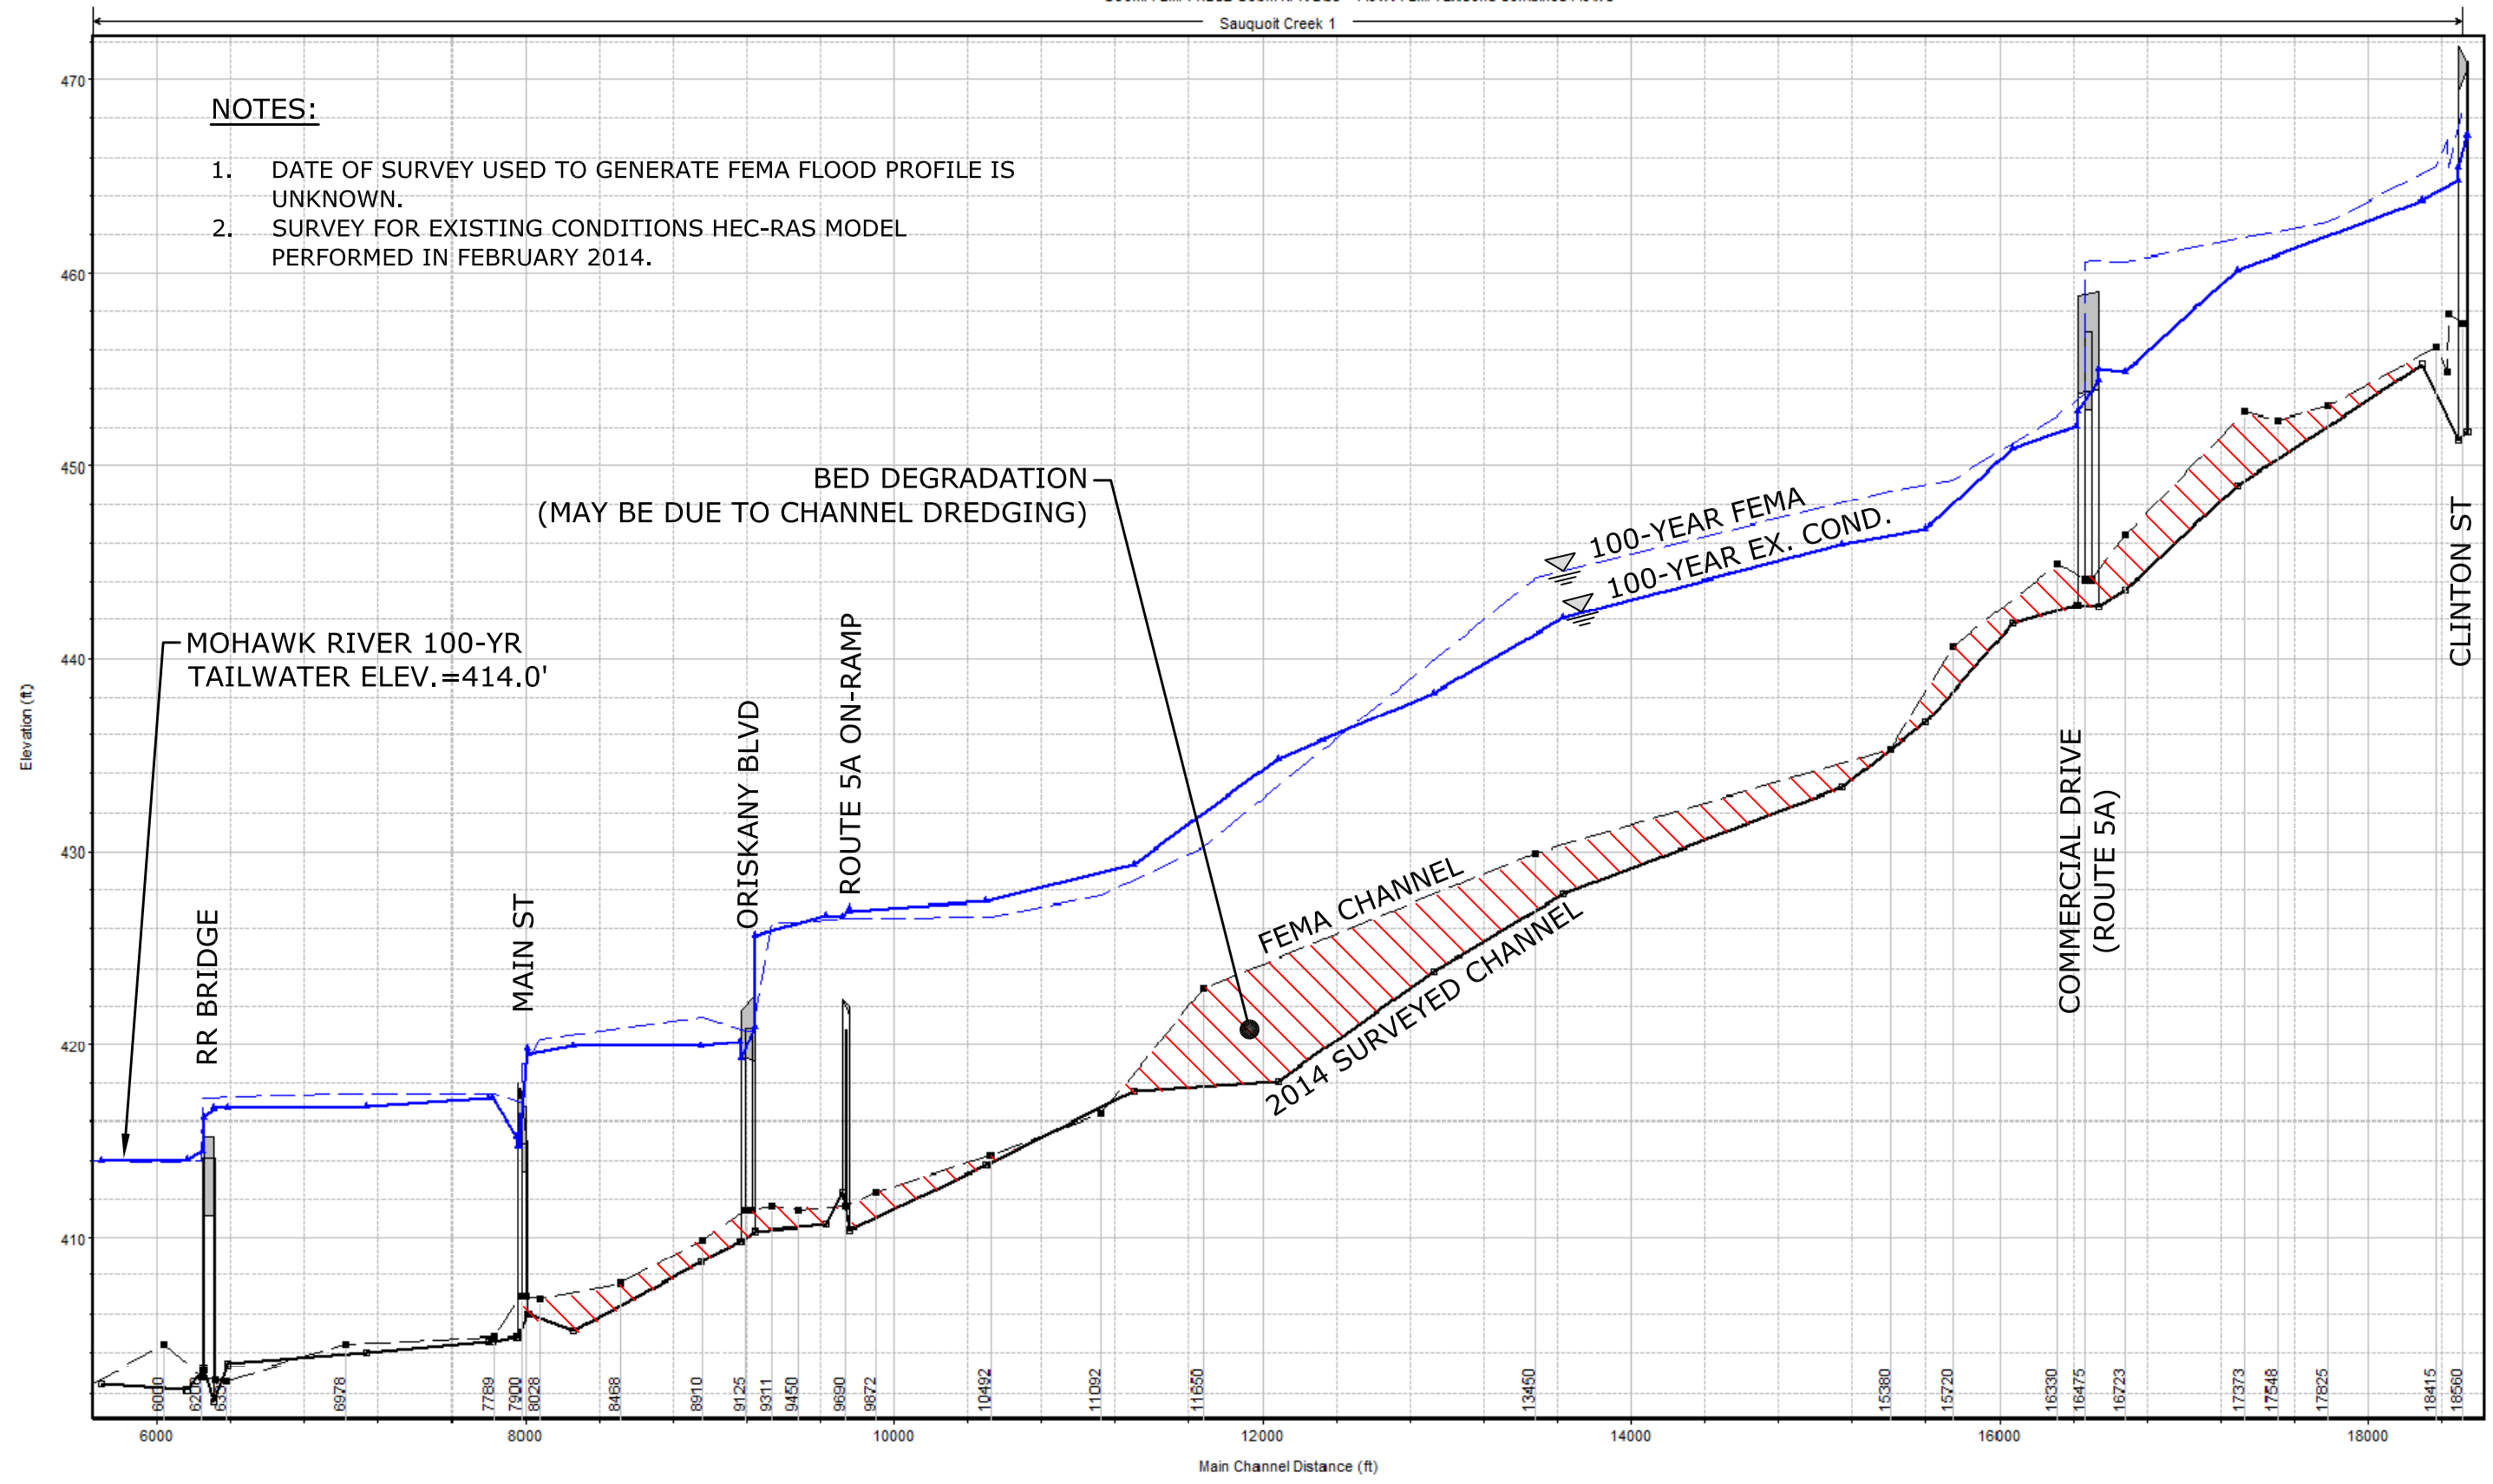
FIG. 13

A comparison of the FEMA baseline model elevations to the recently surveyed conditions suggests that dredging may have occurred through this reach. In some cases, the difference in streambed elevation is five or more feet. Figure 13 shows the FEMA geometry profile against the more recent survey.
