**EMERGENCY TRANSPORTATION INFRASTRUCTURE RECOVERY**  
**WATER BASIN ASSESSMENT**  
**AND FLOOD HAZARD MITIGATION ALTERNATIVES**

**WEST CANADA CREEK**  
**HERKIMER COUNTY, NEW YORK**

April 2014

MMI #5231-01

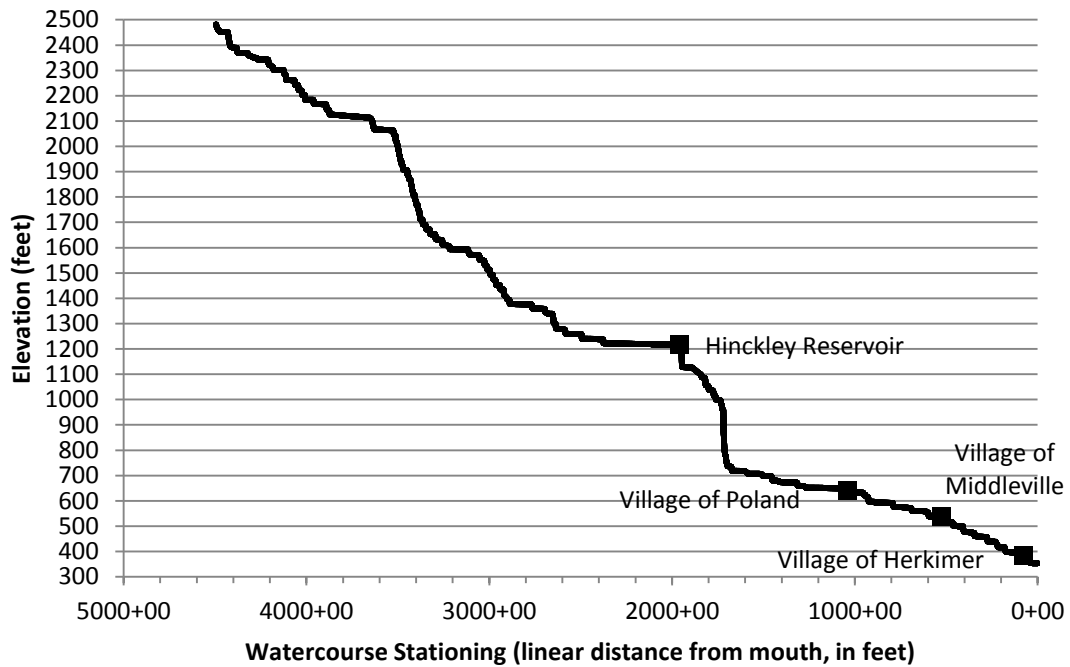
**FIGURE 4  
West Canada Creek Profile**

Figure 4 is a profile of West Canada Creek, showing the watercourse elevation versus the linear distance from the mouth of the watercourse. The creek has an average slope of 0.47 percent over its entire stream length of 85.1 miles. It drops a total of 2,128 vertical feet over its length, from an elevation of 2,481 feet above sea level at its headwaters in the Adirondacks to 354 feet at its mouth at the Mohawk River east of the village of Herkimer.
