EMERGENCY TRANSPORTATION INFRASTRUCTURE RECOVERY WATER BASIN ASSESSMENT AND FLOOD HAZARD MITIGATION ALTERNATIVES

ORISKANY CREEK ONEIDA COUNTY, NEW YORK

April 2014

MMI #5231-01

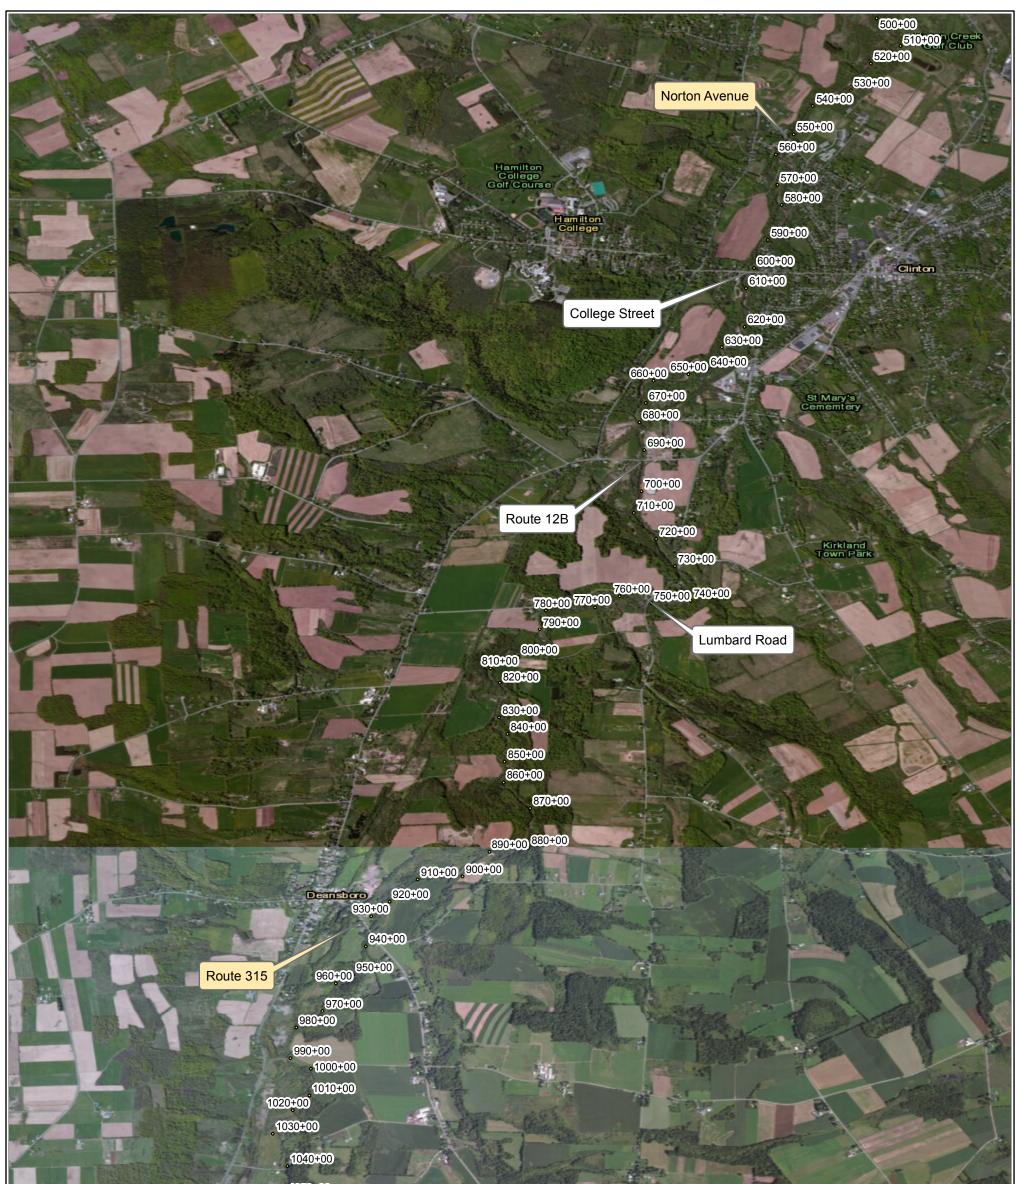
Figure 8 is a location plan of High Risk Area #1. This area focusses on the bridges along Oriskany Creek that cause the creek to overtop its banks during flood events because they are acting as hydraulic constrictions. In many cases, these bridges fail to span even the bankfull channel width and, according to FEMA profiles, are acting as hydraulic constrictions.

The bridges where some of the most severe flooding to buildings and property has been reported are the Route 315 bridge (STA 936+50) and the Norton Avenue bridge (STA 554+00). The FEMA profiles showing these bridges are included as Figures 9 and 10.

Alternative 1-1: Prioritize the most severely floodprone, undersized bridges for replacement.

Tier 1: Replace undersized bridges at Route 315 (STA 936+50) and Norton Avenue (STA 554+00) with structures that are large enough to span the creek's bankfull width and convey flood flows without causing a hydraulic constriction. The Route 315 bridge is one of the bridges identified for replacement in Governor Cuomo's Scour Critical Bridge Replacement Program. According to the Governor's website, "*This bridge carries NY Route 315 over Oriskany Creek in the Town of Marshall, Oneida County. The highway at this location carries an average of 1,980 vehicles a day. This 51 ft. span steel jack arch bridge on high concrete abutments founded on rock was constructed in 1930, connects Waterville with Deansboro. The bridge connects residential and business districts."*

Alternative 1-2: Prioritize second-tier undersized bridges for replacement as funding becomes available.

Tier 2: As funding becomes available, replace or remove bridges at Van Hyning Road (STA 1096+00), Lumbard Road (STA 752+00), Route 12B (STA 692+00), and College Street (STA 603+00). Justification for replacing bridges to protect a relatively few number of developed parcels may be difficult. However, as these structures are scheduled for repair or replacement, modifications should be undertaken to increase their hydraulic capacity.

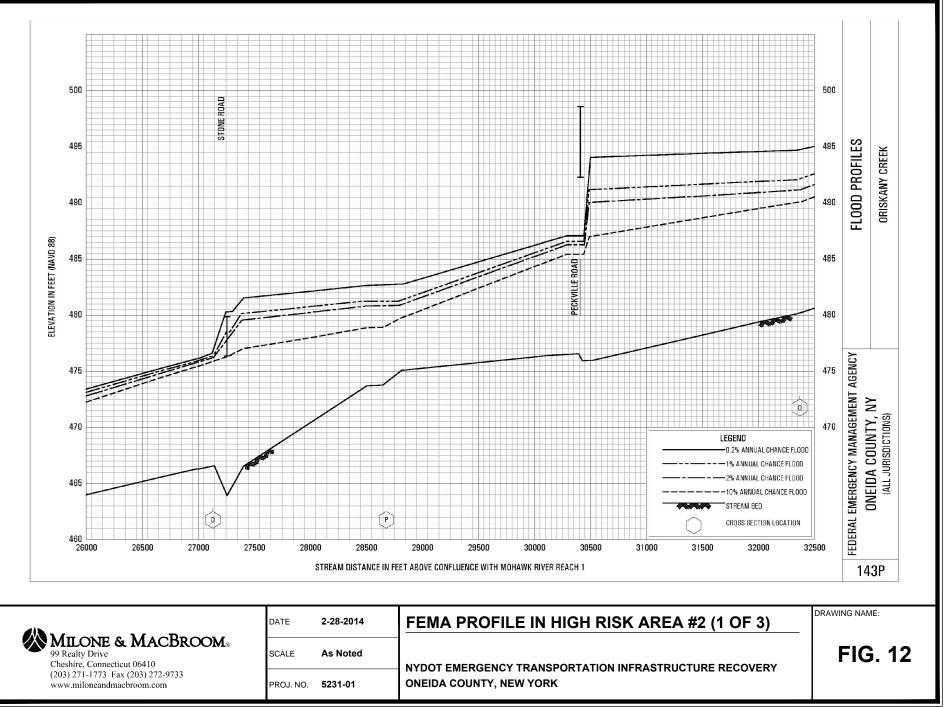
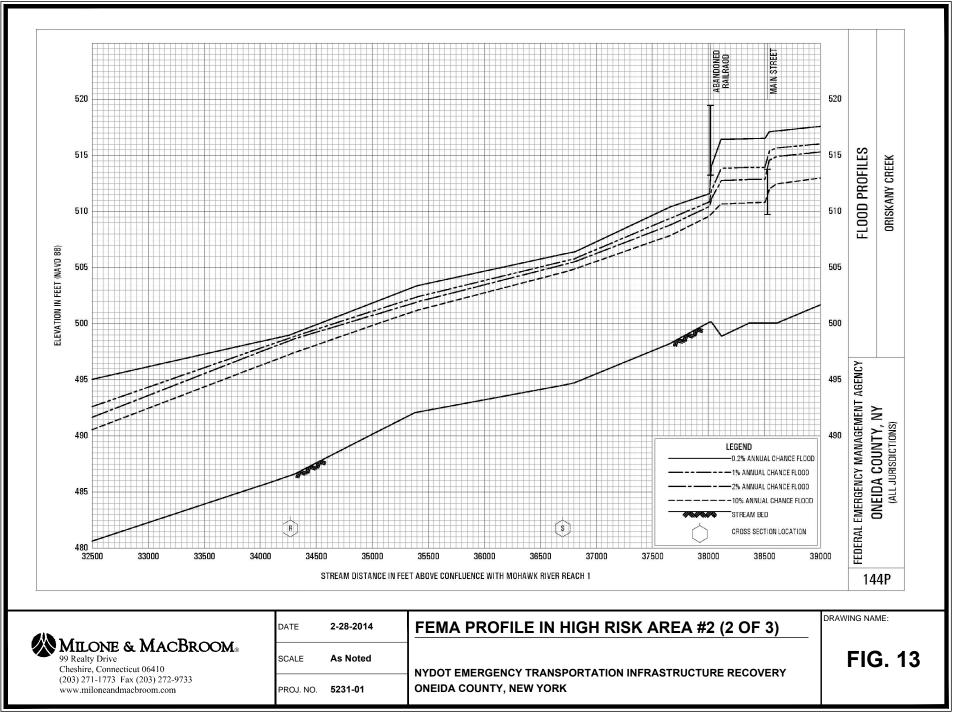
A low-head dam located approximately 3,000 feet downstream of Route 5, at STA 436+00, is acting to increase water surface elevations upstream of the dam by between 5.5 and 6.5 feet during peak flood events, depending on the magnitude of the storm. This influence diminishes gradually moving upstream from the dam but results in a significant increase in water surface elevation that extends through Kirkland beyond the Route 5 bridge. The slope of the channel between the Route 5 bridge and the dam is extremely flat, with only an approximately 0.5-foot drop in elevation between the bed of the channel under the bridge and the crest of the dam.

A number of bridges downstream of the dam also contribute to flooding conditions in the area. These include the Main Street bridge (STA 390+00), an abandoned railroad bridge (STA 385+00), the Peckville Road bridge (STA 310+00), and the Stone Road bridge (STA 278+00). The backwater from the series of bridges reaches the dam. The FEMA profiles showing these bridges and the dam are included as Figures 12 through 14.

Alternative 2-2: Replace Undersized Bridges.

Replace undersized bridges at Main Street (STA 390+00), the abandoned railroad (STA 385+00), Peckville Road (STA 310+00), and Stone Road (STA 278+00). When evaluating the hydraulics for any one of these structures, the hydraulics of the others should be considered as well as the effects of the upstream dam. This reach of Oriskany Creek is complex in that changes from one structure affect the hydraulics of the others.

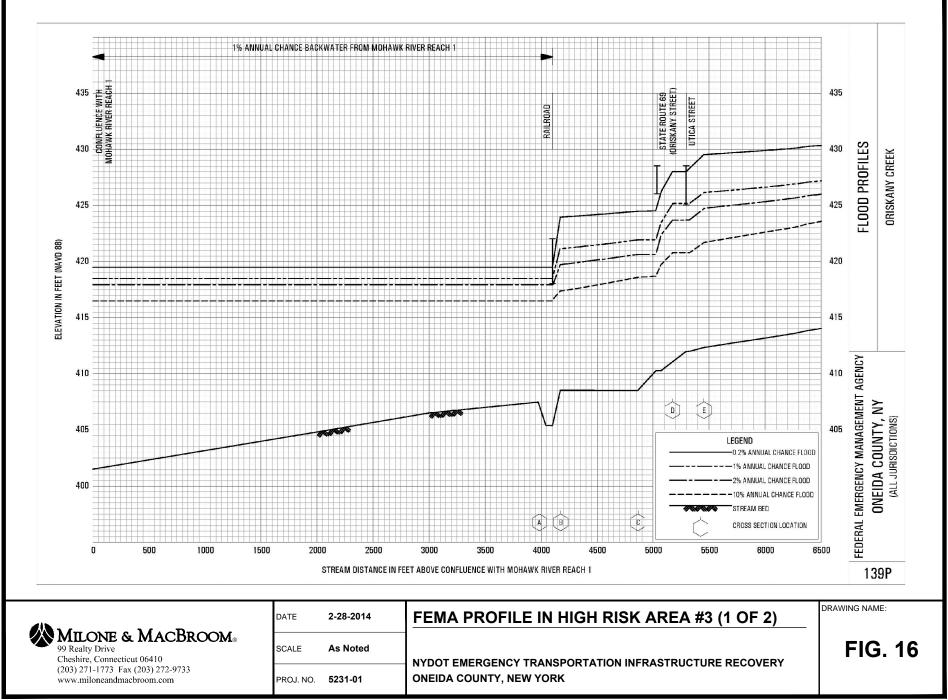
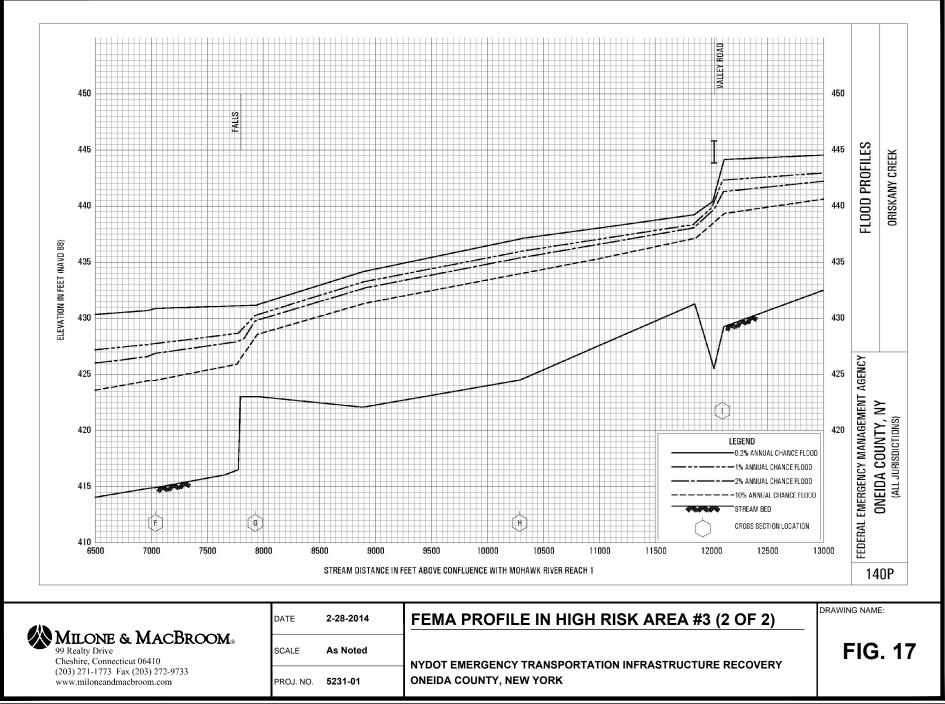
L/TEMP/ACPUBLISH_25328/FIS REPORT FIGS.DWG Layout Tab:FIG16

Figure 15 is a location plan of High Risk Area #3. Flooding and damage to Valley Road (Route 32) has been reported in the vicinity of STA 81+50 upstream to STA 99+00 in the backwater area of the dam located at STA 81+50. According to the FEMA profile, the dam creates an increase in water surface elevation upstream of the dam by more than five feet during the 10-year flood event, which is contributing to flooding and flood-related damages to Valley Road.

In flood events larger than the 10-year frequency, the FEMA profile indicates that the backwater effect caused by hydraulic constrictions at the Utica Street bridge (at STA 56+50, approximately 2,500 feet downstream of the dam) reaches upstream of the dam and combines with the backwater effect of the dam to raise water surface elevations through this reach. The Erie Boulevard and railroad bridges (STA 53+50 and STA 43+50, respectively) also create a backwater effect that extends upstream from these bridges, contributing to increased water surface elevations from STA 43+50 to upstream beyond the dam at STA 81+50, including the Little League fields on the right bank. A recently constructed earthen levee between the Little League fields and the creek was observed during field investigations in October and November 2013. The FEMA profiles showing these bridges and the dam are included as Figures 16 and 17.

The dam at STA 81+50 does not appear to be serving a useful function at the present time. It appears that the original intent of the dam was to store water and direct it through a channel that runs approximately 2,000 feet along the west side of Valley Road from the dam to the Department of Public Works facility, where it returns to the creek. Removal or modification of this dam to reduce or eliminate the backwater effect would decrease water surface elevations upstream of the dam during flood events and would potentially reduce flooding and flood-related damages along Valley Road between STA 81+50 and STA 99+00.

Alternative 3-3: Removal of Levee at Little League Fields

During field inspections in late fall 2013, a recently constructed earthen levee was observed between the Little League fields and associated parking area, and Oriskany Creek, approximately between STA 72+00 and STA 69+00. While flood control levees can serve a useful function for protecting high-value properties and infrastructure from flood damage, they require long-term inspection and maintenance. In cases where a levee overtops, or if runoff collects behind it, a pump system is required to remove water from behind the levee. In certain circumstances such as a breach, levees can worsen flood problems. The levee at the Little League field separates Oriskany Creek from its natural floodplain, thus reducing flood storage and potentially exacerbating flooding at points further downstream. The area being protected by the levee (ball fields, dugouts, and concession stand) are of relatively low value. Complete removal of the levee is recommended.

Alternative 3-4: Removal or Replacement of Three Bridges in Oriskany

Bridges at Utica Street (STA 56+50), Erie Boulevard (STA 53+50), and the railroad (STA 43+50) serve as hydraulic constrictions during flood flows. Removal or replacement of one or a combination of these bridges would provide the largest flood mitigation. Due to the close proximity of Utica Street and Erie Boulevard, it may be feasible and cost effective to replace one of these bridges with a larger structure and remove the other, routing traffic over the remaining bridge.

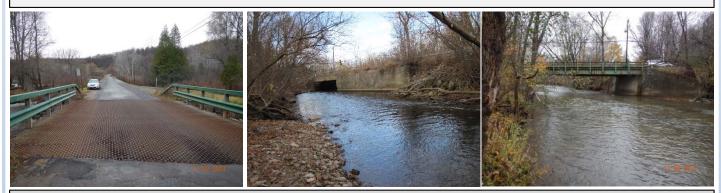
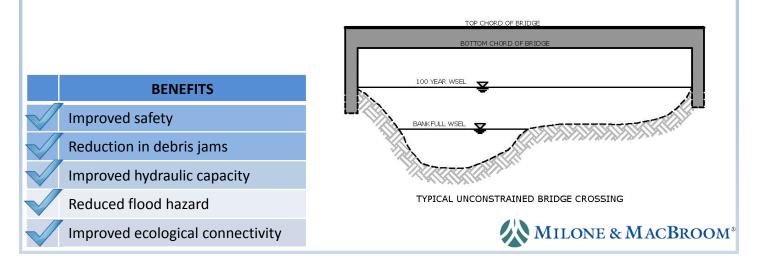
Site Description: Along upper Oriskany Creek, several bridges cause the creek to overtop its banks during flood events because they are acting as hydraulic constrictions. In many cases, these bridges fail to span even the bankfull channel width, and according to FEMA profiles, are acting as hydraulic constrictions during flood conditions.

The bridges where some of the most severe flooding to buildings and property has been reported are the Route 315 Bridge (STA 936+50) and the Norton Avenue Bridge (STA 554+00). The FEMA profiles identify additional bridges that are acting as hydraulic constrictions, but where no flooding of structures has been reported, due in part to the low density of development in proximity to many of these crossings. These include Van Hyning Road (STA 1096+00), Lumbard Road (STA 752+00), Route 12B (STA 692+00), and College Street (STA 603+00).

- Prioritize the most severely flood prone, undersized bridges for replacement. These include Route 315 (STA 936+50) and Norton Avenue (STA 554+00).
- Prioritize second tier undersized bridges for replacement, as funding becomes available. These include Van Hyning Road (STA 1096+00), Lumbard Road (STA 752+00), Route 12B (STA 692+00), and College Street (STA 603+00).
- Replace bridges with structures that are large enough to span the creek's bankfull width and convey flood flows without causing hydraulic constriction.

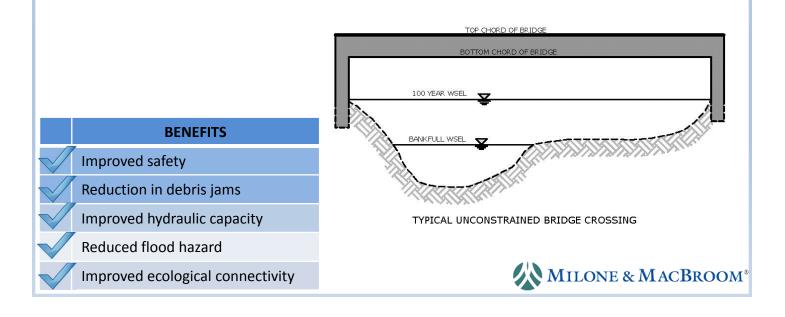
High-Risk Area #2: Low Head Dam at STA 436+00

Site Description: This dam is located approximately 3,000 feet downstream of Route 5 in Kirkland. The dam is acting to significantly increase water surface elevations through Kirkland extending upstream of the Route 5 Bridge. A sediment bar has formed upstream of the dam. The hydraulics in this reach are complex and include the backwater from the dam as well as numerous under-sized downstream bridges.

- Replace undersized bridges at Main Street (STA 390+00), the abandoned railroad (STA 385+00), Peckville Road (STA 310+00), and Stone Road (STA 278+00).
- When evaluating the hydraulics for any one of these structures, the hydraulics of the others should be considered as well as the effects of the upstream dam. This reach of Oriskany Creek is complex and changes from one structure affect the hydraulics of the others and vice versa.

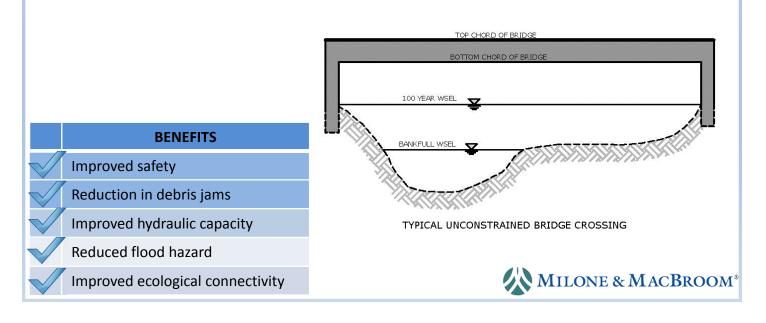
Site Description: According to the FEMA profile, the dam at STA 81+50 creates an increase in water surface elevation upstream of the dam by more than 5 feet during the 10-year flood event, which is contributing to flooding and flood-related damages along Valley Road. In flood events larger than the 10-year frequency flood, the backwater effect caused by hydraulic constrictions at the Utica Street Bridge (at STA 56+50, approximately 2,500 feet downstream of the dam) reaches upstream of the dam and combines with the backwater effect of the dam to raise water surface elevations through this reach.

- Remove or replace one or a combination of these three bridges to provide the largest flood mitigation. Due to the close proximity of Utica Street and Erie Boulevard, it may be feasible and cost effective to replace one of these bridges with a larger structure and remove the other, routing traffic over the one remaining bridge.
- The hydraulic analysis and design will need to take into account the backwater effect of the Mohawk River.
